SUBJECT: SAFETY RECALL (SPECIAL SERVICE CAMPAIGN) – 70B
(FRONT SUSPENSION LOWER BALL JOINTS)

**Special Service Campaign 70B – Front Suspension Lower Ball Joint
2004 through Early 2007 Sequoia and 2004 through late 2006 Tundra
SAFETY RECALL NOTICE**

SPECIAL SERVICE CAMPAIGN 70B (SAFETY RECALL)

FRONT SUSPENSION LOWER BALL JOINTS

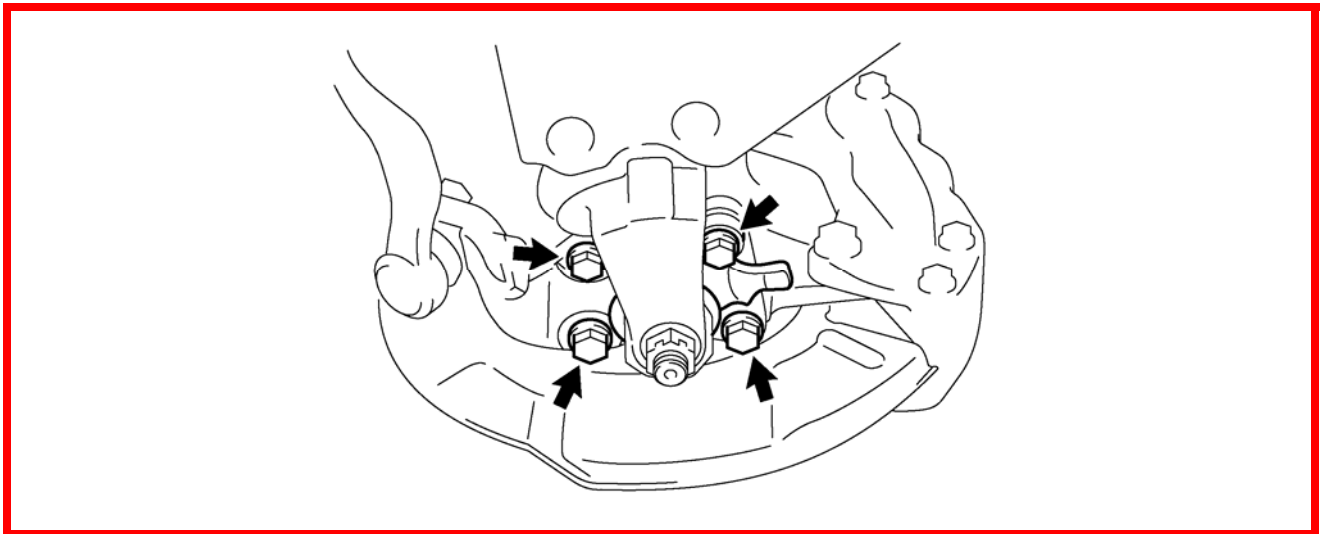
- 1) Confirm the size of the “**Front Suspension Lower Ball Joint Bolt Heads.**”
 - a) For vehicles with...

14mm bolt heads

17mm bolt heads

- Vehicle is involved in SSC 50J. See SSC 50J instructions and replace the ball joint. Please note previous instructions for 50J should be replaced with revised ones available from TIS which reflect that 17 mm bolt heads fall under 70B.

- The vehicle is involved in SSC 70B.
- Proceed to **A. REPLACE THE FRONT SUSPENSION LOWER BALL JOINTS** on page 5.
