SUBJECT: SAFETY RECALL (SPECIAL SERVICE CAMPAIGN) – 80A
(CERTAIN 2003 THROUGH 2004 MODEL YEAR COROLLA AND COROLLA MATRIX
FRONT DOOR GLASS BOLTS)

**Special Service Campaign (SSC) – 80A (SAFETY RECALL)
Certain 2003 through 2004 model year Corolla and Corolla Matrix Front Door Glass Bolts**

**SPECIAL SERVICE CAMPAIGN 80A (SAFETY RECALL)
FRONT DOOR GLASS BOLTS**

**2003 THROUGH 2004 MODEL YEAR COROLLA & COROLLA MATRIX
WITH POWER WINDOWS**

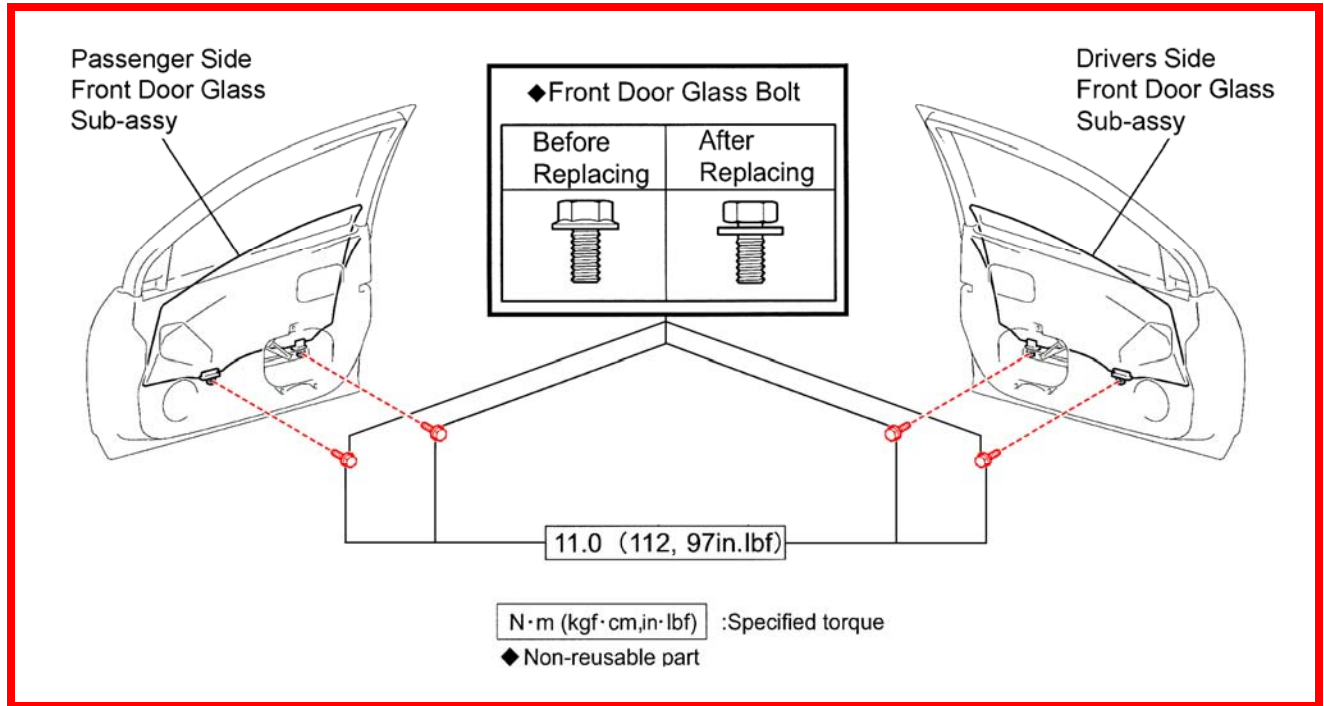
V. BACKGROUND AND COMPONENTS

On certain 2003 through 2004 model year Corolla and Corolla Matrix vehicles equipped with power windows, the driver and front passenger door glass bolts may loosen and come off, causing the door glass to separate from the window regulator. This Safety Recall involves replacement of the 2 driver and 2 front passenger door glass bolts. Total of 4 bolts.
