Subject: Special Service Campaign (SSC) – 90A  
2006 – 2007 Model Year Highlander HV and 2007 Model Year Camry HV Electric Power Steering Link (EPS) Assembly

**Special Service Campaign 90A  
Certain 2006-2007 Highlander HV and 2007 Camry HV  
Electric Power Steering Link (EPS) Assembly Replacement**

**ELECTRIC POWER STEERING LINK (EPS) ASSEMBLY REPLACEMENT**

**2007 CAMRY HV & 2006 THROUGH 2007 HIGHLANDER HV**

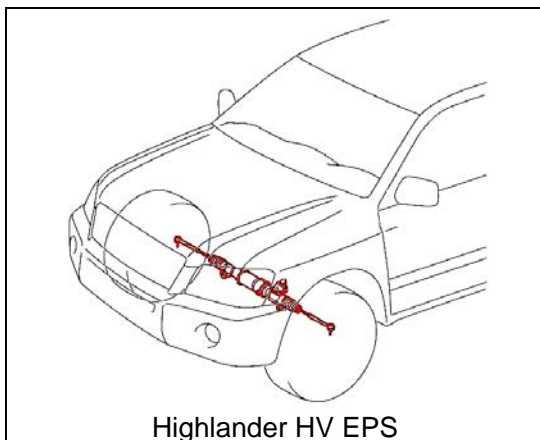
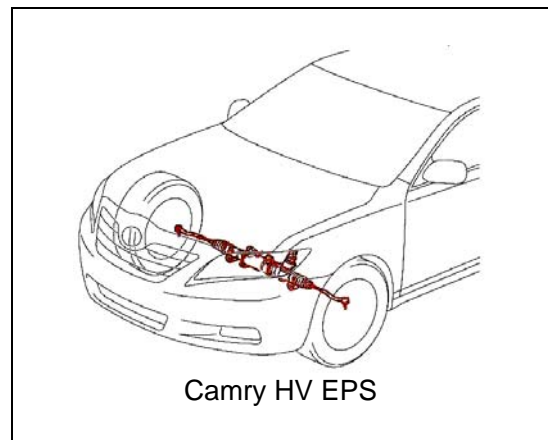
In certain 2006 – 2007 model year Highlander HV and 2007 model year Camry HV's, due to insufficient adhesion between the permanent magnets and the rotor of the EPS, the motor may gradually lose torque when the wheel is turned to the complete left or right position. If this condition occurs, customers may experience a noticeable gradual increase in the steering effort necessary at low speeds. This condition may be most perceptible when parking the vehicle.

**Toyota will initiate a Special Service Campaign to replace the Electric Power Steering Link (EPS) Assembly in certain 2006 – 2007 model year Highlander HV and 2007 model year Camry HV's.**

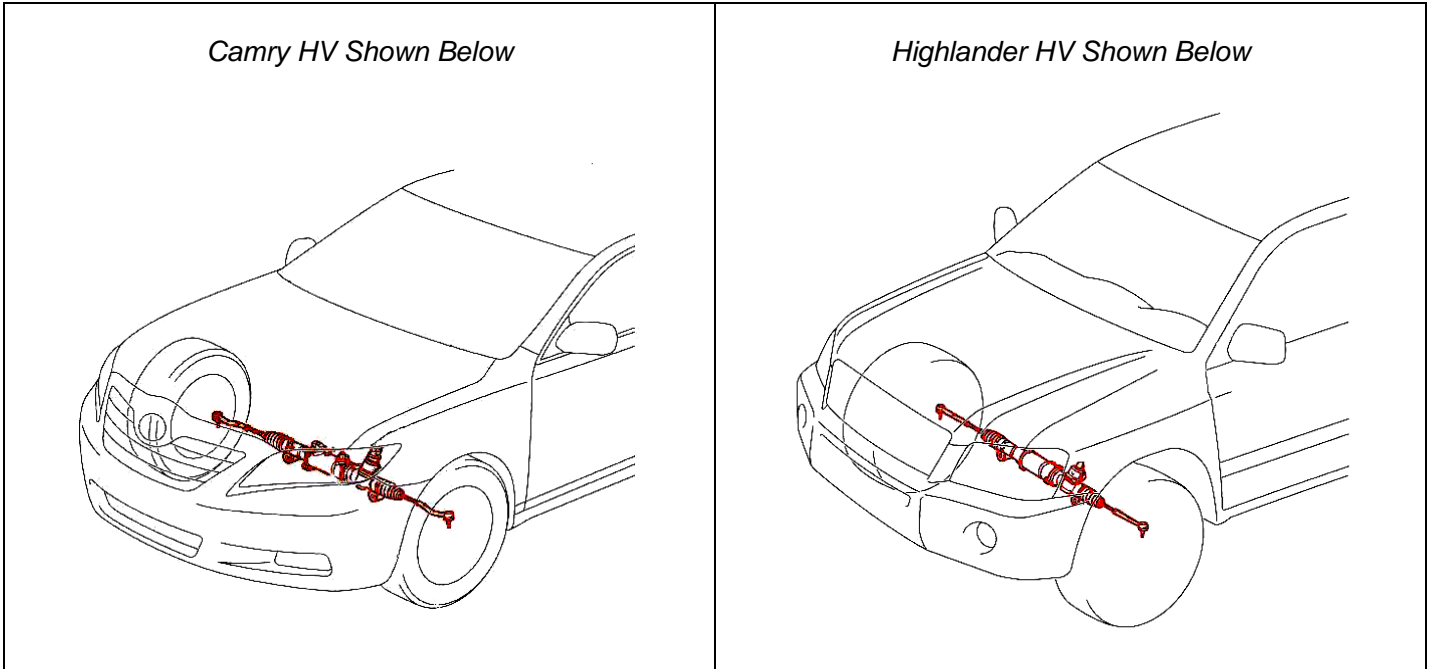
In certain '06 – '07 MY Highlander HV and '07 MY Camry HV, due to insufficient adhesion between the permanent magnets and the rotor of the EPS, the motor may gradually lose torque when the wheel is turned to the complete left or right position. If this condition occurs, customers may experience a noticeable gradual increase in the steering effort necessary at low speeds. This condition may be most perceptible when parking the vehicle.
