Subject: Special Service Campaign (SSC) – 90B
Early 2004 Sienna Driver's Side Center Console Trim Panel (Floor Carpet Cover)

Early 2004 Sienna - Floor Carpet Cover and Retaining Clip Safety Recall Campaign 90B

SPECIAL SERVICE CAMPAIGN 90B

DRIVER'S SIDE CENTER CONSOLE TRIM PANEL
(FLOOR CARPET COVER)

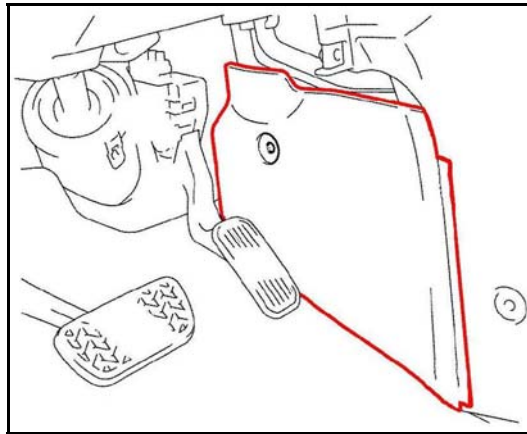
Toyota has received reports that the Retaining Clip for the Driver's-side Center Console Trim Panel (Floor Carpet Cover) was missing in a handful of vehicles. If this Retaining Clip is missing, the Floor Carpet Cover may become loose. If this condition is not repaired and the accelerator pedal is depressed to nearly full throttle, a loose floor carpet cover may interfere with the accelerator pedal.

Toyota will initiate a Special Service Campaign to replace the Driver Side Center Console Trim Panel (Floor Carpet Cover) and retaining clip on certain early 2004 model year Sienna vehicles.

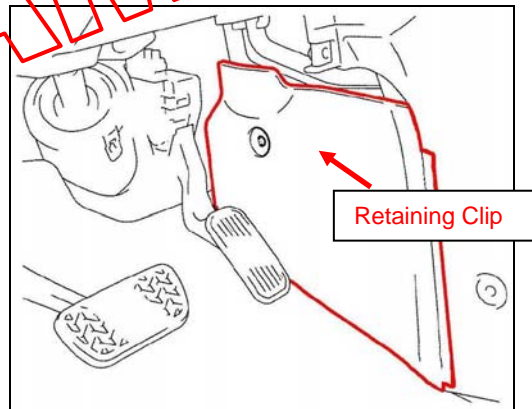
Until this repair is completed on your vehicle, you may verify the Retaining Clip is installed on your vehicle by inspecting for it as indicated below. If the clip is missing, please call your local Toyota dealership.

Any Toyota dealer will replace the Retaining Clip and Floor Carpet Cover with a newly designed one at **NO CHARGE** to you.

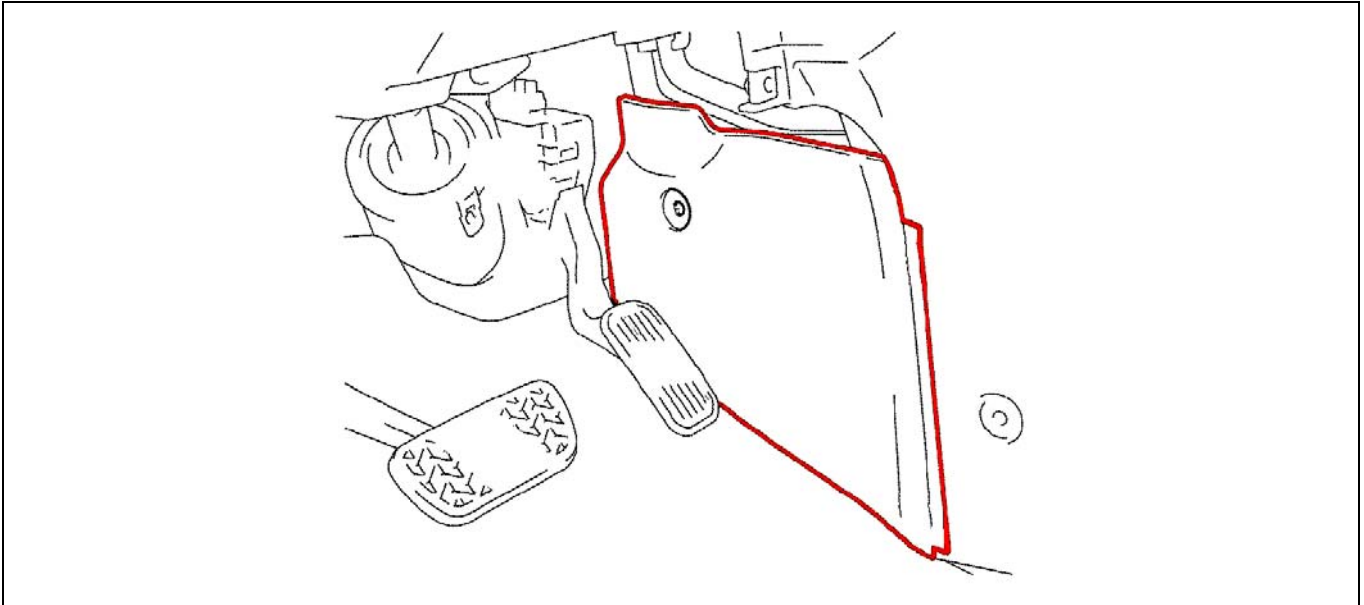
Driver's Side Center Console Trim Panel (Floor Carpet Cover)

Toyota has received reports that the Retaining Clip for the Driver's side Center Console Trim Panel (Floor Carpet Cover) was missing in a handful of vehicles. If this Retaining Clip is missing, the Floor Carpet Cover may become loose. If this condition is not repaired and the accelerator pedal is depressed to nearly full throttle, a loose floor carpet cover may interfere with the accelerator pedal.
