TECHNICAL INSTRUCTIONS
FOR
SAFETY RECALL C0B
SPIRAL CABLE REPLACEMENT
CERTAIN 2005 TO EARLY 2009 MODEL YEAR TACOMA

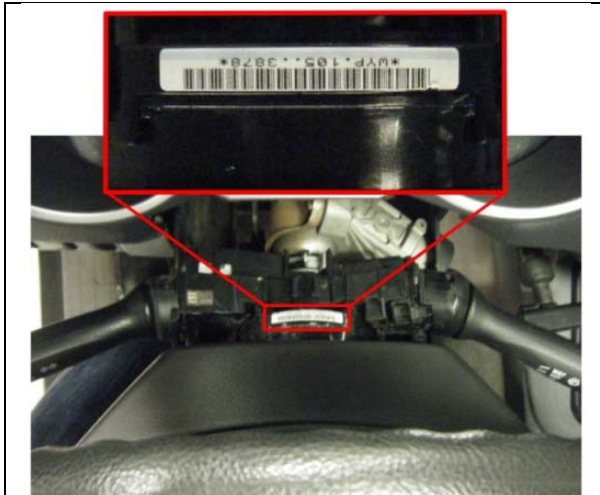
NOTE: When viewing from the driver seat, the lot number will be upside down.

- a) Position yourself to view the lot number correctly.
- b) Record the 10 digit lot number on the repair order.

NOTE: If the lot number cannot be determined, the spiral cable should be replaced.

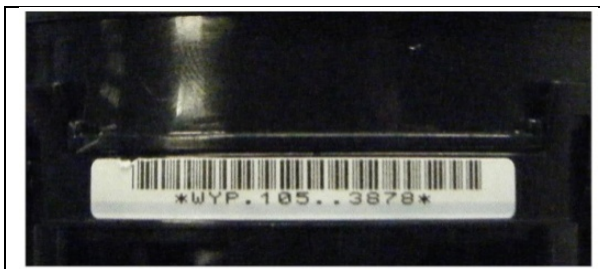
* XFT . **R84** .. 4643 *

1. [] [] [] [] . [**4**] [] [] [] [] [] [] []

2. [] [] [] [] . [**5**] [] [] [] [] [] [] []

3. [] [] [] [] . [**6**] [] [] [] [] [] [] []

4. [] [] [] [] . [**7**] [] [] [] [] [] [] []

5. [] [] [] [] . [**8**] [] [] [] [] [] [] []

c) Compare the lot number on the spiral cable to the illustration. Does the spiral cable digit match any of the 5 patterns?

- The only digit relevant to this inspection is the one shown highlighted.
- Approximately 85-90% of all vehicles will require spiral cable replacement. If initial inspection indicates that replacement is not necessary, reconfirm the inspection was performed correctly.

- YES** – Replace the spiral cable. Refer to TIS for instructions on [spiral cable replacement](#).
- NO** – The spiral cable is not affected. Campaign complete.
