Toyota Motor Sales, U.S.A., Inc.
19001 South Western Avenue
Torrance, CA 90501
(310) 468-4000

To: All Toyota Dealer Principals, Service Managers, and Parts Managers

Subject: Safety Recall - C0M **Remedy Notification**
Multiple Models and Model Years
Power Window Master Switch (PWMS)

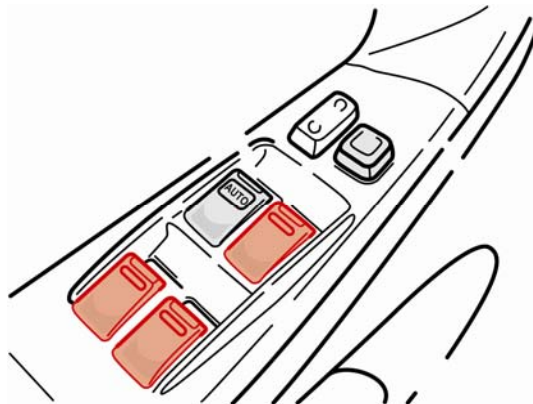
The Power Window Master Switch assembly ("PWMS assembly") which controls the windows for the driver and passengers is located in the driver's door. The switches that control the **passengers' windows** in this PWMS assembly may overheat and possibly cause a fire.

We appreciate your patience while we prepare the remedy. Over time, the passenger window switches in the PWMS assembly may begin to feel uneven or "notchy" when they are operated. This may be an indication that your switch is not operating properly. Please make an appointment as soon as possible with your Toyota dealership to have the PWMS assembly inspected. If it is determined that the switch is not operating due to this condition, the assembly will be repaired at **NO CHARGE** to you.

In the meantime, do not attempt to make repairs by applying commercially available chemicals (for example, lubricants or cleaners) into the PWMS assembly. Doing so may cause the PWMS assembly to smoke, melt or under some circumstances cause a fire. In the event commercially available chemicals have already been applied to the PWMS assembly, please make an appointment with your dealer as soon as possible to have the PWMS assembly inspected.

The remedy will involve an inspection of the PWMS assembly and application of a specialized grease. In limited instances, based upon the results of the inspection, the PWMS assembly circuit board may also be replaced.

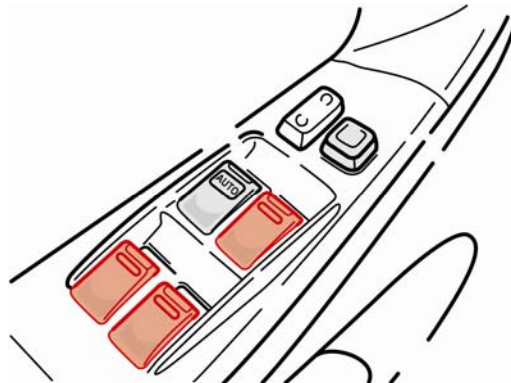
The Power Window Master Switch assembly ("PWMS assembly") which controls the windows for the driver and passengers is located in the driver's door. The switches that control the **passengers' windows** in this PWMS assembly may overheat and possibly cause a fire.

We appreciate your patience while we prepare the remedy. Over time, the passenger window switches in the PWMS assembly may begin to feel uneven or "notchy" when they are operated. This may be an indication that your switch is not operating properly. Please make an appointment as soon as possible with your Scion dealership to have the PWMS assembly inspected. If it is determined that the switch is not operating due to this condition, the assembly will be repaired at **NO CHARGE** to you.

In the meantime, do not attempt to make repairs by applying commercially available chemicals (for example, lubricants or cleaners) into the PWMS assembly. Doing so may cause the PWMS assembly to smoke, melt or under some circumstances cause a fire. In the event commercially available chemicals have already been applied to the PWMS assembly, please make an appointment with your dealer as soon as possible to have the PWMS assembly inspected.

The remedy will involve an inspection of the PWMS assembly and application of a specialized grease. In limited instances, based upon the results of the inspection, the PWMS assembly circuit board may also be replaced.

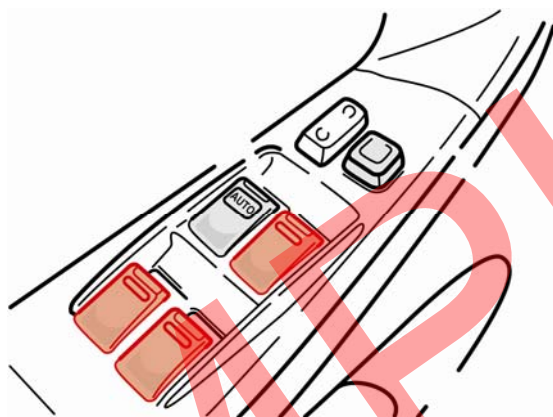
The Power Window Master Switch assembly ("PWMS assembly") which controls the windows for the driver and passengers is located in the driver's door. The switches that control the **passengers' windows** in this assembly may overheat and possibly cause a fire.

Any authorized Toyota dealer will inspect the PWMS assembly and apply a specialized grease. In a limited number of instances, based upon the results of the inspection, the PWMS assembly circuit board may also be replaced. This inspection and repair will be performed at **NO CHARGE** to you.

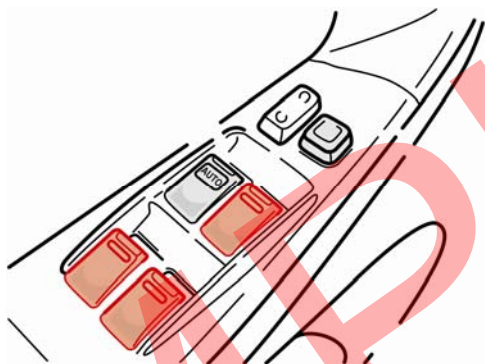
The Power Window Master Switch assembly ("PWMS assembly") which controls the windows for the driver and passengers is located in the driver's door. The switches that control the **passengers' windows** in this assembly may overheat and possibly cause a fire.

Any authorized Scion dealer will inspect the PWMS assembly and apply a specialized grease. In a limited number of instances, based upon the results of the inspection, the PWMS assembly circuit board may also be replaced. This inspection and repair will be performed at **NO CHARGE** to you.
