Rubbing or Grinding Noise From Rear on Turns

Service Category Brake

Section Brake (rear)

YEAR(S)	MODEL(S)	ADDITIONAL INFORMATION
2007 - 2012	Tundra

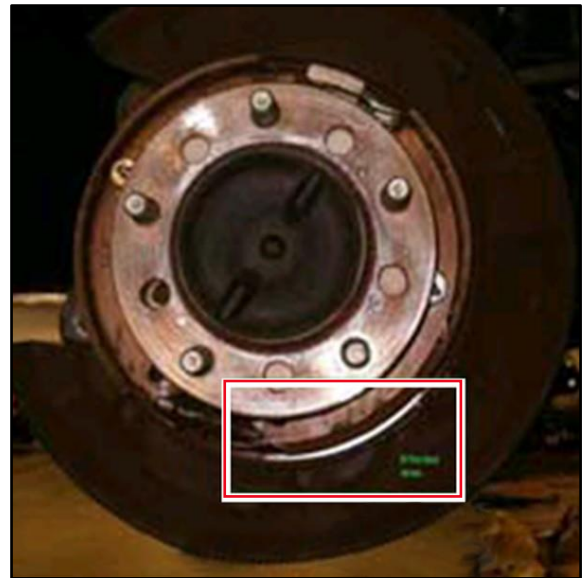
Figure 1. Example of Irregular Contact on Brake Plate

2. Place the vehicle on the lift, remove the rear wheels and rear rotors, and check for any irregular contact on the brake plate from the rotors.

3. If there appears to be irregular contact from the rotor to the brake plate, replace ALL parts specified in the Special Service Part Bearing Kit (including the parking brake backing plate).
