Service

Category Vehicle Interior

Section Interior Panels/Trim Market USA

Door Trim Panel Rattle

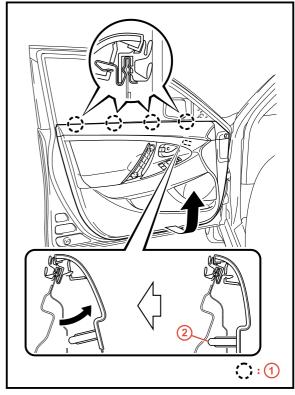
I	1	Claw
Ī	2	Reference Boss

C. Pull up the front door trim board in the direction Figure 6. indicated by the arrow.

- D. Disengage the reference bosses from the front door panel.
- E. Raise the front door trim board to disengage the 4 claws and remove the front door trim board together with the front door inner glass weatherstrip.
