MIL "ON" DTC P0418 and/or P2445

Service Category Engine/Hybrid System

Section Engine Control

YEAR(S)	MODEL(S)	ADDITIONAL INFORMATION
2012 – 2013	Sequoia	
2012 – 2013	Tundra

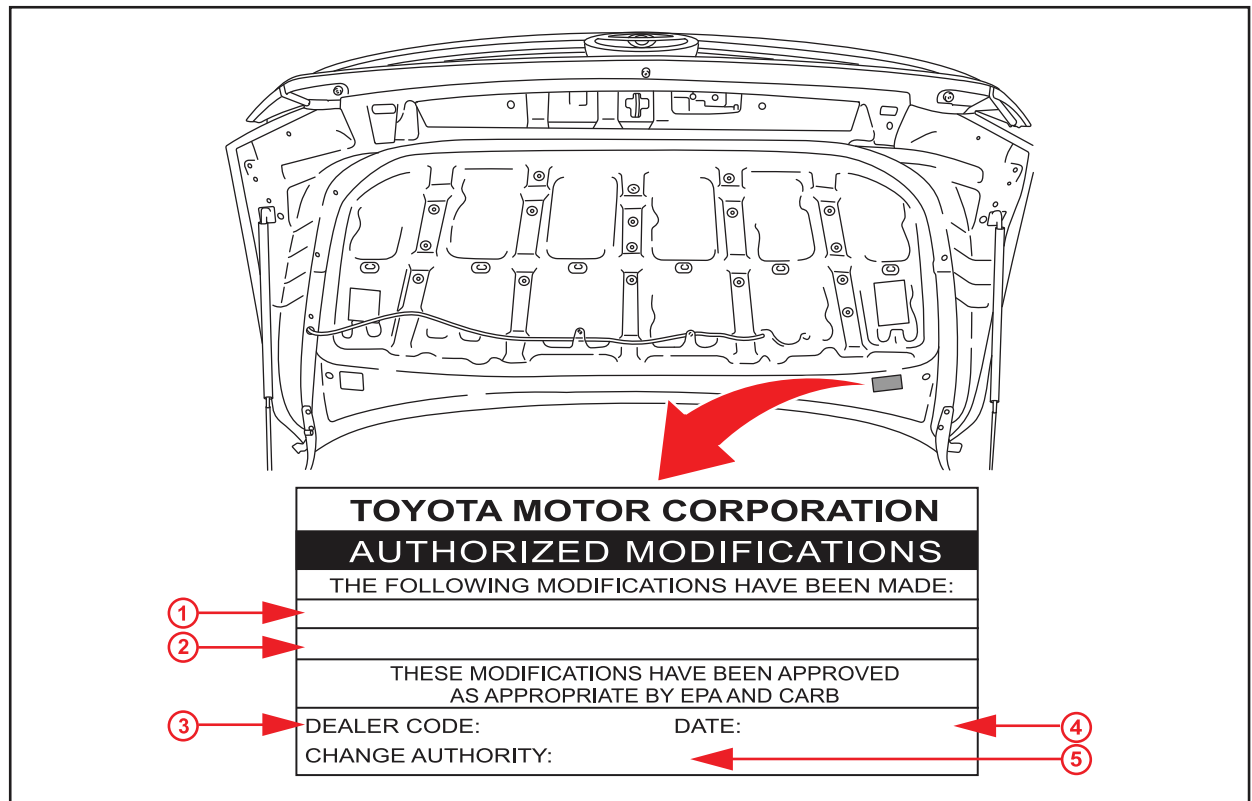
Figure 1. Location of Authorized Modifications Label on 2012 – 2013 Sequoia and Tundra

- Check for the Authorized Modifications Label affixed to the vehicle in the location shown in Figure 1. Confirm if the ECM (PCM) calibration has been updated. If the calibration ID listed is NOT the latest ECM (PCM) calibration — go to step 3.

4. Install the Authorized Modifications Label.
 - A. Using a permanent marker, enter the following information on the label:
 - ECM part number [*Refer to the **Parts Information** section for the **CURRENT PART NUMBER***]
 - Calibration ID(s) [*Refer to the **Calibration Identification Chart** for the **NEW CALIBRATION ID***]
 - Dealer Code
 - Repair Date
 - Change Authority [***This SB number***]
 - B. Affix the Authorized Modifications Label to the vehicle at the location shown in Figure 1. The Authorized Modifications Label is available through the MDC, P/N 00451-00001-LBL.
5. Replace the Bank 1 Air Pump Assembly.
