Spark Knock Noise

Service Category Engine/Hybrid System

YEAR(S)	MODEL(S)	ADDITIONAL INFORMATION
2012 – 2014	Tacoma

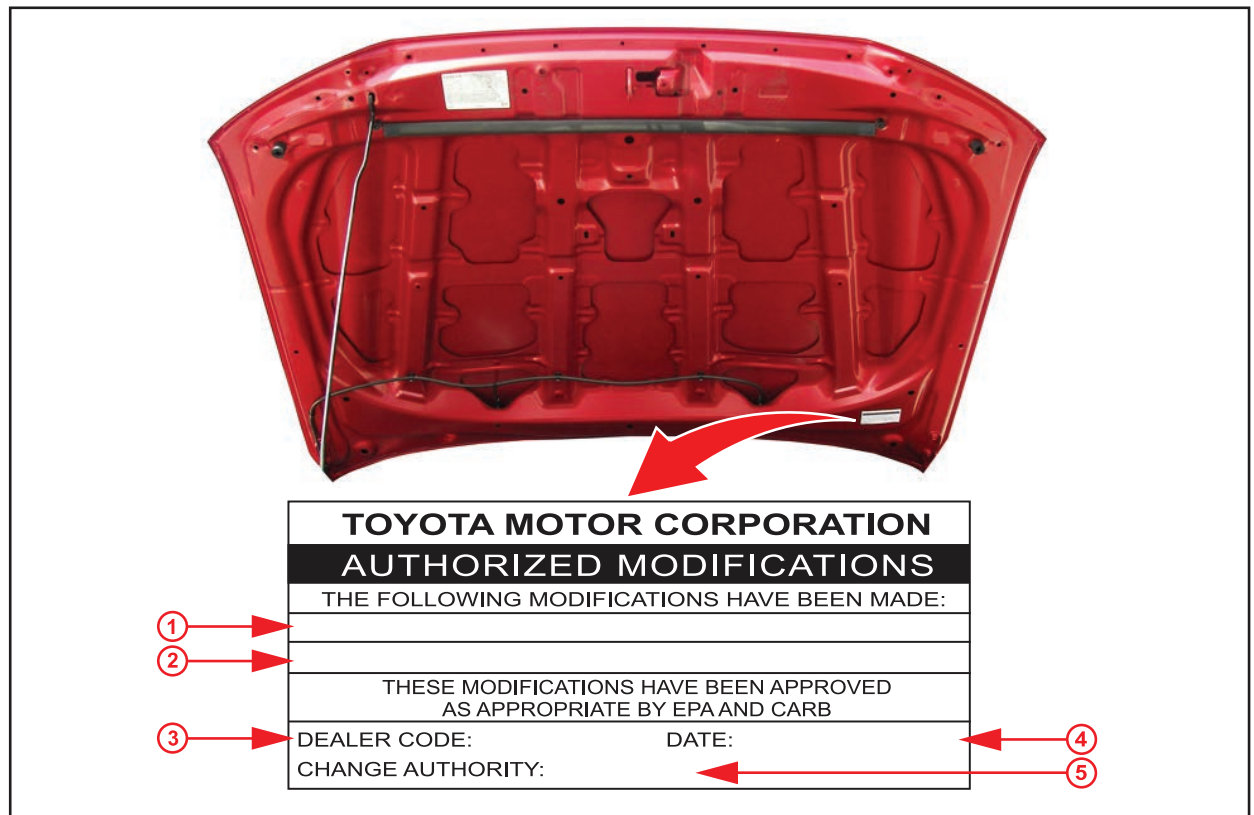
Figure 1. Location of Authorized Modifications Label on 2012 – 2014 Tacoma

2. Check for the Authorized Modifications Label affixed to the vehicle in the location shown in Figure 1. Confirm if the ECM (PCM) calibration has been updated. If the calibration ID listed is NOT the latest ECM (PCM) calibration — go to step 3. If the calibration ID is the latest, go to step 5.

4. Install the Authorized Modifications Label.
 - A. Using a permanent marker, enter the following information on the label:
 - ECM part number [*Refer to the **Parts Information** section for the **NEW PART NUMBER***]
 - Calibration ID(s) [*Refer to the **Calibration Information** section for the **NEW CALIBRATION ID***]
 - Dealer Code
 - Repair Date
 - Change Authority [***This bulletin number***]
 - B. Affix the Authorized Modifications Label to the vehicle at the location shown in Figure 1. The Authorized Modifications Label is available through the MDC, P/N 00451-00001-LBL.
5. Test drive to confirm the repair.
