Transmission Fluid Leak through Driveshaft Yoke

Service Category Drivetrain

Section Drive Shaft/Propeller Shaft

YEAR(S)	MODEL(S)	ADDITIONAL INFORMATION
2007	Tundra	Body Type(s): Double Cab Truck, Crew Max, Regular Cab, Drive Type(s): 2WD Engine(s): 2UZ, 3UR, 1GR Transmission(s): 6AT VDS(s): ET541, ET581, EV541, EV581, JT521, JU521, JV521, LT521, LU521, LV521, RT541, RT581, RU541, RV541, RV581, ST541, SV541

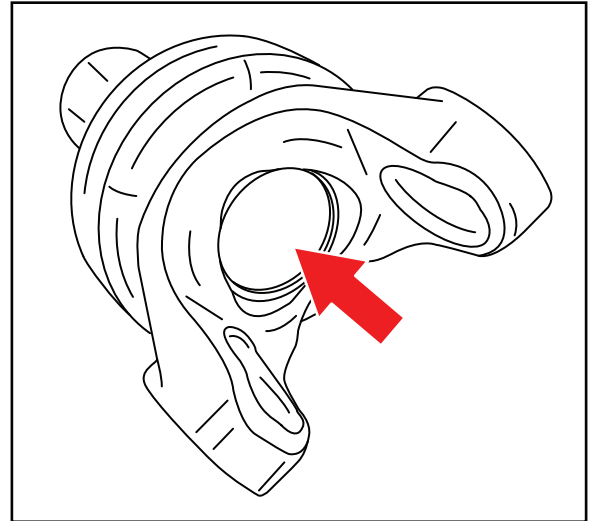
Some 2007 model year 2WD Tundra vehicles may display a small transmission fluid leak through the driveshaft (propeller shaft) slip yoke plug in the center of the yoke. Manufacturing process changes were implemented at the supplier to eliminate this condition. Replacement of the driveshaft will correct this condition.

1. Confirm source of automatic transmission fluid leak is through the driveshaft slip yoke plug in the area indicated below.
 - If transmission fluid leak is NOT originating in this area, do **NOT** perform this TSB.
 - If leak originates from driveshaft yoke, **go to step 2**.

Figure 1. Area of Transmission Fluid Leak in Driveshaft Slip Yoke Plug

2. Remove the driveshaft.

3. Install the NEW driveshaft using markings on the original driveshaft to assist in properly aligning the phase of the replacement driveshaft.

Refer to TSB No. [DL001-07](#), “*Driveshaft (Propeller Shaft) Installation Instructions*”, to properly install the driveshaft and align the center support bearings (when equipped).

4. Check transmission fluid level.
