MIL "ON" DTC P0136

YEAR(S)	MODEL(S)	ADDITIONAL INFORMATION
2007 – 2011	Camry HV

Some 2007 – 2011 model year Camry HV vehicles equipped with a 2AZ-FXE engine may exhibit a MIL "ON" condition with Diagnostic Trouble Code (DTC) P0136 – Oxygen Sensor Circuit Malfunction (Bank 1 Sensor 2). The oxygen sensor and Hybrid Vehicle ECU (HV ECU) logic have been modified to reduce the possibility of this condition occurring. Use the following repair procedure to address this condition.

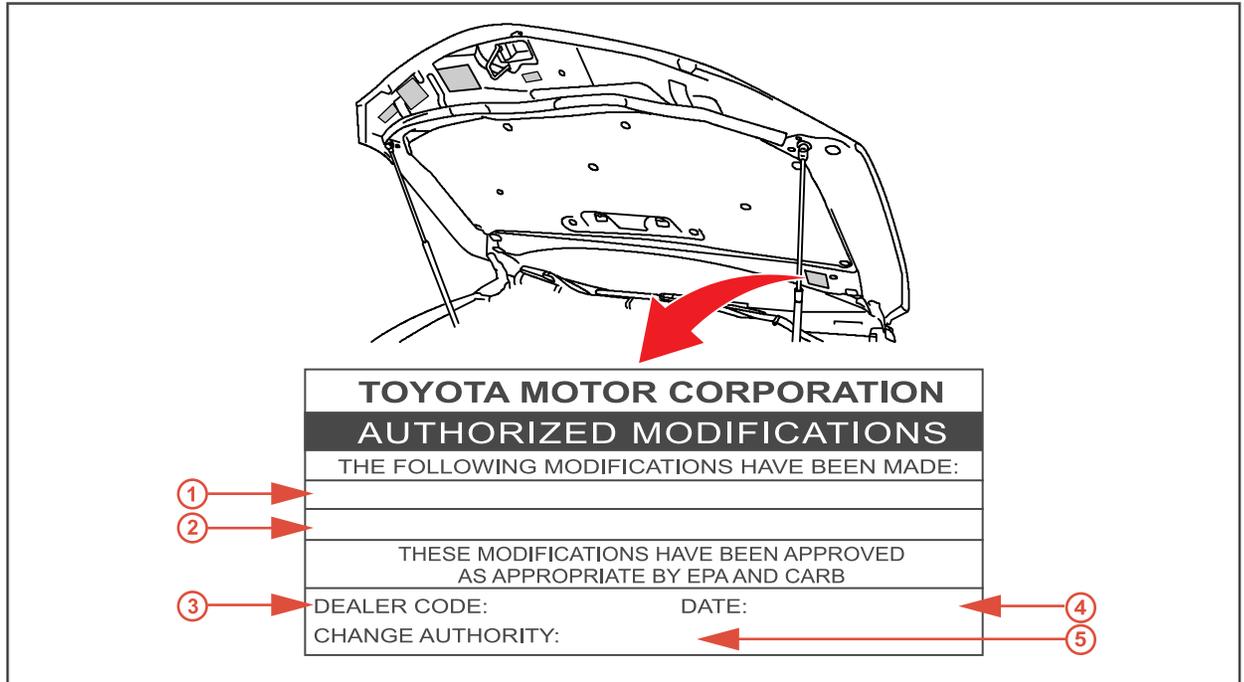
Figure 1. Location of Authorized Modifications Label on 2007 – 2011 Camry HV

3. Check for the Authorized Modifications Label affixed to the vehicle in the location shown in Figure 1. Confirm if the HV ECU calibration has been updated. If the calibration ID listed is NOT the latest HV ECU calibration — go to step 4.

6. Install the Authorized Modifications Label.

B. Affix the Authorized Modifications Label to the vehicle at the location shown in Figure 1. The Authorized Modifications Label is available through the MDC, P/N 00451-00001-LBL.
