# Tire Pressure Monitoring System (TPMS) Tire Registration "Lost Communication With ECU"

The purpose of this bulletin is to provide procedures on Tire Pressure Monitoring System sensor registration when Lost Communication With ECU appears on the Techstream display.

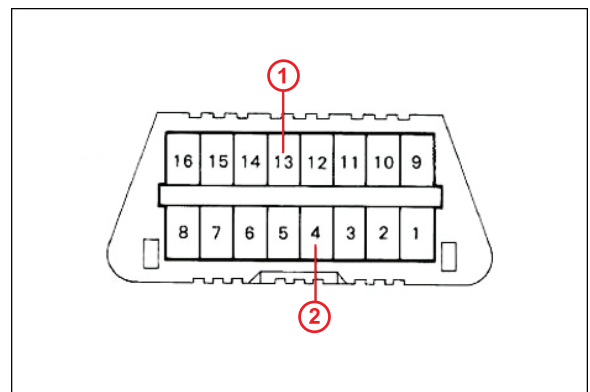
**Figure 1.**

1	TC
2	CG

1. Connect TIS Techstream to the vehicle
2. Turn the ignition switch to the "IG-ON" position.
3. Select the datalist for the Tire Pressure Monitoring System.
4. Check and set all tire pressures to specification with an accurate tire pressure gauge and compare the information to what is displayed on the datalist.
5. After checking the tire pressure, record the TPMS sensors ID numbers.
6. With the vehicle set to "IG-ON" mode, disconnect the TIS Techstream.
7. Using Jumper wire or equivalent, connect terminals TC and CG at the DL3 connector for at least 30 seconds. Do not cycle the ignition switch to "OFF" position during this step. (Landcruiser use TC and E1 at DLC1)
