Upper/Lower Windshield/Rear Glass Tick Noise

Service Category Vehicle Exterior

Section Window/Glass

The information contained in this bulletin supersedes T-SB-0142-08.

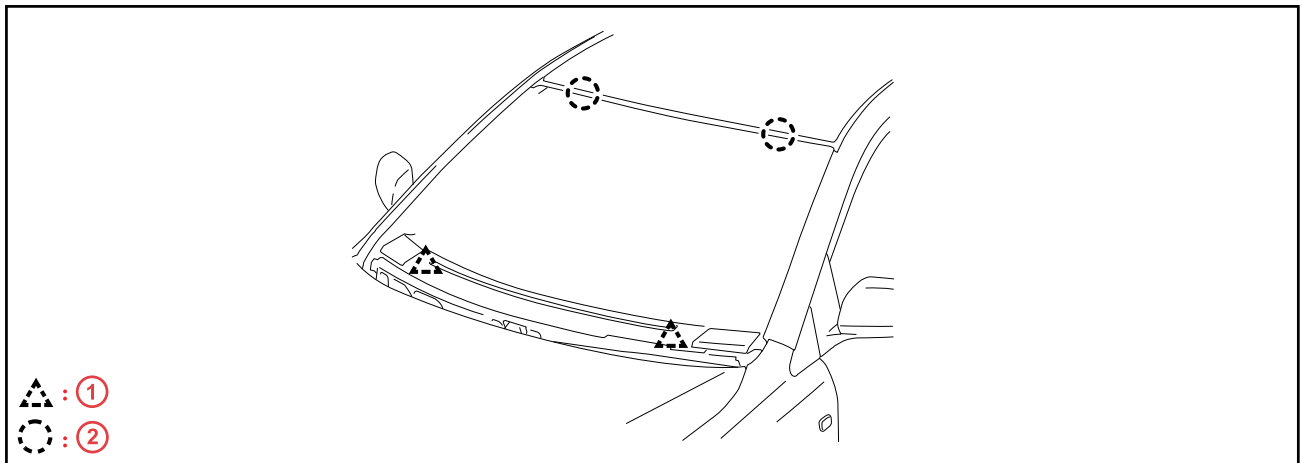
Figure 1. Retainer and Stopper Locations

If a creak, tick, or rattle noise is heard at the top or bottom of the windshield, or at the top of the rear glass, the source of the noise may be the two stoppers bonded to the top of the windshield/rear glass, or the windshield retainers bonded to the lower edge of the windshield. This bulletin provides the recommended repair procedure to eliminate these types of noises from the windshield/rear glass area.

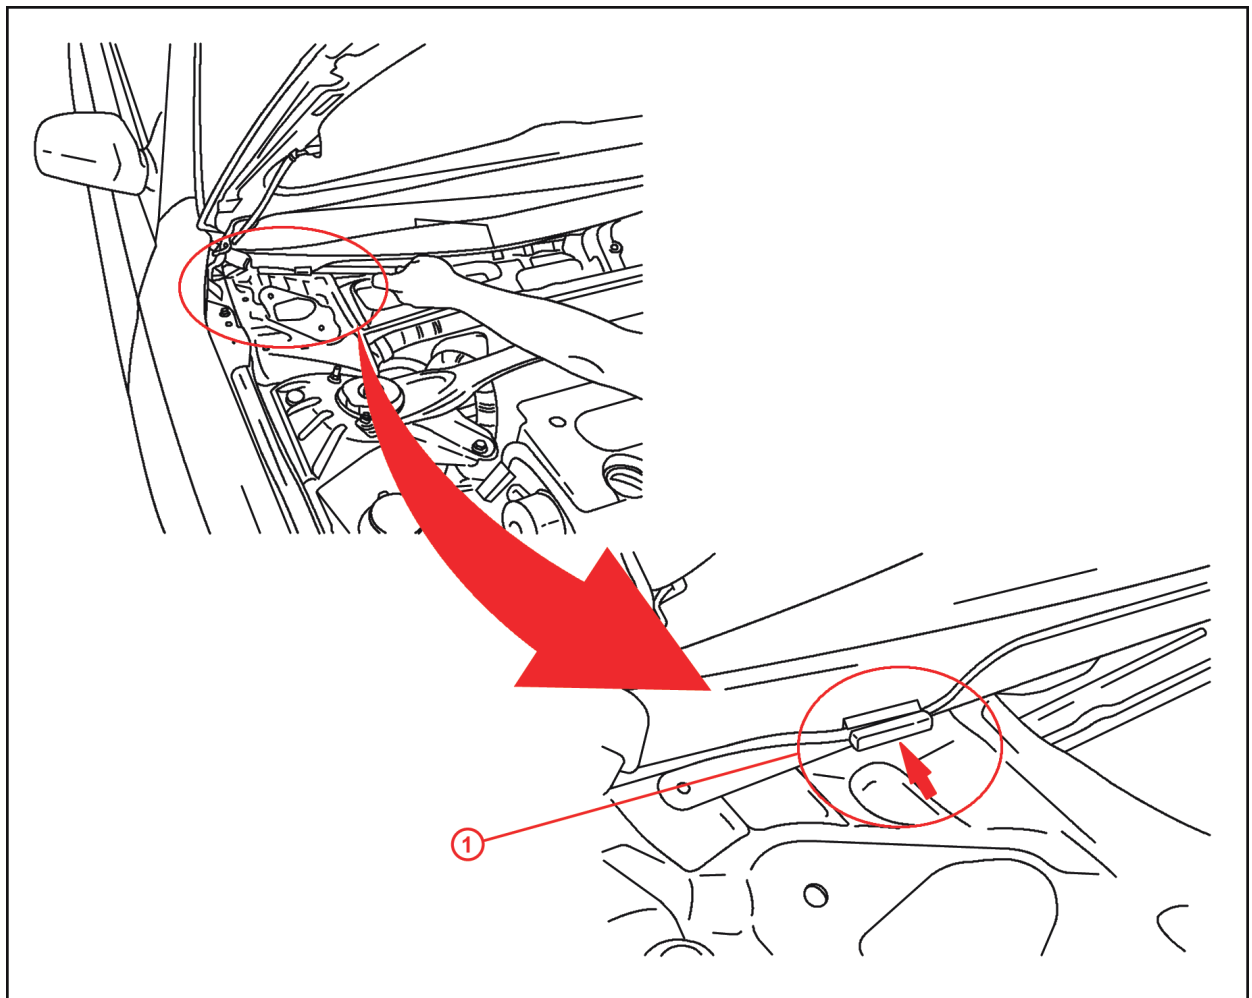
Figure 8.

The retainers are typically located 140 – 200 mm (5.5 – 7.9 in.) inboard of the lower corners of the windshield. The flat portion of the retainer is adhered to the backside of the windshield with double-sided, foam-backed tape.

2. Locate the lower windshield retainers.
