Service

YEAR(S)	MODEL(S)	ADDITIONAL INFORMATION	
2007 – 2009	Camry, Camry HV	WMI(s): 4T1, 4T4

Some 2007-2009 Camry customers may experience a condition where the front center console door will not open due to interference with the lower edge of the HVAC unit. Follow the repair procedure below to address this condition.

Center Console Door Will Not Open

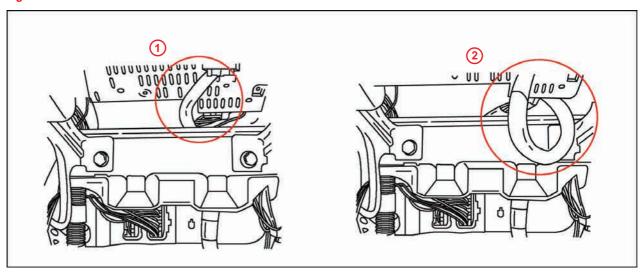
Figure 13.

- 1 Correct
 2 Incorrect
- 11. Reassemble in reverse order of disassembly.
- 12. Verify the repair by ensuring the proper operation of the center console door.

10. Confirm the correct routing of the HVAC control wire harness.
