# 2nd Row Tip-Up Style Seat Lower Cushion Excessive Movement

| YEAR(S) | MODEL(S) | ADDITIONAL INFORMATION |
|---|---|---|
| 2011 – 2013 | Sienna | |

T-SB-0180-12

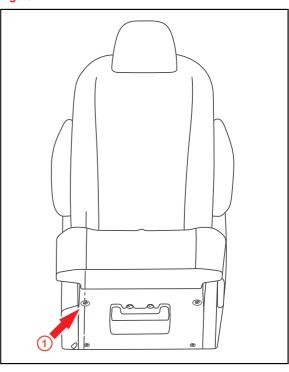
- **Inboard Seat Support Cushion**
- 2. Remove the inboard seat support cushion and screw.
- 3. Install the 3 mm shim to the bottom of the inboard Figure 3. seat support cushion and reinstall the seat support cushion and screw.

For vehicles built before 12/2011, a new seat support cushion and screw are required to properly install the 3 mm shim.
