# Moon Roof Stuck/Improper Operation

YEAR(S)	MODEL(S)	ADDITIONAL INFORMATION
2003 – 2008	4Runner

The information contained in this TSB supersedes TSB No. BO016–06.

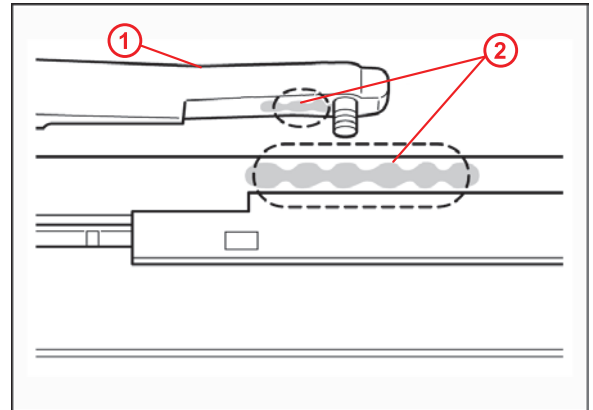
**Figure 8.**

A. Using a piece of cloth or scraper, remove the old grease from the holder-sliding surface on the rail and the deflector arm.

<b>1</b>	<b>Deflector Arm</b>
<b>2</b>	<b>Old Grease</b>

B. Install the NEW holder (P/N 63257–35040/50, included in repair kit P/N 63207–35040) to the rail by performing the removal procedure in reverse order.

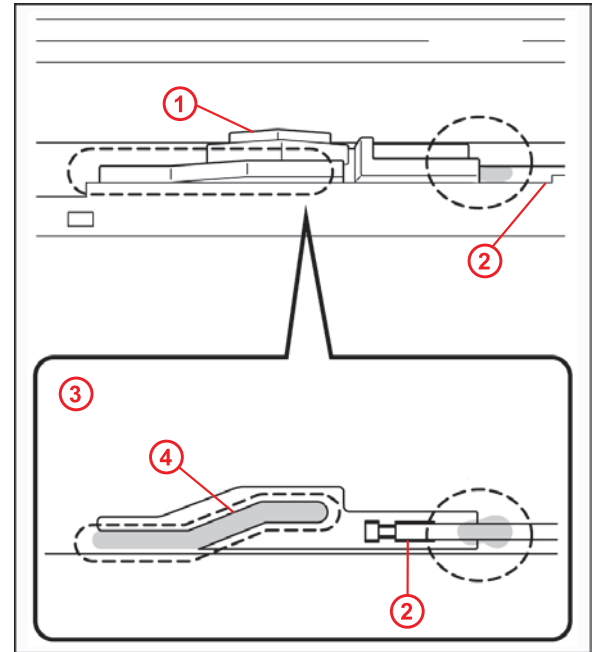
**Figure 11.**

1	Holder
2	Rod
3	Cross Section of Holder
4	Groove

- D. Apply grease (P/N 09170-35010, included in the repair kit) to the contact surface between the holder and the rail and the groove (deflector arm installation portion).

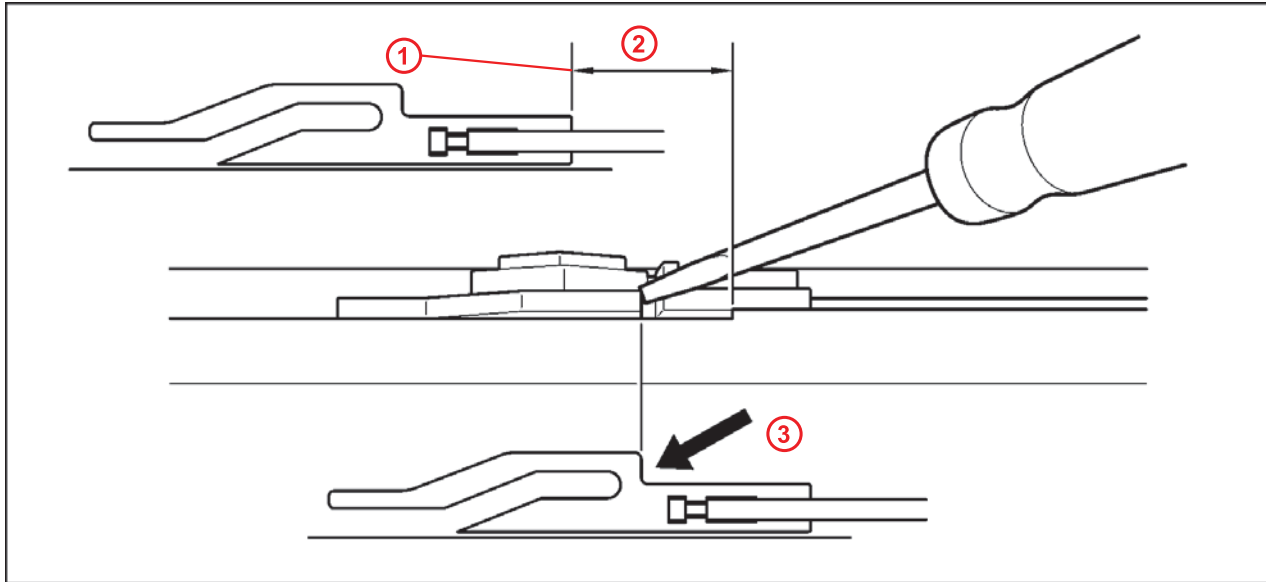
**Figure 14.**

<b>1</b>	<b>Half-up Position</b>
<b>2</b>	<b>Distance Between End of Holder &amp; Cutout of Rail: Approximately 17 mm (0.67 in.)</b>
<b>3</b>	<b>Push Stepped Portion of Holder Toward Front Side &amp; Move Deflector to Half-up Position</b>

- A. Place a flathead screwdriver against the stepped portion of the holder and push the holder toward the front of the vehicle to move the deflector to the half-up position. Align the RH and LH holder positions.

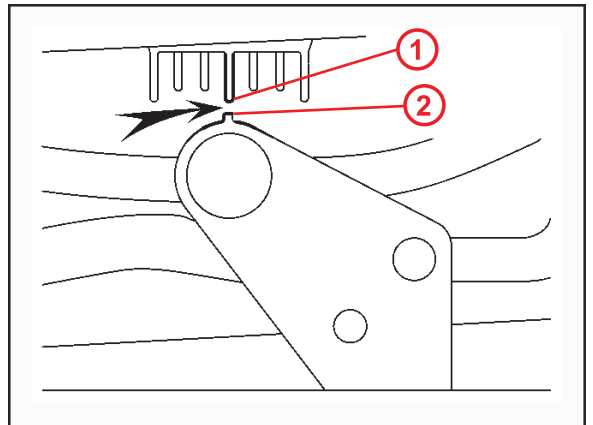
**Figure 18.**

<b>1</b>	<b>Center Marking</b>
<b>2</b>	<b>Protrusion</b>

- (2) Align the protrusion of the link to the center marking of the bracket.
