# Repair Manual Supplement: Vehicle Pulling to One Side

**Service Category** Suspension

**Section** Alignment/Handling Diagnoses

**February 20, 2013 Rev1:**

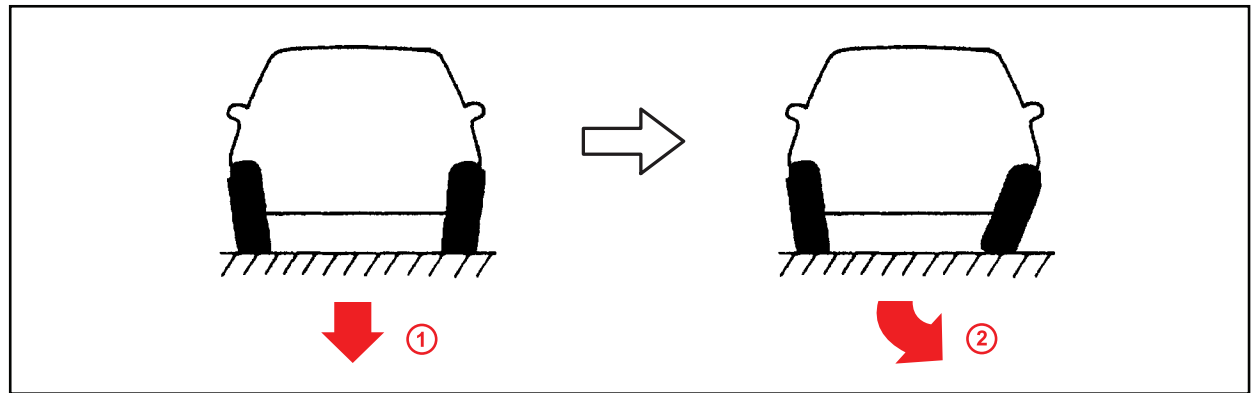
Figure 1. Camber

When the cross camber or caster of the front wheel alignment is large, it can cause vehicle pulling.

WHEEL ALIGNMENT	DIRECTION OF VEHICLE PULLING
Camber	Vehicle Pulls in Direction of Wheel with Increasing Camber Value (Figure 1)
Caster	Vehicle Pulls in Direction of Wheel with Decreasing Caster Value (Figure 2)

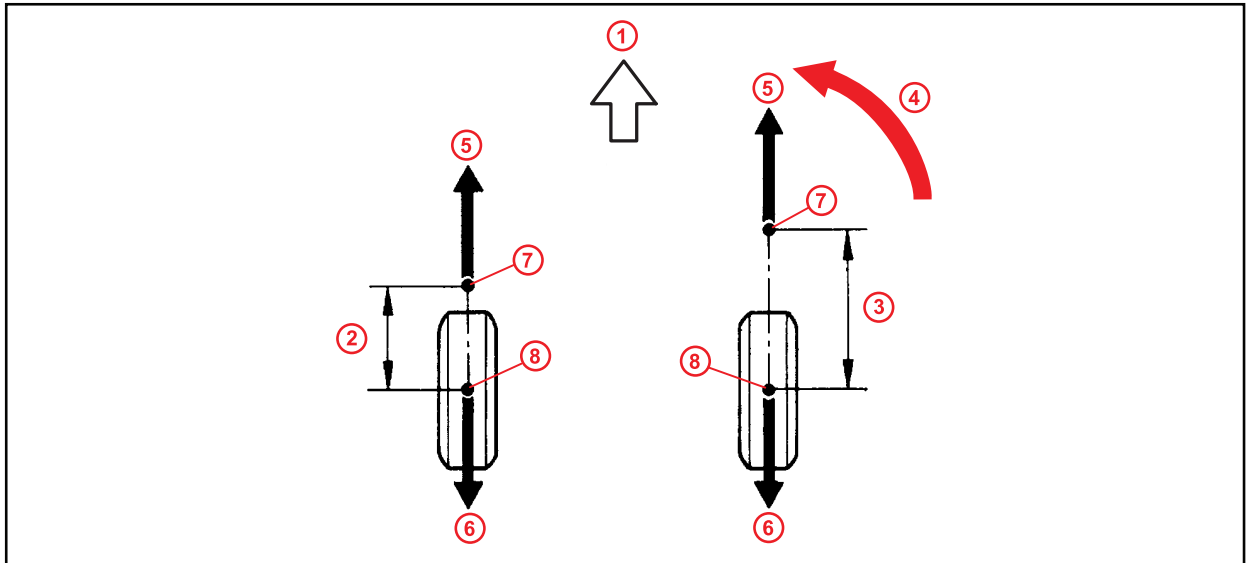
Figure 2. Caster

If the cross camber or caster is within the specified range (30' or less), noticeable vehicle pulling will not occur due to side-to-side differences in camber or caster.

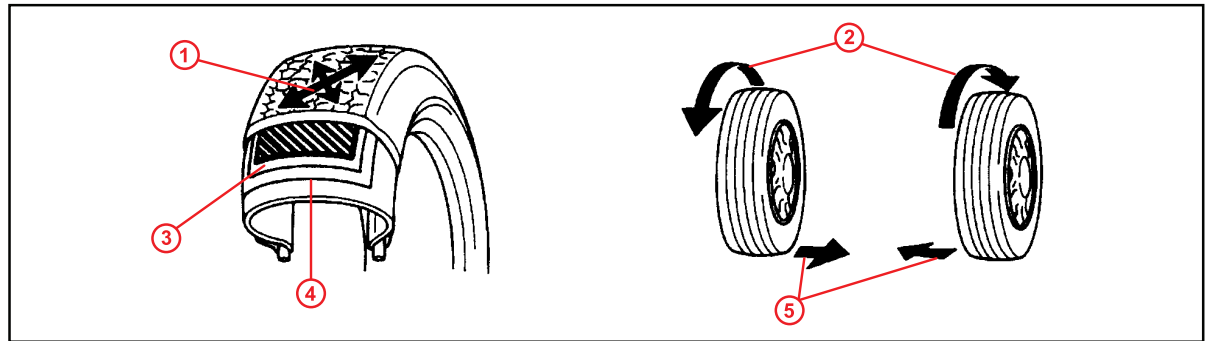
Figure 3.

Lateral force due to ply-steer is produced by the construction of the belts inside the tire tread. With radial tires, the wire of the belt is slanted as shown in the illustration below. Thus, it is in the lateral direction that tire tread easily changes shape (stretches), and lateral force is generated between the tire and the road surface in the lateral direction.

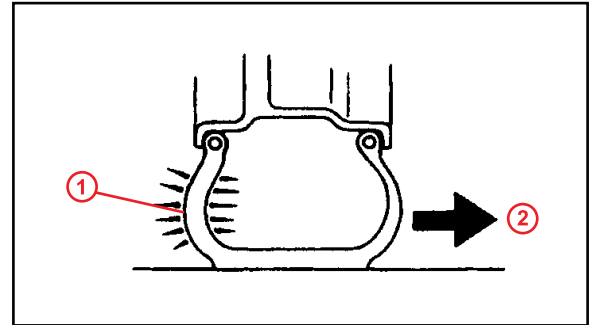
Figure 4.

Conicity is lateral force resulting from uneven formation of the left and right sides of the tire. The direction the lateral force is exerted depends on the hardness of the side walls and the difference in height between the left/right sides of the tire.

- In the case of vehicle pulling caused by tires, the lateral force which is exerted as a result of conicity has the greatest effect. On a flat road, if the steering wheel is held without exerting steering effort for 109 yards (100 m) when traveling at 62 mph (100 km/h), the vehicle may drift as much as 5 feet (1.5 m).
- When vehicle pulling is due to conicity, the amount of drift can be reduced and the direction of drift can be changed by changing the location of the tire or reversing the tire when installing it on the wheel.

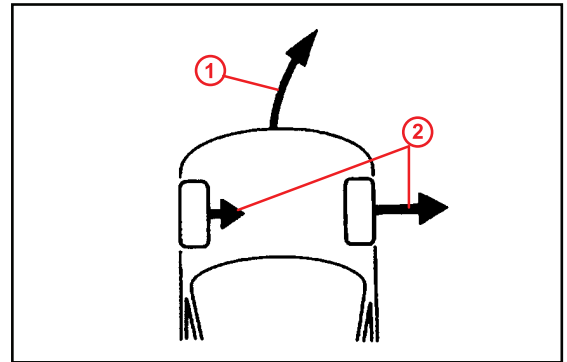
**Figure 6. Original Tire Positions**

- The direction of lateral force from tire conicity becomes reversed when the left and right tires are switched. Therefore, if the pulling direction changes when the tires are switched, it can be concluded that vehicle pulling is caused by tire conicity.
  - The vehicle is pulled to the right by the lateral force exerted to the right.

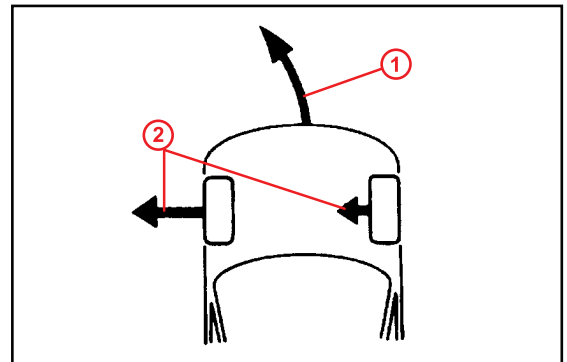
**Figure 7. Tires Switched**

- The direction of the tires which exerted lateral force to the right has been changed, so the tires now exert lateral force to the left and the vehicle now pulls to the left.

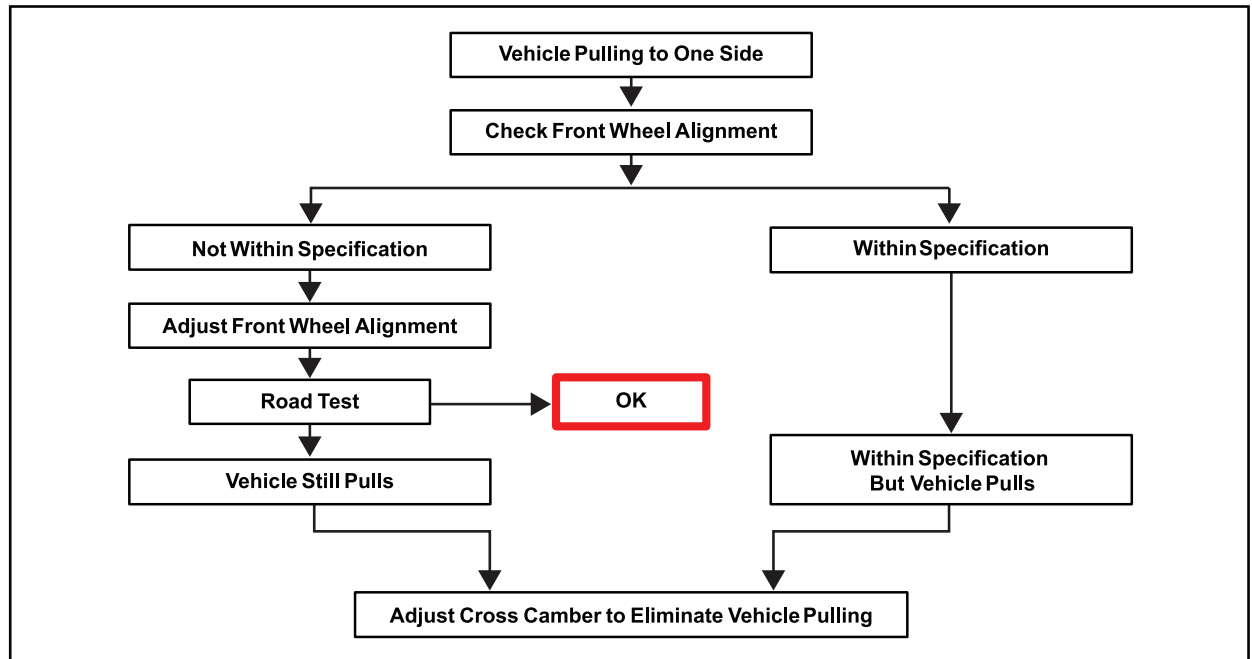
Figure 8.

When it is determined by troubleshooting that the vehicle pulling to one side is caused by wheel alignment, perform repairs according to the following procedure.

WHEN VEHICLE PULLS TO LEFT	WHEN VEHICLE PULLS TO RIGHT
Increase right front camber and decrease left front camber until vehicle pulling is eliminated	Increase left front camber and decrease right front camber until vehicle pulling is eliminated

- Keep the cross camber within 1° or less.
- Keep the camber of each wheel within specifications (+/-45' of center value).
- If adjustment exceeds the specifications, uneven tire wear will result.

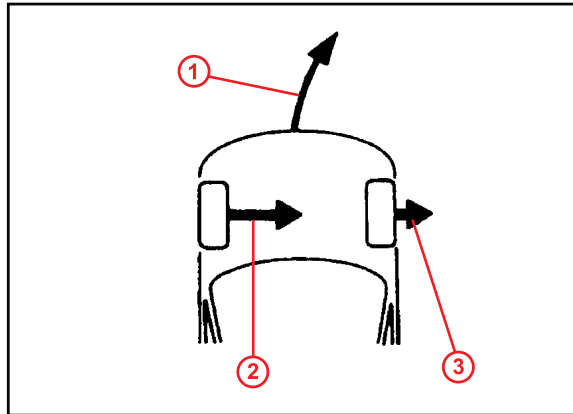
**Figure 11. Original Tire Positions**

The lateral force generated by the left front tire is greater than the right tire, so the vehicle is pulling due to the lateral force of the left tire.
