**Technical Service
BULLETIN**

November 28, 2007

**M.I.L. "ON" DTC P2714 WITH
TRANSMISSION PERFORMANCE DTCs**

TRANSMISSION & CLUTCH
TC017-07

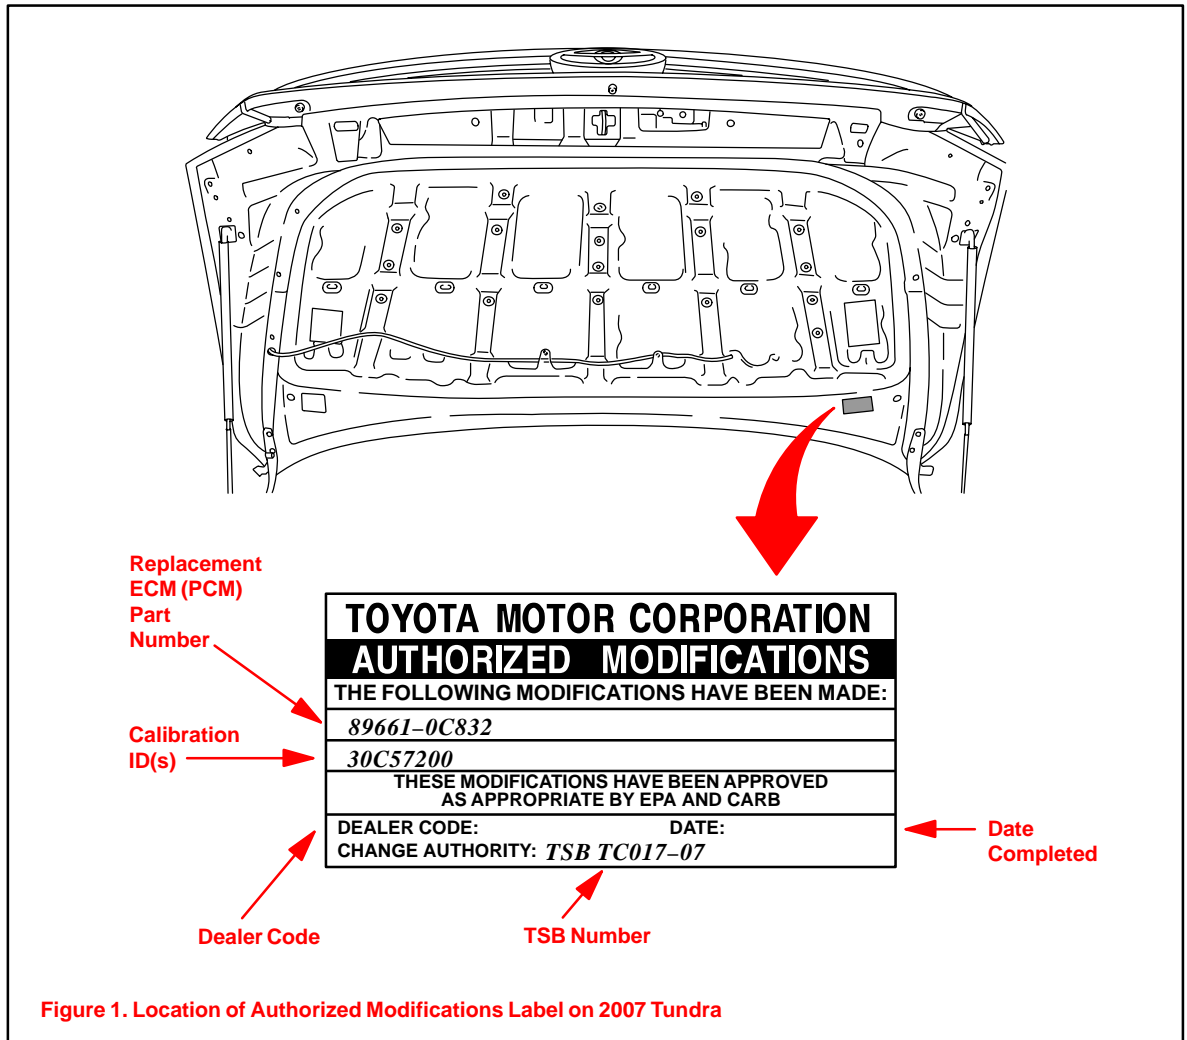
- Check for the Authorized Modifications Label affixed to the vehicle in the location shown in Figure 1. Confirm if the ECM (PCM) calibration has been updated. If the calibration ID listed is NOT the latest ECM (PCM) calibration — go to step 7.

10. Install the Authorized Modifications Label.
 - A. Using a permanent marker, enter the following information on the label:
 - ECM part number: *[Refer to the **Parts Information** section for the **CURRENT PART NUMBER]***
 - Calibration ID(s): *[Refer to the **Calibration Identification Chart** for the **NEW CALIBRATION ID]***
 - Dealer Code
 - Repair Date
 - Change Authority (this TSB number): *TC017-07*
 - B. Affix the Authorized Modifications Label to the vehicle at the location shown in Figure 1. The Authorized Modifications Label is available through the MDC, P/N 00451-00001-LBL.
