**Parts Information**

**Repair Procedure**

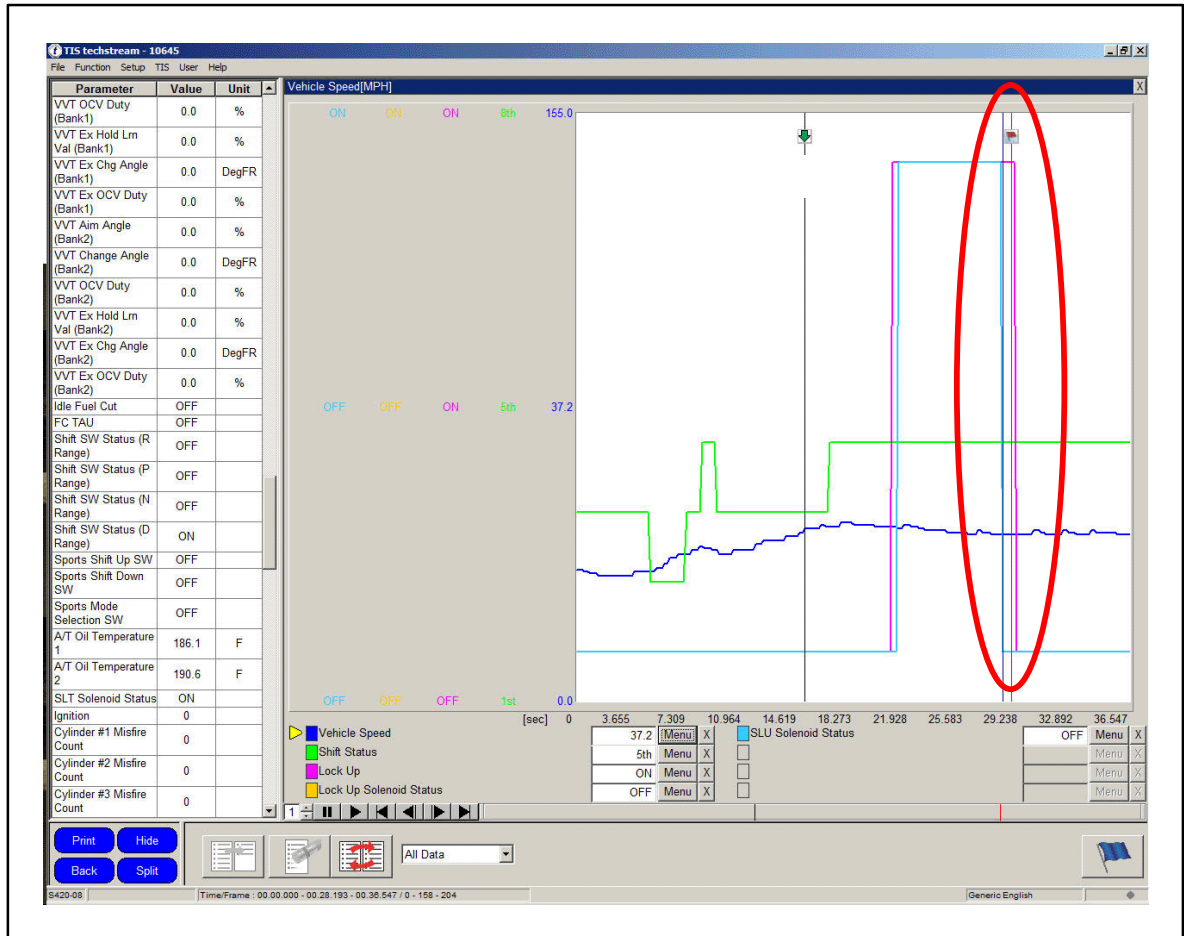
4. Use Data List and the graphing functions of Snapshot to confirm the following data parameters when the shudder condition occurs:
  - Vehicle Speed
  - Shift Status
  - Lock Up
  - Lock Up Solenoid Status
  - SLU Solenoid Status

- If the shudder occurs with Lock Up “ON”, Lockup Solenoid Status “OFF”, and SLU Solenoid Status “OFF”, then the shudder is related to torque converter flex lockup. **Go to step 5.**
- If the shudder occurs with Lock Up “OFF”, Lock Up Solenoid Status “OFF”, and SLU Solenoid Status “OFF”, then the condition is **NOT** related to torque converter flex lockup and this **TSB DOES NOT APPLY**. Continue diagnosis to identify the root cause for this shudder.

5. Replace the torque converter.  
Refer to TIS, 2007 or 2008 model year Tundra Repair Manual:
  - 2WD transmission:
    - *Drivetrain – Automatic Transmission/Transaxle – “AB60E Automatic Transmission: Automatic Transmission Assembly: Removal”*
    - *Drivetrain – Automatic Transmission/Transaxle – “AB60E Automatic Transmission: Automatic Transmission Assembly: Installation”*
  - 4WD transmission:
    - *Drivetrain – Automatic Transmission/Transaxle – “AB60F Automatic Transmission: Automatic Transmission Assembly: Removal”*
    - *Drivetrain – Automatic Transmission/Transaxle – “AB60F Automatic Transmission: Automatic Transmission Assembly: Installation”*
6. Adjust the transmission fluid level in the transmission.  
Refer to TSB No. TC009–07, “*Transmission Fluid Level*”, to properly adjust the transmission fluid level.
