TECHNICAL INSTRUCTIONS
FOR
SAFETY RECALL E0E
SOFTWARE UPDATE FOR MOTOR GENERATOR ECU AND POWER
MANAGEMENT ECU
CERTAIN 2010-2014 MODEL YEAR PRIUS

UPDATED August 15, 2014

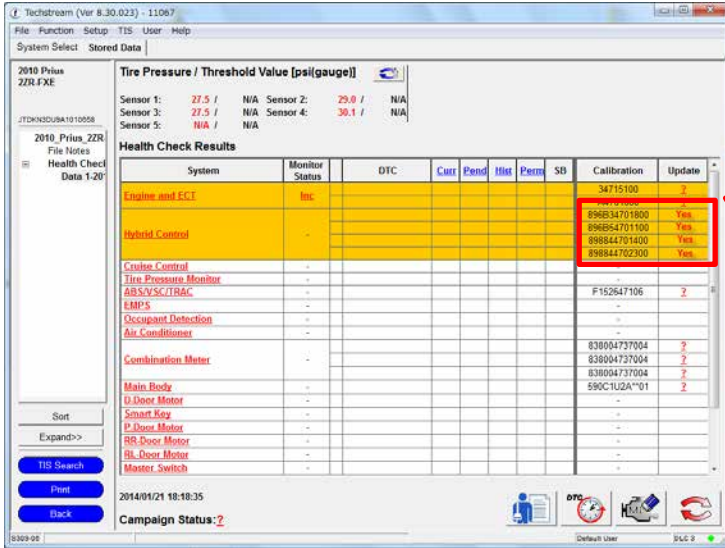
a) Confirm the current calibration ID in the MG ECU and Power Management ECU.

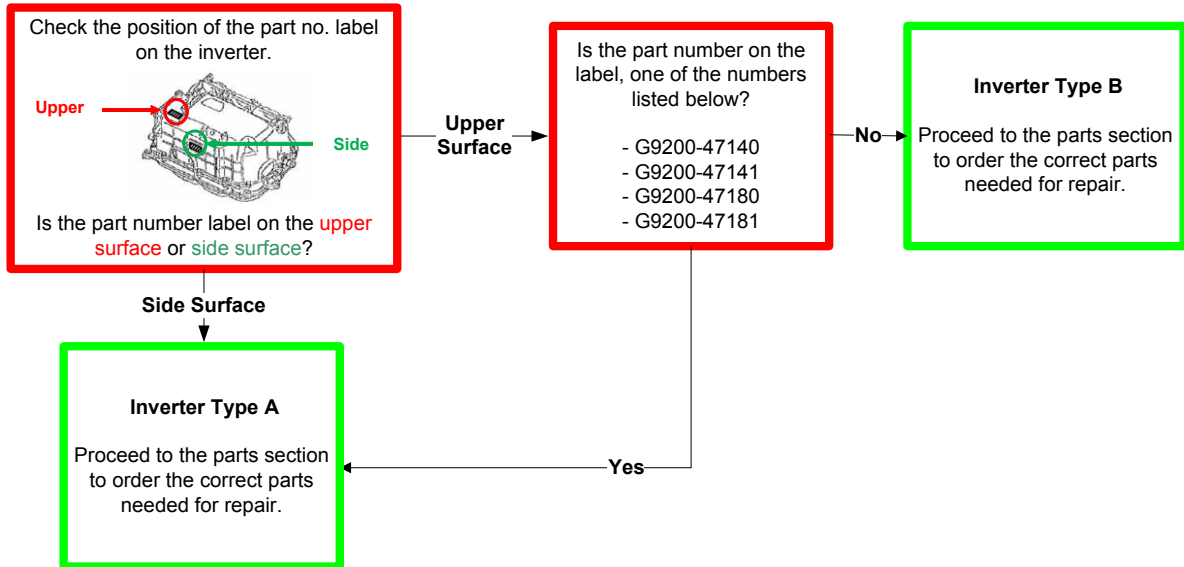
a) Using the flowchart below determine the inverter type.
