Service Category Vehicle Exterior

Section Exterior Panels/Trim

YEAR(S)	MODEL(S)	ADDITIONAL INFORMATION	
2007 – 2011	Camry, Camry HV	WMI(s): 4T1, 4T4

Some 2007 – 2011 North American produced (NAP) Camry and Camry HV vehicles may exhibit a knocking, popping, ticking, or snapping noise from the moon roof area while driving. The repair procedures below have been developed to address this condition.

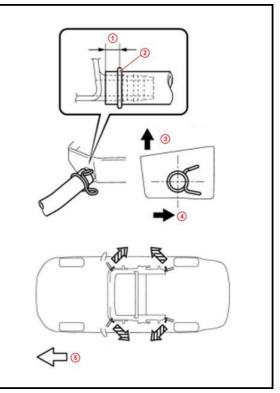
Figure 20.

The clip must face toward the outside of the vehicle and also be above the lower surface of the sliding roof housing when installing the drain hoses or damage to the headliner may occur.

D. Confirm that all the 4 sliding roof drain hoses are pushed all the way onto the sliding roof housing and that the 4 clips are installed as shown in the illustration.
