Power Back Door Does Not Close Properly

Service Category Vehicle Exterior

YEAR(S)	MODEL(S)	ADDITIONAL INFORMATION
2008 – 2012	Highlander, Highlander HV	WMI(s): 5TD, JTE

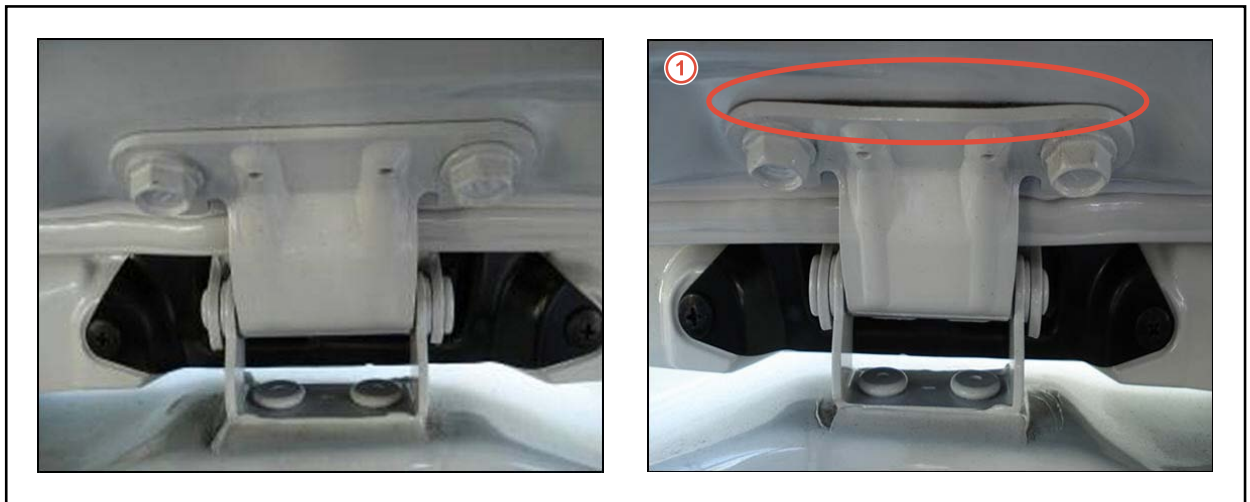
1. Inspect the upper hinges for any gaps present by placing a 0.05 mm (0.002 in.) or greater feeler gauge between the 2 bolts mounted to the back door as shown in Figure 1. If a gap exists, replacement of both Back Door Hinges AND the Back Door Panel Sub-assembly is required. Proceed to step 2.

1	Gap Location
----------	---------------------

1. Sublet vehicle repair of the back door and back door hinges refinishing to a body shop if necessary. Repainting and repair of the back door and hinges should be done in accordance with Toyota's body repair recommendations.

Remove and replace the back door, hinges, and lift arm/Power Back Door motor as needed based off inspection procedures in this bulletin.

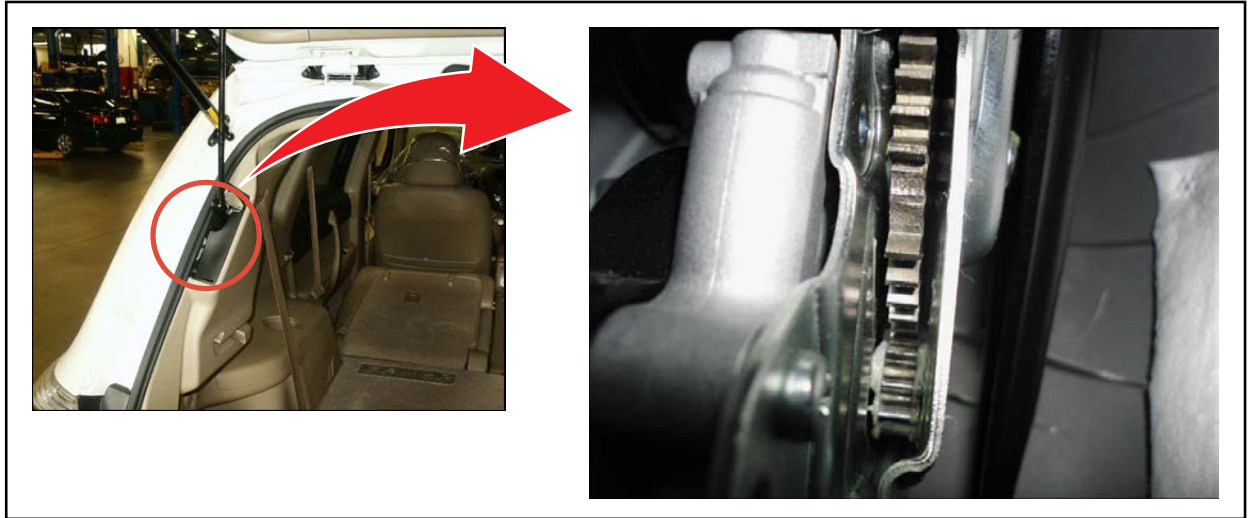
2. Visually inspect the back door motor teeth for damage by opening the back door and manually moving the door towards the half-closed position while observing the large gear teeth for damage, as shown in Figure 2. If damage is found, replacement of the Back Door Motor Unit is required.

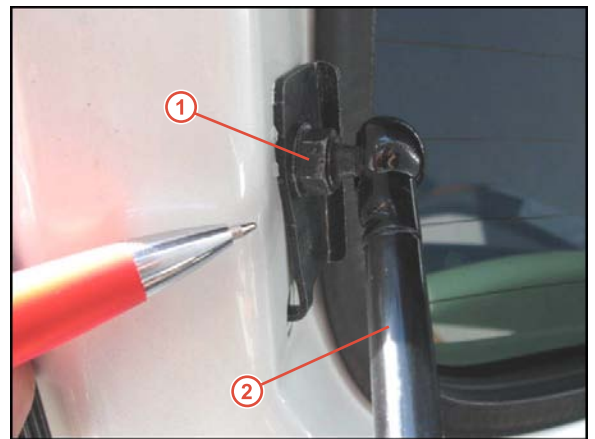
Figure 3.

3. Visually inspect the Back Door Upper Rod and Lift Arm Stud for bends or damage. If it is bent, or damage is found, replacement is required.

1	Lift Arm Stud
2	Back Door Upper Rod

NOTE
 The Back Door Upper Rod and Lift Arm Stud are available as separate service parts from the Back Door Motor Unit if found damaged or bent.
