**TECHNICAL INSTRUCTIONS**

**SAFETY (NON-COMPLIANCE) RECALL CAMPAIGN BSN  
SUPPLEMENTAL PHASE FOR VEHICLES WITH SPECIFIC ACCESSORIES**

**TIRE AND LOADING INFORMATION PLACARD**

**2011 – CERTAIN 2012 MODEL YEAR SIENNA**

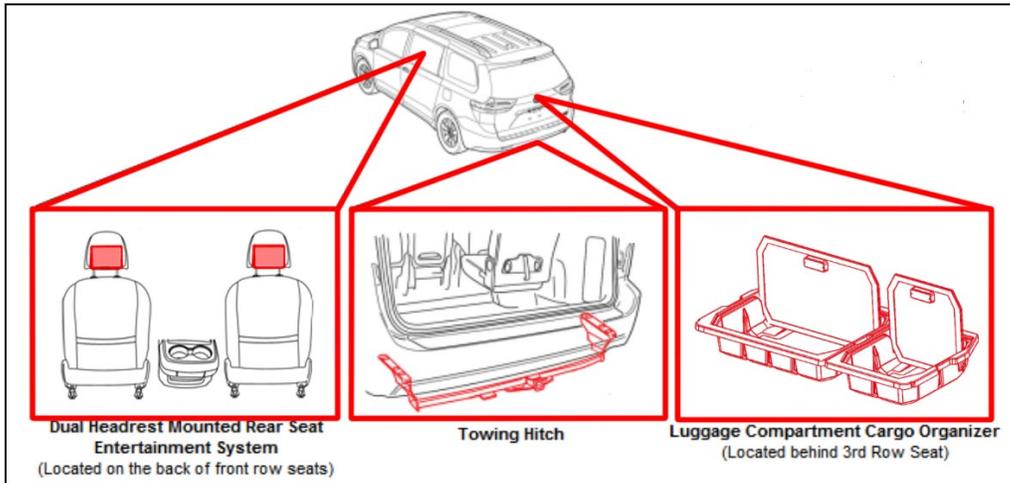
### 2. RECORD THE ACCESSORIES INSTALLED ON THE VEHICLE

- Tow Hitch
- Cargo Organizer
- Headrest Mounted Rear Seat Entertainment

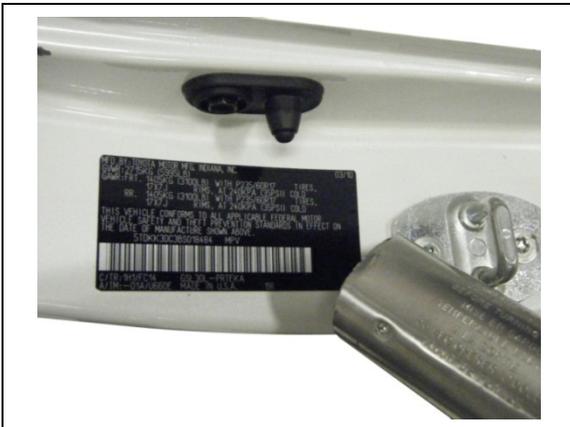
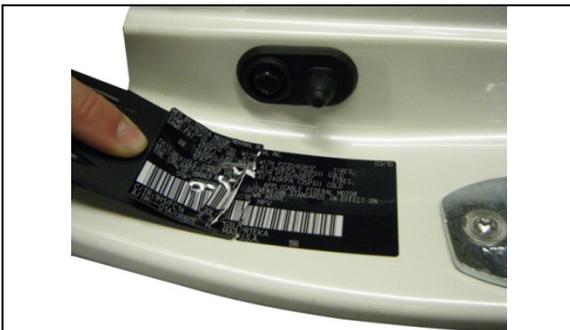
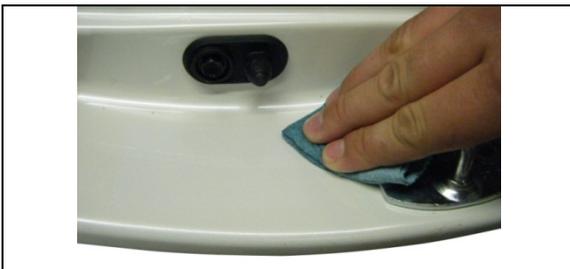
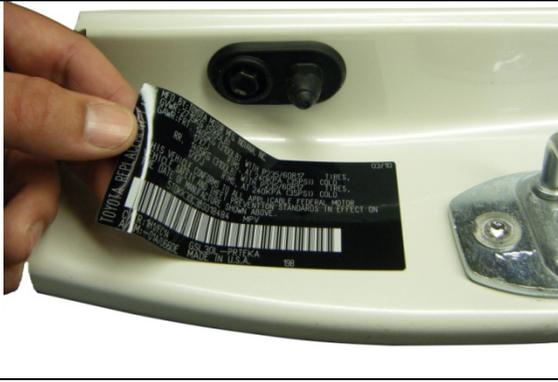
- a) Heat the original certification label evenly using a heat gun.

- b) While continuing to apply heat, peel the label using the provided scraper.

- c) Clean the panel to remove all adhesive residue using '3M General Purpose Adhesive Remover', or equivalent.

- a) Place the updated certification label on the panel in the same location as the old label.

**NOTE:** Confirm there are no bubbles or creases when installing the updated label.
