Power Steering Rack Leak from Right Side: Overhaul Procedure

YEAR(S)	MODEL(S)	ADDITIONAL INFORMATION
2004 – 2010	Sienna	Drive Type(s): 4WD, 2WD Engine(s): 3MZ, 2GR

The information contained in this bulletin supersedes SB No. T-SB-0097-12.

A new repair procedure and overhaul kit have been developed for repairing the power steering rack to improve the overall serviceability and reduce ownership cost. This repair procedure only applies to vehicles where the steering rack leak is originating from the right (passenger) side **and** is the OEM steering rack assembly.

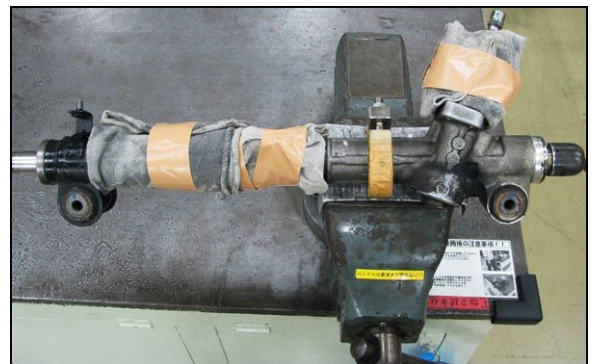
Figure 2.

3. Remove the steering right turn pressure tube.
 - A. Disconnect the right turn pressure tube using the procedure above.
 - B. Remove the 2 O-rings from the right turn pressure tube and discard.

HINT
Wrap the steering rack in cloth or shop rags to capture any excess power steering fluid that will leak during the repair.

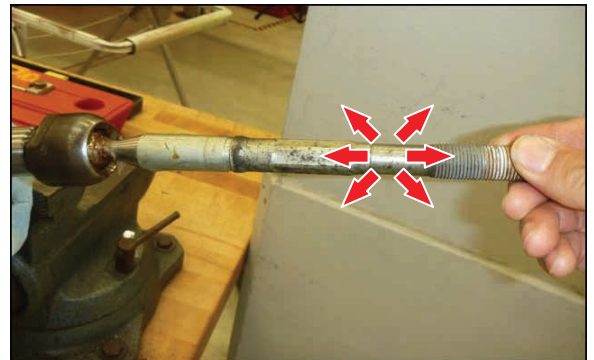
Figure 7.

14. Inspect the left-hand and right-hand tie rod ends for excessive wear and play. Push and pull the tie rod to confirm condition. Replace as necessary.

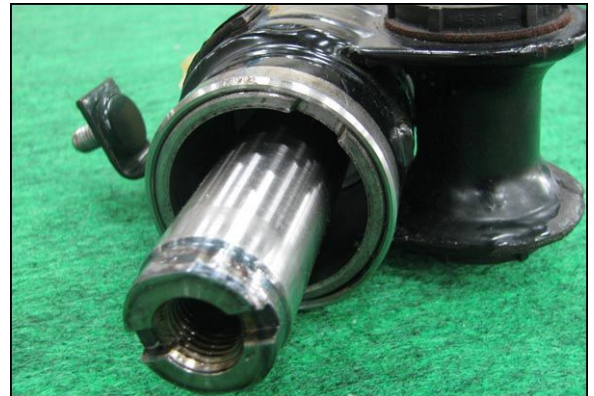
Figure 8.

15. Thoroughly clean the steering rack assembly.

Be sure to clean the inside of the rack assembly to prevent foreign material from damaging the rack surface (for example, when boot has torn and allowed debris to collect around the inside of the rack).

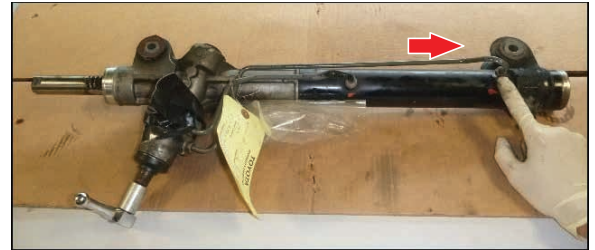
Figure 11.

Plug the port while simultaneously turning the input shaft counterclockwise.

The internal air pressure will cause the rack bushing to get pushed out.

Do NOT turn the input shaft clockwise; it may cause damage to the center seal on the rack bar if it goes beyond its normal travel.

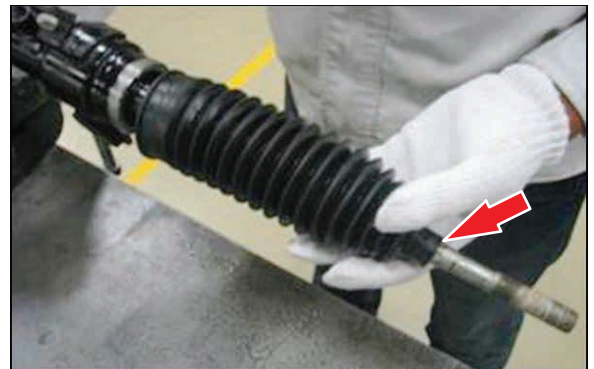
Figure 22.

4. Install the steering rack boot.
 - A. Apply a small coat of silicone grease to the inside clamping surface of the small end of the boot as shown.
 - B. Install the steering rack boot.
 - C. Install the steering rack boot clip using pliers.
