# Instrument Panel (Dashboard) Cracked and/or Sticky

**Service Category** Vehicle Interior

**Section** Interior Panels/Trim

Some 2003 – 2011 model year Toyota vehicles may exhibit a condition where the instrument panel pad (dashboard) becomes cracked and/or sticky. Follow the procedure in this bulletin to address this condition.

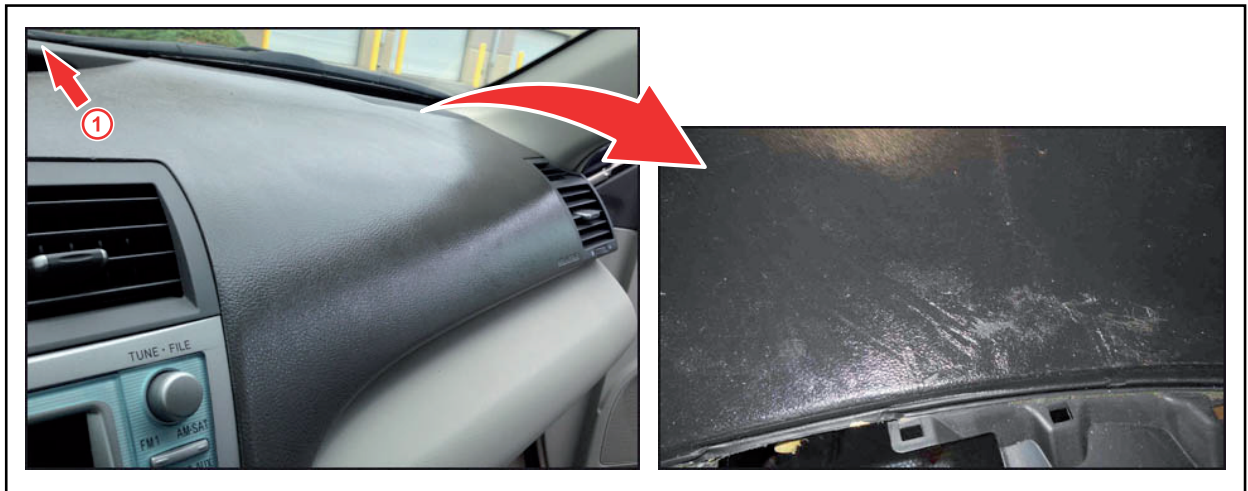
**Figure 1. Example of Sticky Condition**

**1** Front of Vehicle

1. Confirm the dashboard exhibits the cracked and/or sticky appearance condition. Refer to Figures 1 – 3 for examples of these conditions.

2. Replace the instrument panel safety pad sub-assembly.

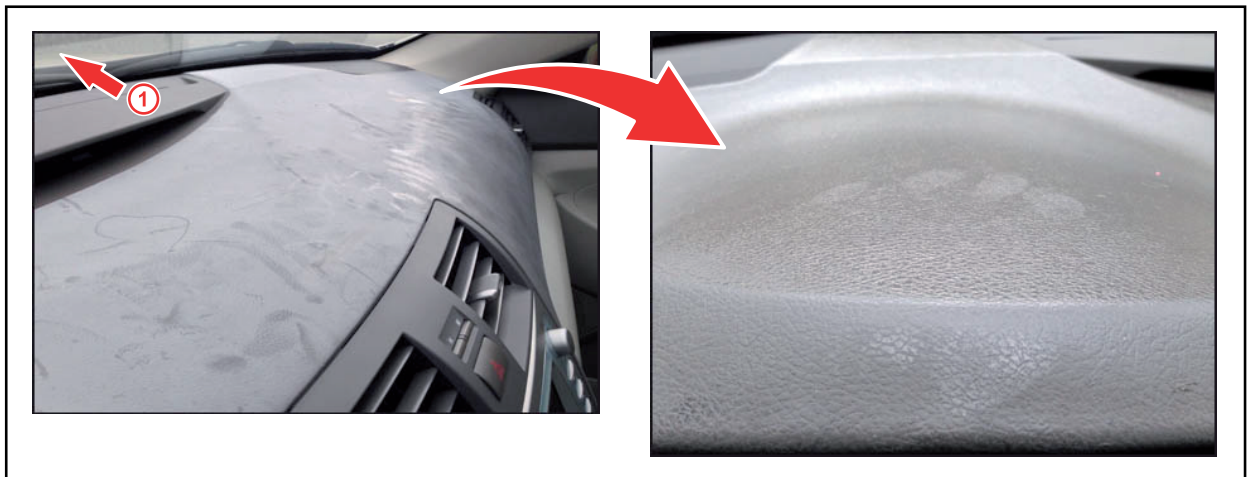
**Figure 2. Example of Chalky Condition (Becomes Sticky in the Heat)**

**1** Front of Vehicle

When a vehicle with a sticky dashboard is parked out of heat and humidity for more than a few hours, the dashboard surface becomes chalky. Once the vehicle is exposed to heat again, the sticky condition returns.

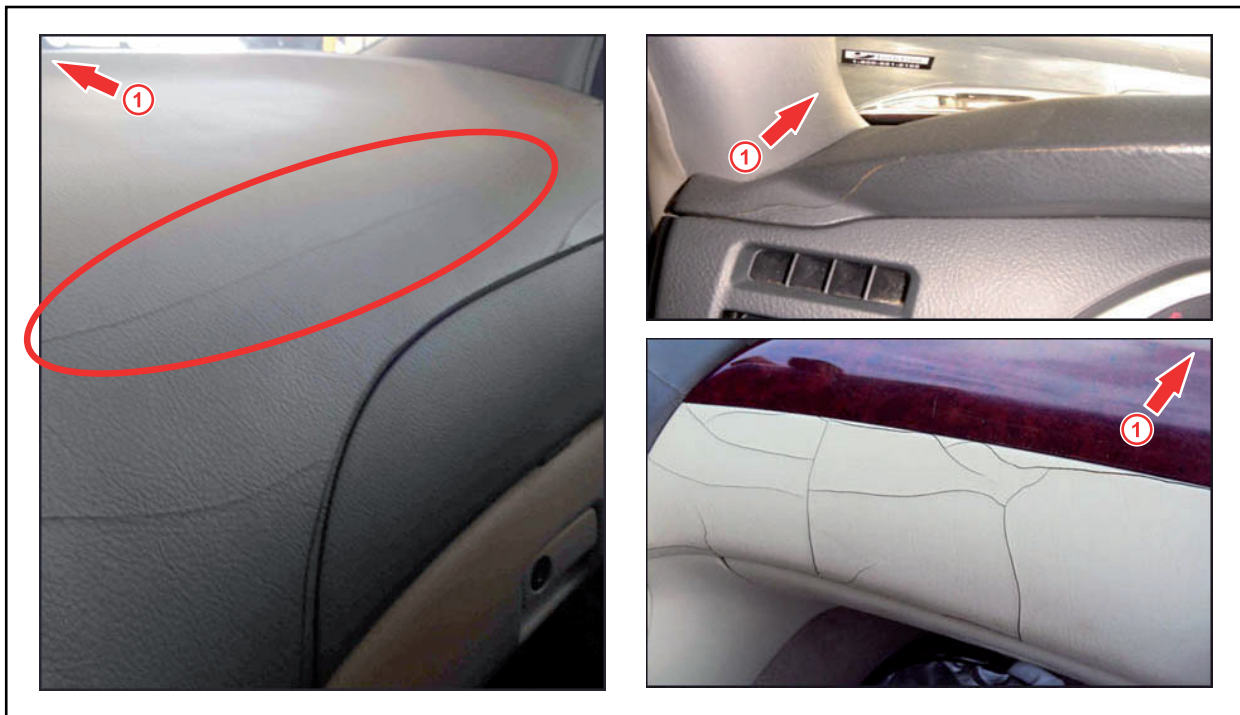
**Figure 3. Examples of Cracked Condition**

| <b>1</b> | Front of Vehicle |
