Spare Tire Carrier Binding

Service Category Suspension

Section Tire/Wheel

| YEAR(S) | MODEL(S) | ADDITIONAL INFORMATION |
|---|---|---|
| 2004 – 2008 | Sienna | VDS(s): MK29C |

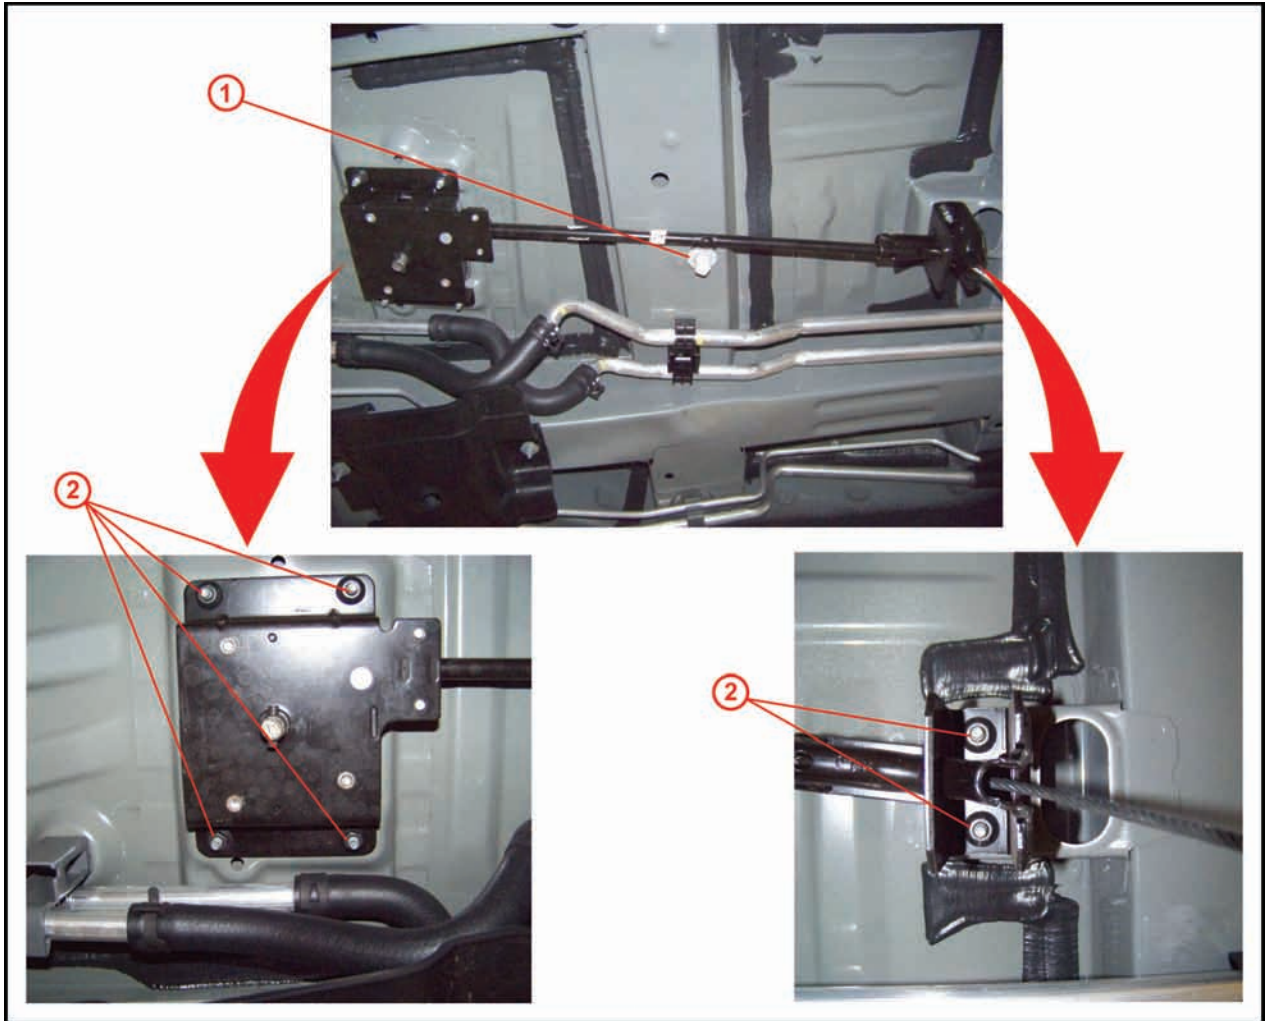
Figure 1.

| 1 | Plastic Cover |
| 2 | 6 Nuts |

1. Lower and remove the spare tire from the carrier assembly.
2. Remove and replace the spare tire carrier assembly.
 - A. Remove the six nuts, plastic cover, and remove the spare tire carrier assembly (see Figure 1).
