**TECHNICAL INSTRUCTIONS**  
**FOR**  
**SAFETY RECALL 90L PHASE II**  
**CTS ACCELERATOR PEDAL MODIFICATION**  
**2007 – 2010 MODEL YEAR CAMRY**

***REVISED MARCH 11, 2010***

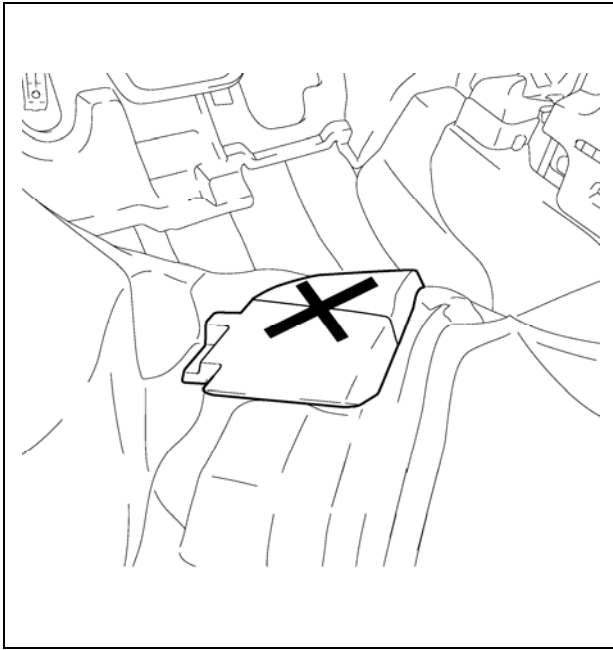
## 5. REMOVE THE TIBIA PADS

- Place an "X" mark on the tibia pads before removing. This will prevent them from being mixed up with the new pads.
- Using a hair dryer or a low temperature heat gun, warm up the carpet side of the 2 tibia pads until the adhesive is loose. This will make it easier to remove the 2 tibia pads from the carpet. **Pay close attention when using the hair dryer or low temperature heat gun to prevent damage to the carpet.**
- Remove the tibia pads. **CAUTION: DO NOT forcefully pull the pads. Doing so may damage the carpet. If necessary, re-heat the carpet to make the adhesive more pliable.**
