Grille Wind Whistle Noise

Service Category Vehicle Exterior

Section Exterior Panels/Trim

YEAR(S)	MODEL(S)	ADDITIONAL INFORMATION
2012 – 2013	Tacoma

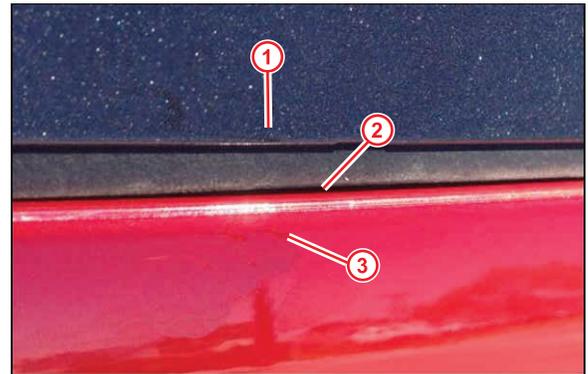
Figure 1.

Noise occurs due to a gap between the radiator rubber seal and the radiator grille.

1	Hood
2	Gap Between Rubber and Radiator Grille
3	Radiator Grille

2. Duplicate the noise, then mask off the rubber seal between the radiator grille and the hood.

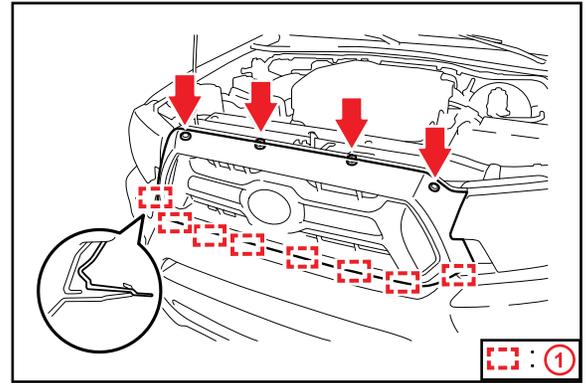
Figure 2.

3. Remove the radiator grille.
 - A. Remove the 2 screws.
 - B. Using the plastic pry tool, remove the 2 clips.
 - C. Disengage the 8 guides and remove the radiator grille.

1	Guides
----------	---------------

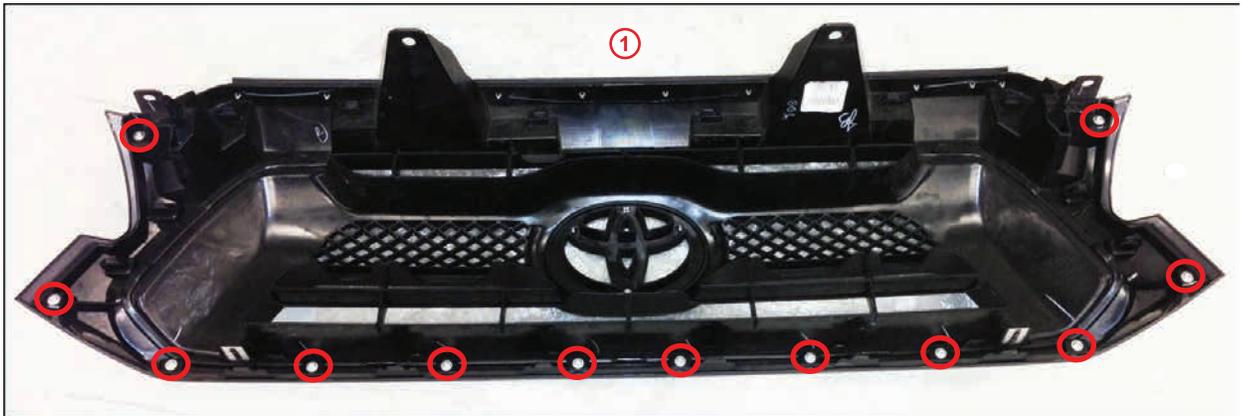
Figure 3. Back View of Radiator Grille

4. Remove the 12 screws from the back side of radiator grille.

1	Screw Location
----------	-----------------------

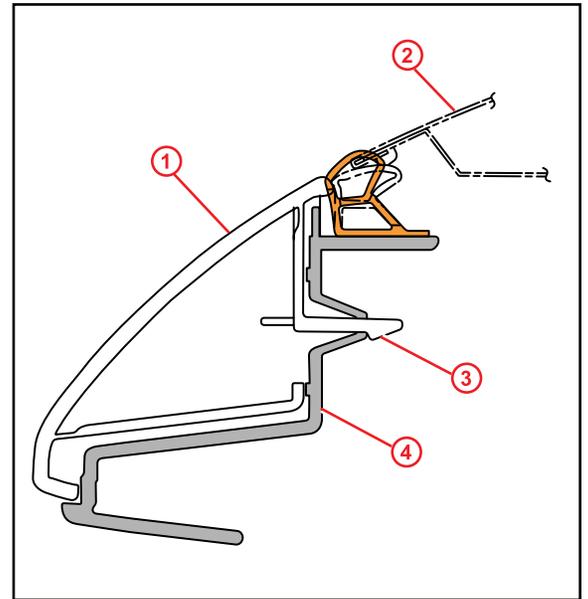
Figure 4. Cross Section View

A. Using a plastic pry tool, remove the 10 claws.

1	Radiator Outer Grille
2	Hood
3	Claw
4	Radiator Inner Grille

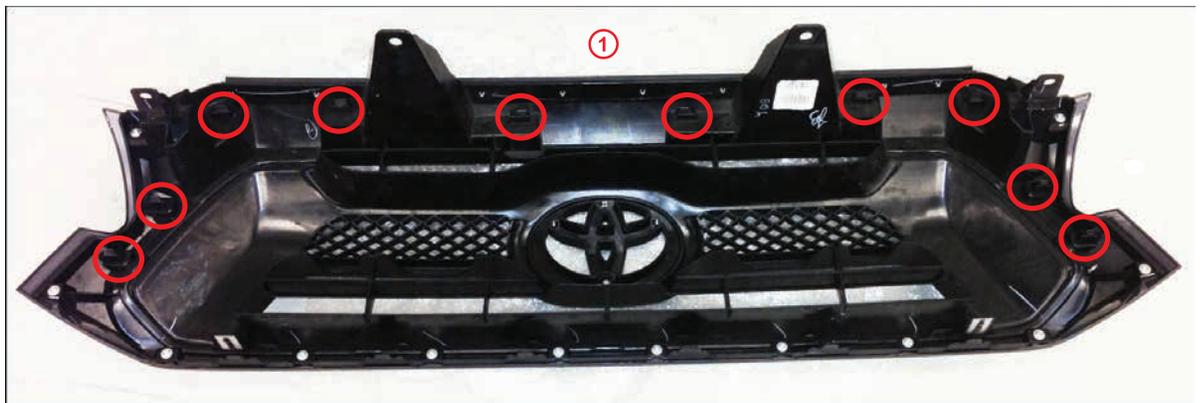
Figure 5. Back View of Radiator Grille

B. Disengage the 10 claws and separate the radiator outer grille and inner grille.

1	Claw Location
----------	---------------

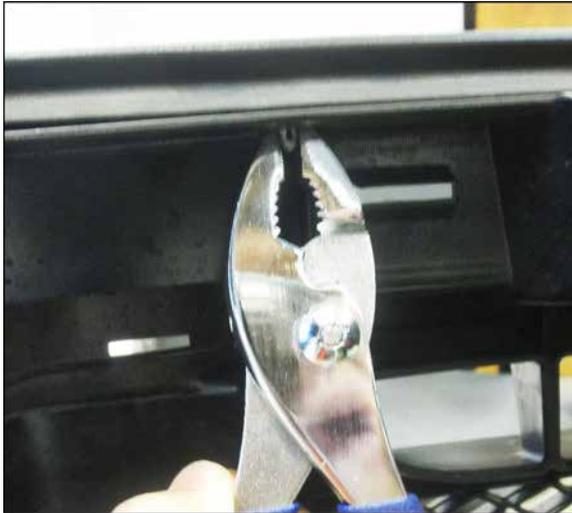
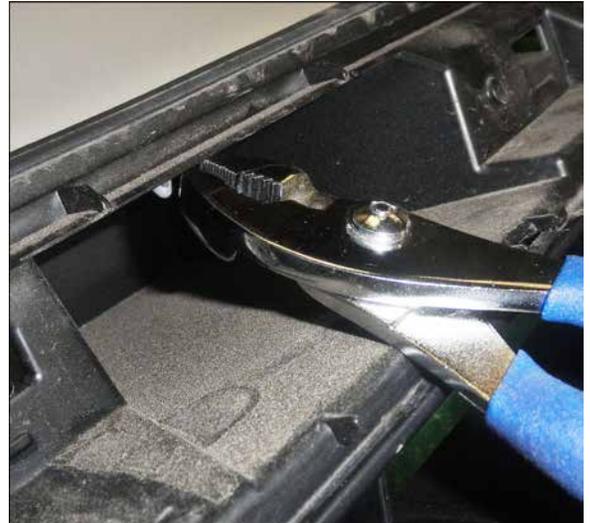
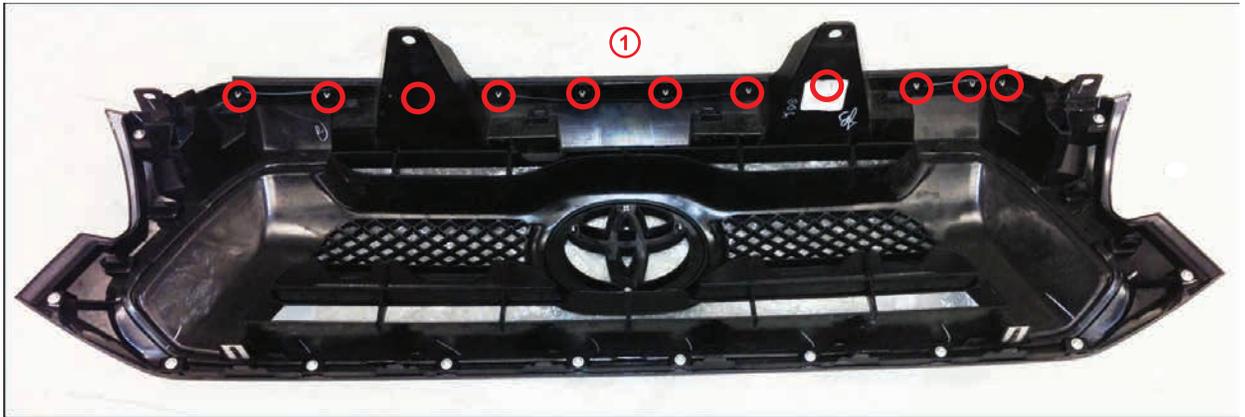
6. Remove the Radiator Grille Seal by removing the 11 clips with the pliers.

Figure 6. Back Side of Radiator Grille

Figure 7. Front Side of Radiator Grille

Figure 8. Back View of Radiator Grille

1	Clip Location
----------	---------------

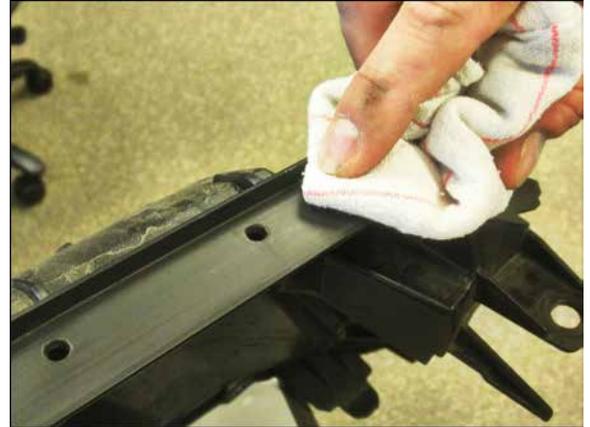
Figure 9.

7. Clean the top of the surface of the radiator inner grille using a cloth.

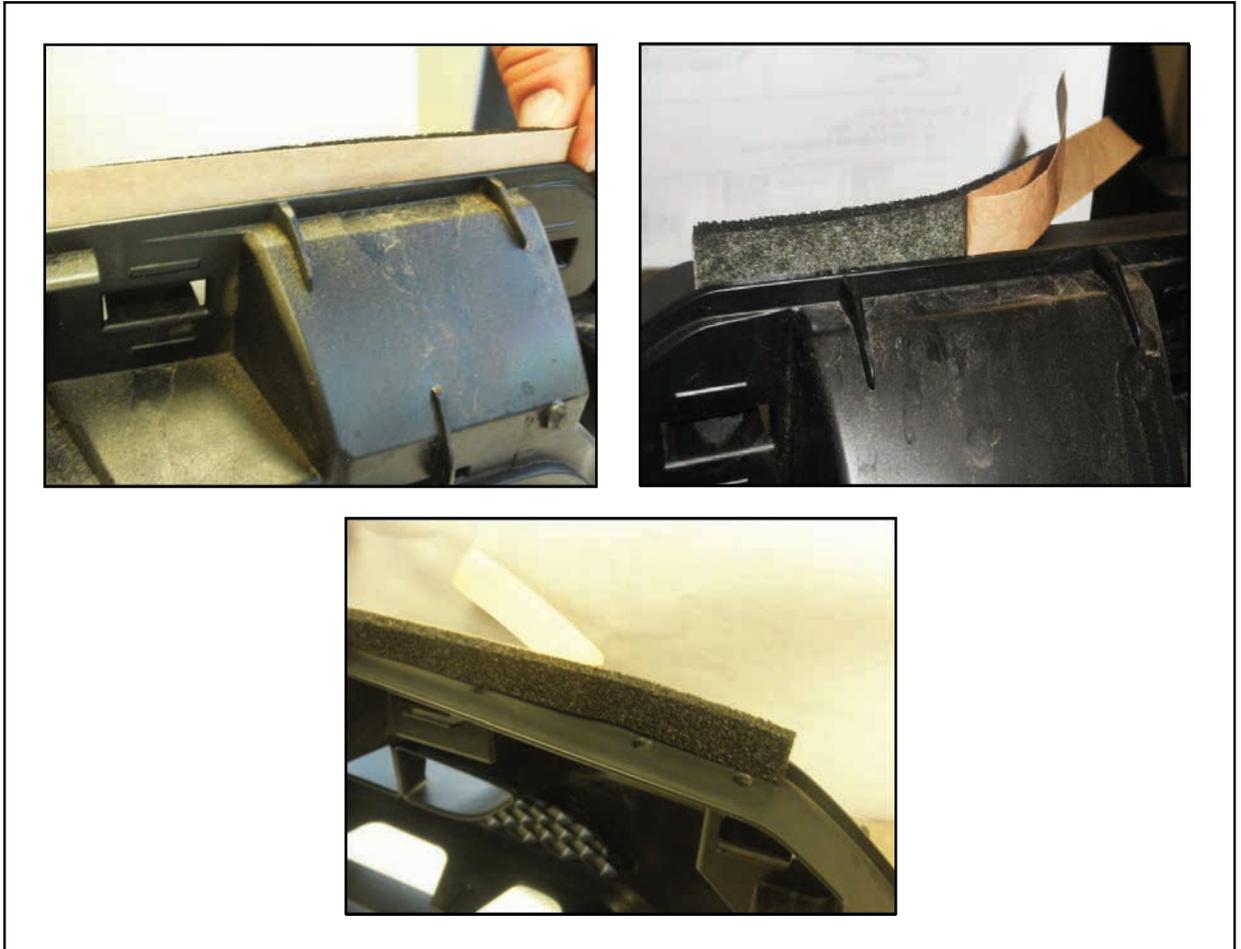
Figure 10.

8. Apply the Radiator Grille Seal to the rib and be sure to center the seal sealer so that it overlaps both sides of the rib equally.

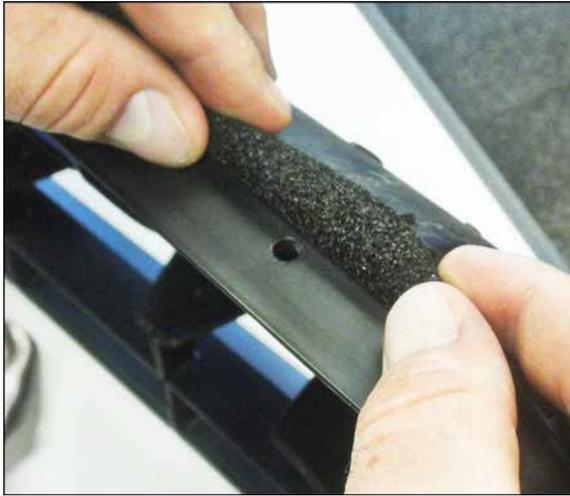
Figure 11.

9. Roll up the Radiator Grille Seal over the rib.

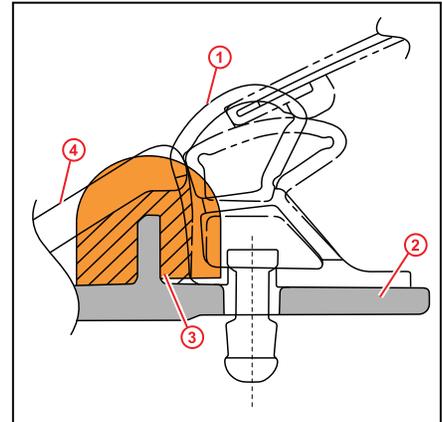
Figure 12. Cross Section View

1	Hood Seal
2	Radiator Inner Grille
3	EPT Seal
4	Radiator Outer Grille

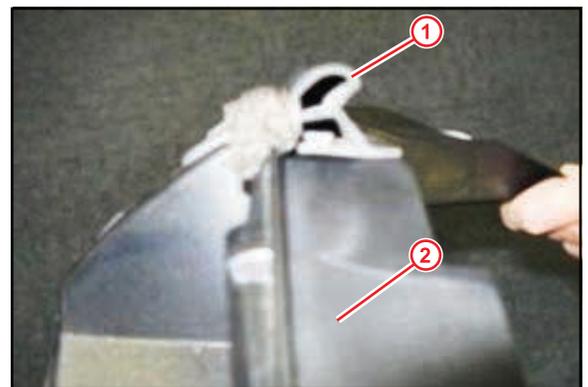
Figure 13.

A. Reinstall the Radiator Grille Seal.

1	Radiator Grille Seal
2	Radiator Grille Inner

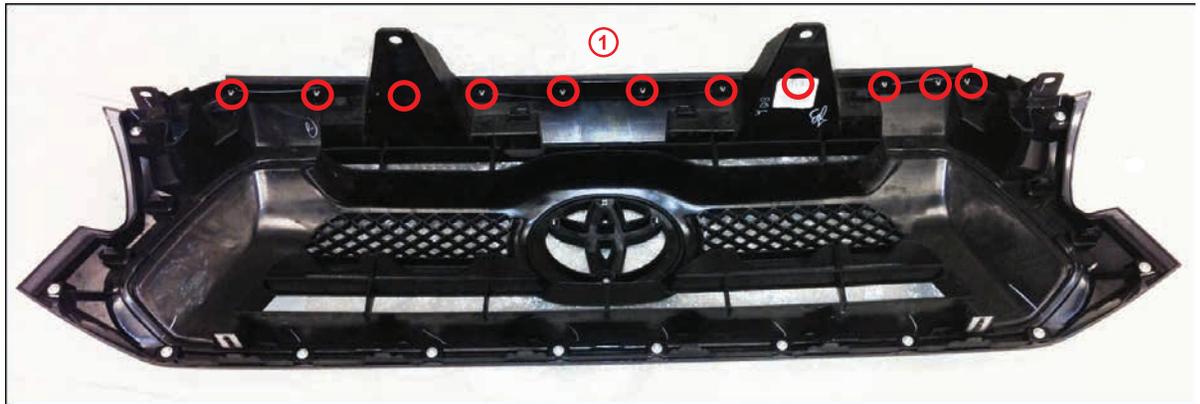
Figure 14. Back View of Radiator Grille

B. Install the 11 clips.

1	Clip Location
----------	---------------

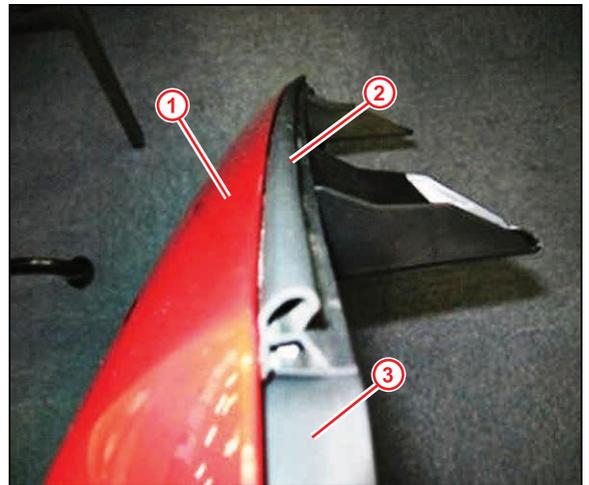
Figure 15.

C. Reinstall the front radiator grille outer cover.

1	Radiator Grille Outer (Cover)
2	Radiator Grille Seal
3	Radiator Grille Inner

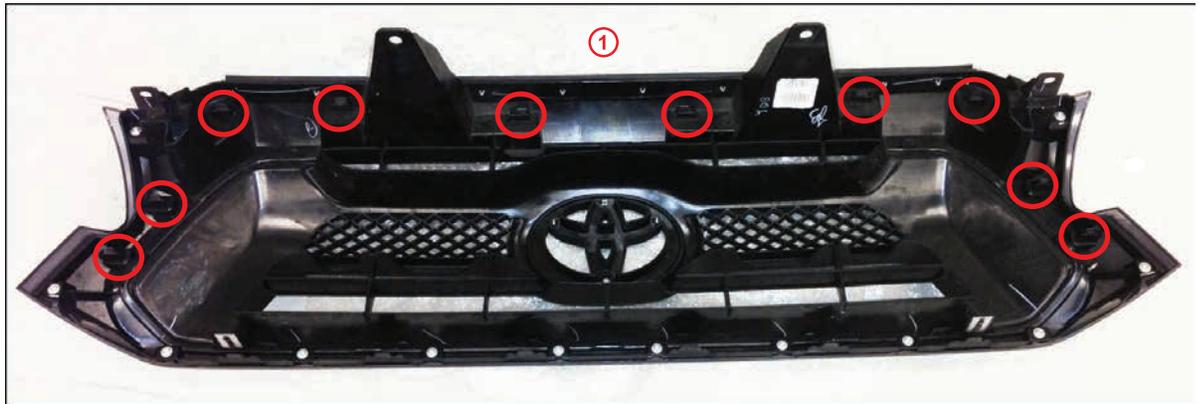
Figure 16. Back View of Radiator Grille

D. Engage the 10 claws.

1	Claw Location
----------	----------------------

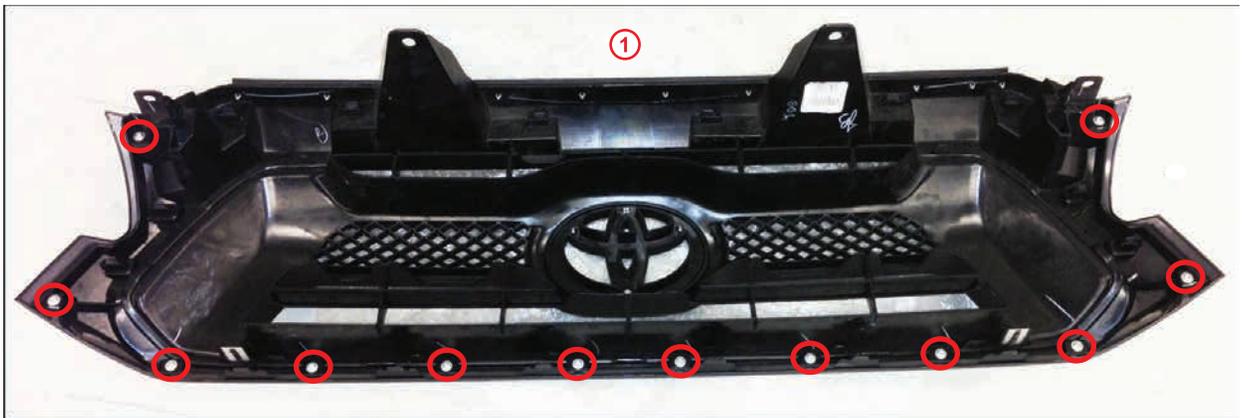
Figure 17. Back View of Radiator Grille

E. Install the 12 screws.

1	Screw Location
----------	-----------------------
