SUBJECT: SAFETY RECALL (SPECIAL SERVICE CAMPAIGN) – 70B
(FRONT SUSPENSION LOWER BALL JOINTS)

**Special Service Campaign 70B – Front Suspension Lower Ball Joint
2004 through Early 2007 Sequoia and 2004 through late 2006 Tundra
SAFETY RECALL NOTICE**

SPECIAL SERVICE CAMPAIGN 70B (SAFETY RECALL)

FRONT SUSPENSION LOWER BALL JOINTS

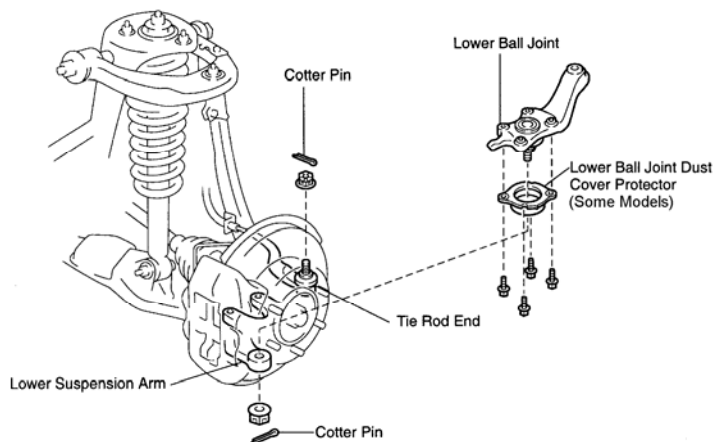
2004 - Early 2007 Model Year Sequoia or Tundra
Front Suspension Lower Ball Joint Replacement

On certain 2004 through early 2007 Model Year Sequoia and 2004 through late 2006 Model Year Tundra vehicles, there is a possibility that the Front Suspension Lower Ball Joint may experience excessive wear and looseness causing increased steering effort, reduced vehicle self-centering, and noise in the front suspension. In the worst case, if the vehicle is continued to be operated in this condition, the lower ball joint may separate causing a loss of vehicle steering control.

Replace* the Front Suspension Lower Ball Joints.
