TECHNICAL INSTRUCTIONS
FOR
SAFETY RECALL C0B
SPIRAL CABLE REPLACEMENT
CERTAIN 2005 TO EARLY 2009 MODEL YEAR TACOMA

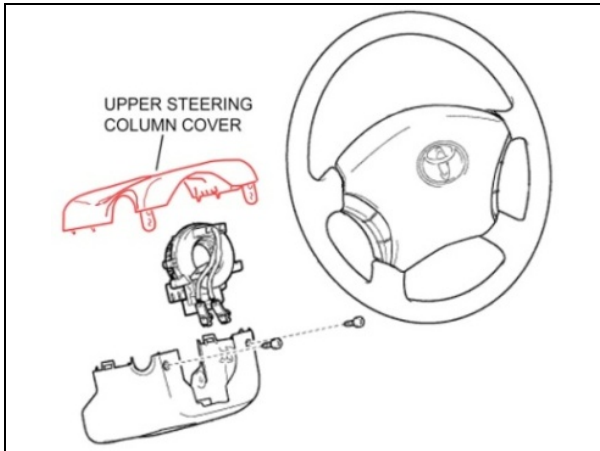
B. SPIRAL CABLE INSPECTION

- Follow all precautions as outlined on TIS before servicing the SRS system.
- Approximately 85-90% of all vehicles will require spiral cable replacement. If initial inspection indicates that replacement is not necessary, reconfirm the inspection was performed correctly.
