# Repair Manual Supplement: Vehicle Pulling to One Side

**Service Category** Suspension

**Section** Alignment/Handling Diagnoses

**February 20, 2013 Rev1:**

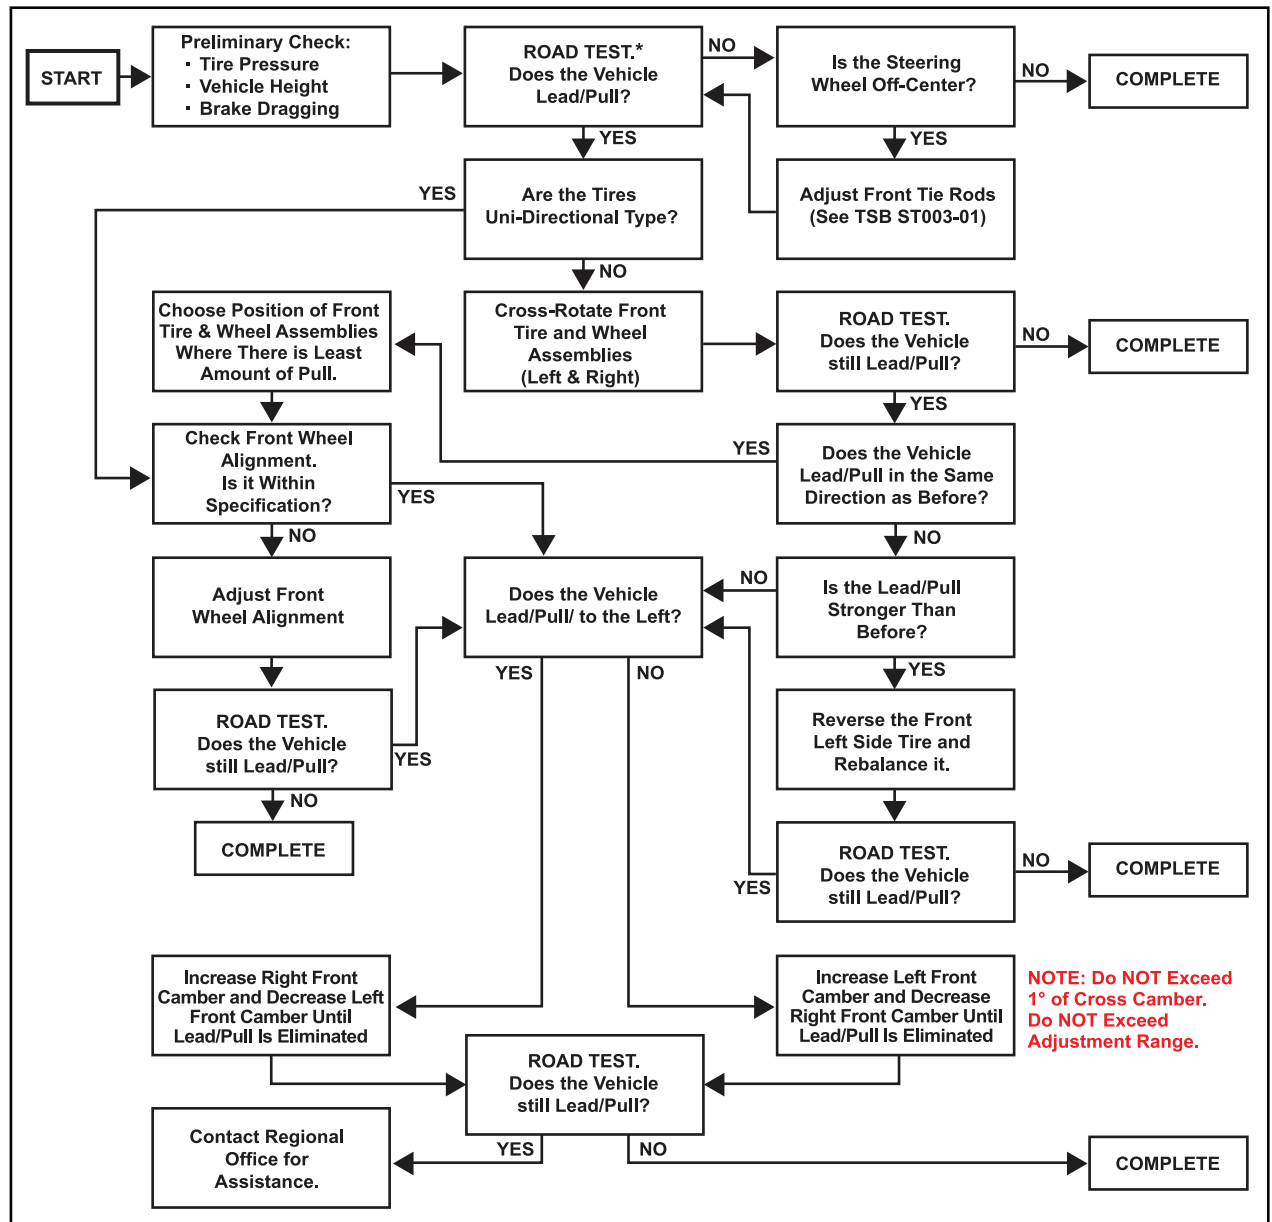
Figure 5.

\* Select a flat road where the vehicle can be driven in a straight line for 109 yards (100 meters) at a constant speed of 35 mph (56 km/h). Please confirm safety and set the steering wheel to its straight position. Drive the vehicle in a straight line for 109 yards (100 meters) at a constant speed of 35 mph (56 km/h) without exerting steering effort on the steering wheel.

- **Steering Off Center:** The vehicle goes straight but the steering wheel has some angle.
- **Steering Pull:** The vehicle does NOT go straight.
