TECHNICAL INSTRUCTIONS
FOR
SAFETY RECALL E0E
SOFTWARE UPDATE FOR MOTOR GENERATOR ECU AND POWER
MANAGEMENT ECU
CERTAIN 2010-2014 MODEL YEAR PRIUS

UPDATED August 15, 2014

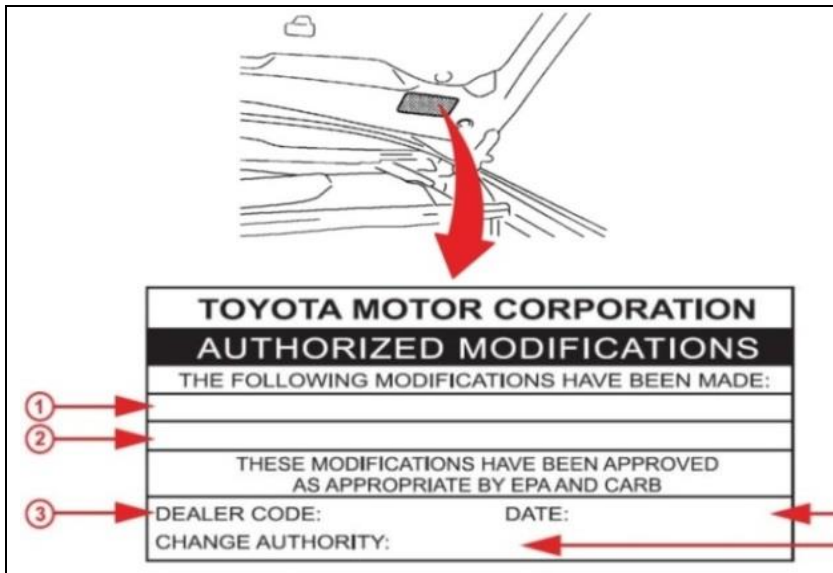
10. Affix the label to the under-side of the hood.

The authorized modification label only needs to have the Power Management ECU Information.
