Subject: Voluntary Safety Recall – A0H
Certain 2000 through 2004 Toyota Avalon
Steering Column Upper Bracket Replacement

STEERING COLUMN UPPER BRACKET ASSEMBLY REPLACEMENT

2000 – 2004 MODEL YEAR AVALON

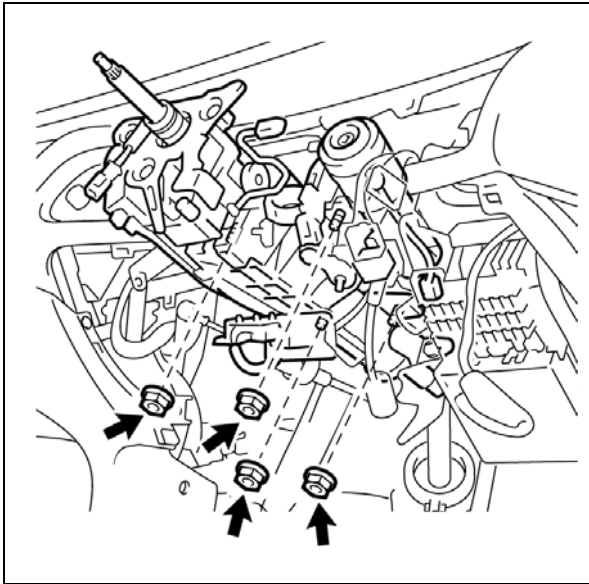
14. REMOVE THE STEERING COLUMN ASSEMBLY

- a) Remove the 2 nuts and the pedal bracket stay No. 1.

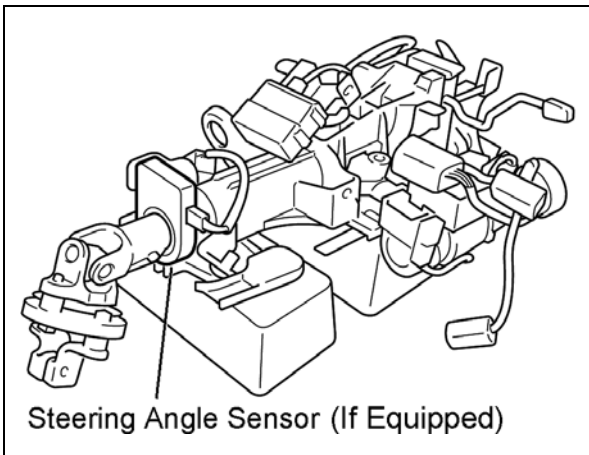
- b) Disconnect the 5 connectors.
- c) Disconnect the 3 wire harness clamps.
- d) Remove the 4 nuts and the steering column assembly.

NOTE:

Make sure to wear protective gloves when removing the steering column assembly, as there may be sharp edges on the surrounding components.

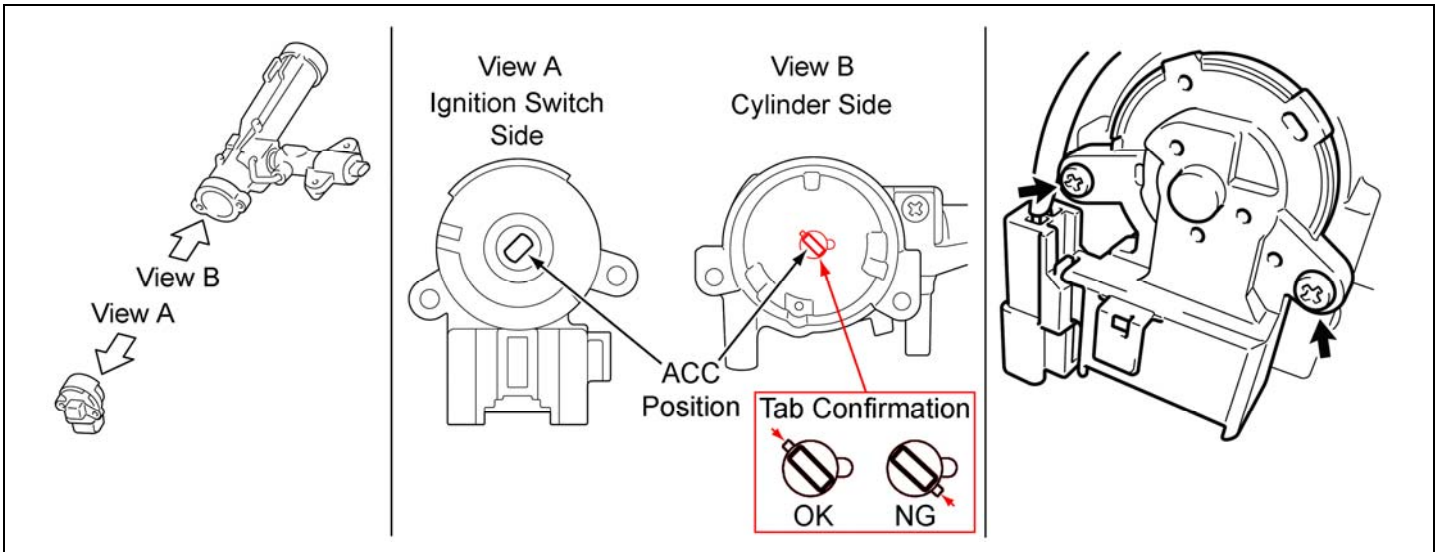
7. REINSTALL THE IGNITION SWITCH'

- Place the **NEW** steering column upper bracket cylinder shaft in the ACC position, while making sure the tab is in the correct location as shown.
- Reinstall the ignition switch to the **NEW** steering column upper bracket with the 2 screws.

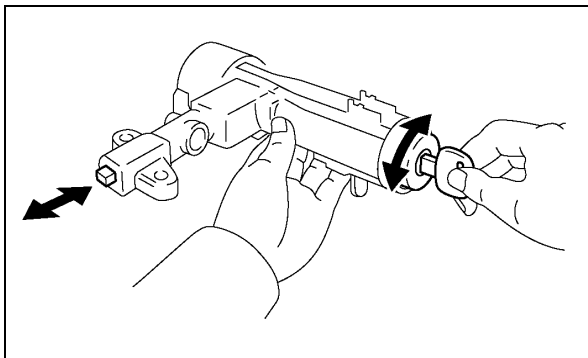
9. REINSTALL THE KEY CYLINDER

- a) Make sure the key cylinder is in the ACC position.
- b) Insert the key cylinder assembly into the **NEW** steering column upper bracket assembly.
- c) Confirm the key cylinder assembly is firmly fixed.

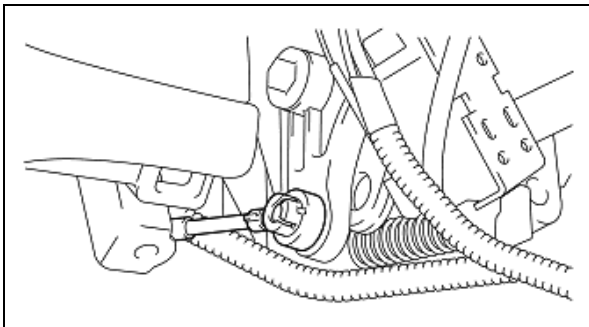
2. RECONNECT THE TRANSMISSION CONTROL CABLE (COLUMN SHIFT ONLY)

- a) Reconnect the transmission control cable to the column tube bracket.

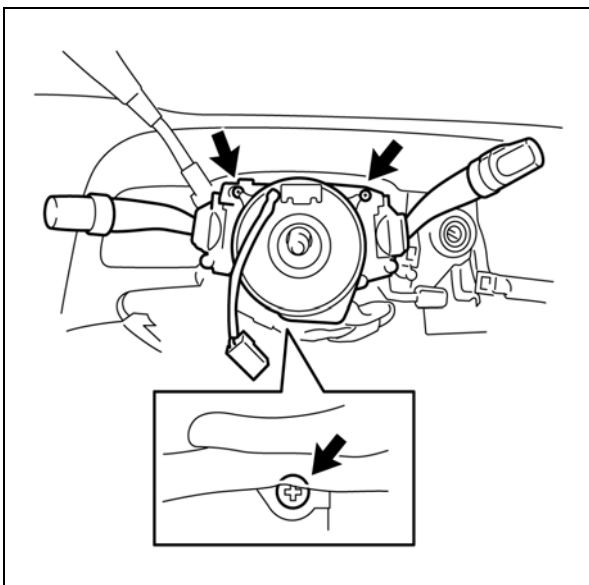
3. REINSTALL THE COMBINATION SWITCH WITH SPIRAL CABLE

- a) Reinstall the combination switch with spiral cable using the 3 screws.
- b) Reconnect the 4 connectors.

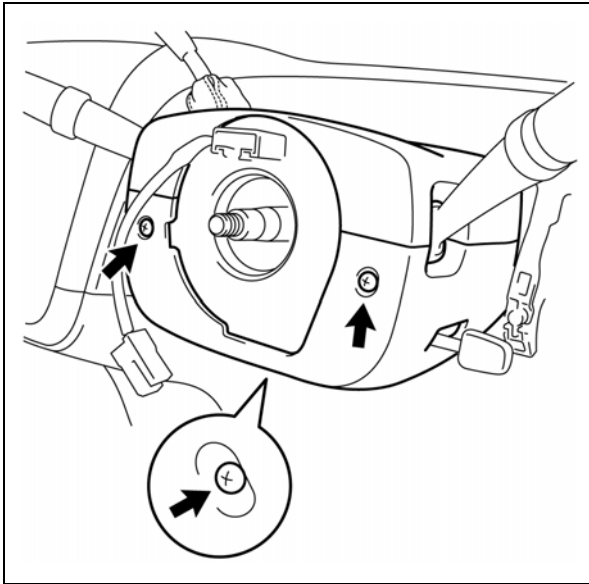
4. REINSTALL THE STEERING COLUMN COVERS

- a) Reinstall lower and upper steering column covers.
- b) Reinstall the 3 screws.

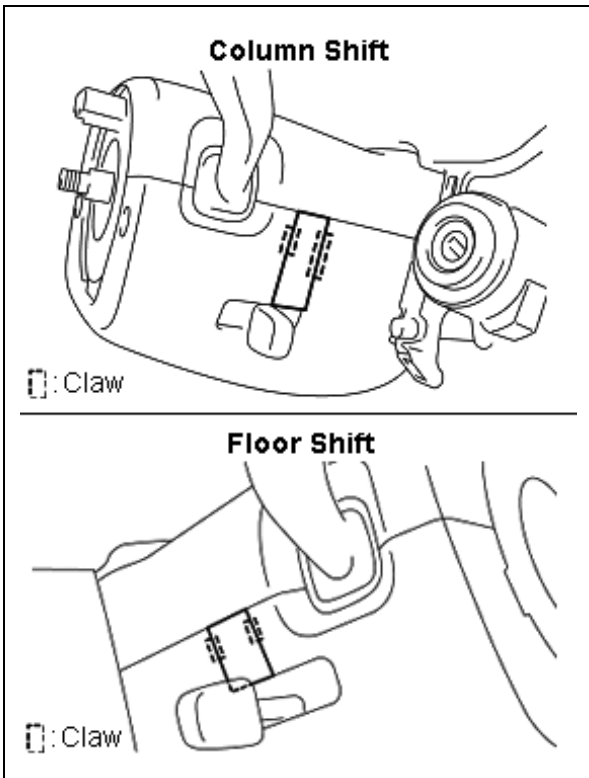
5. REINSTALL THE NO. 2 COLUMN LOWER COVER

- a) Reinstall the column lower cover by engaging the 2 claws.

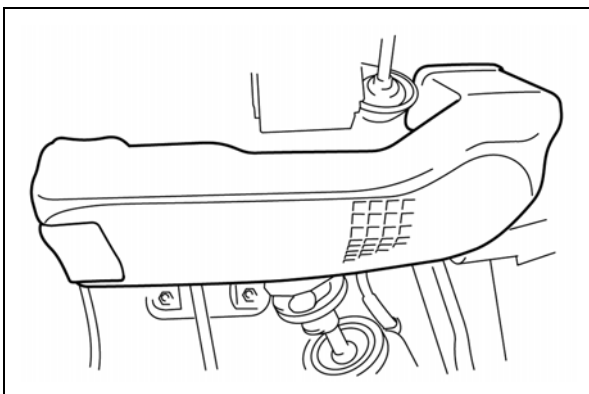
6. REINSTALL THE NO. 2 HEATER TO REGISTER DUCT

- a) Reinstall the heater to register duct with the clip.

- **DO NOT** deform the duct when reinstalling.
- **Make sure** the duct is firmly installed.

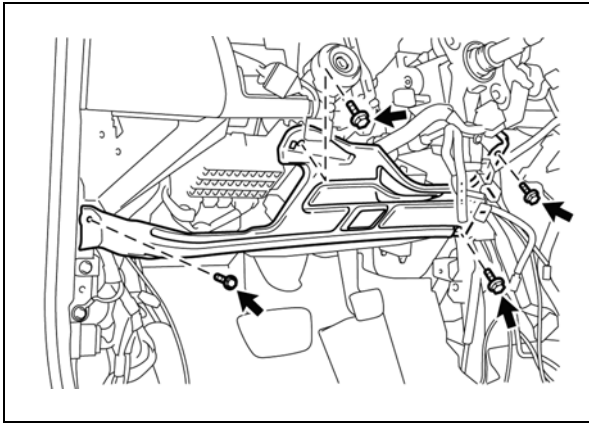
7. REINSTALL THE LOWER LH INSTRUMENT PANEL INSERT SUB-ASSEMBLY

- a) Reinstall the Instrument panel insert sub-assembly with the 4 bolts and torque to spec.

Torque: 10 N·m (102 kgf·cm, 7 ft·lbf)

- b) Reconnect the DLC connector by engaging the 2 claws.

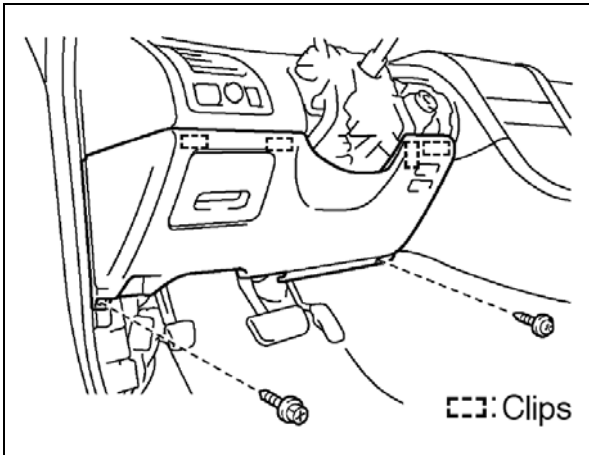
8. REINSTALL THE LOWER NO. 1 INSTRUMENT PANEL SUB-ASSEMBLY

- a) *If equipped* with a room temperature sensor, reconnect the hose and connector.
- b) Reconnect the power outlet switch and traction control switch (*if equipped*) connectors.
- c) Reinstall the instrument panel sub-assembly by engaging the 4 clips.
- d) Reinstall the screw and bolt.

DO NOT damage the room temperature sensor when disconnecting the hose.

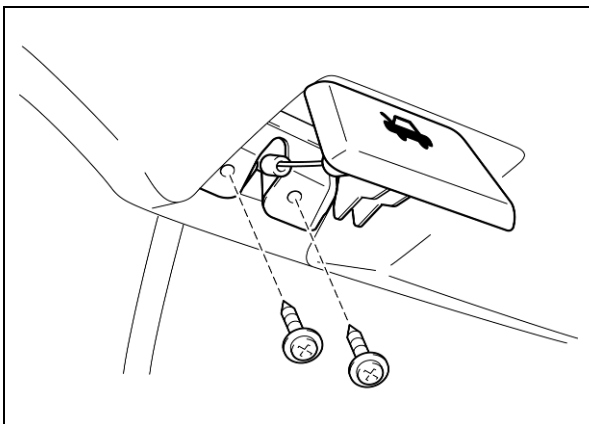
9. REINSTALL THE HOOD LOCK RELEASE LEVER

- a) Reinstall the hood lock cable to the release lever.
- b) Reinstall the hood lock release lever with the 2 screws.

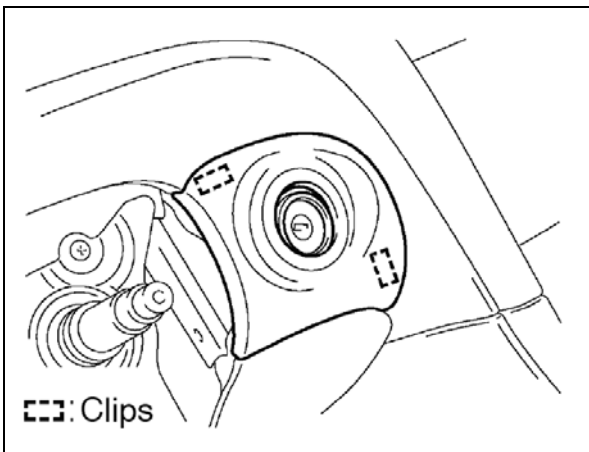
10. REINSTALL THE LOWER INSTRUMENT FINISH PANEL ASSEMBLY

- a) Reinstall the finish panel assembly by engaging the 2 clips.

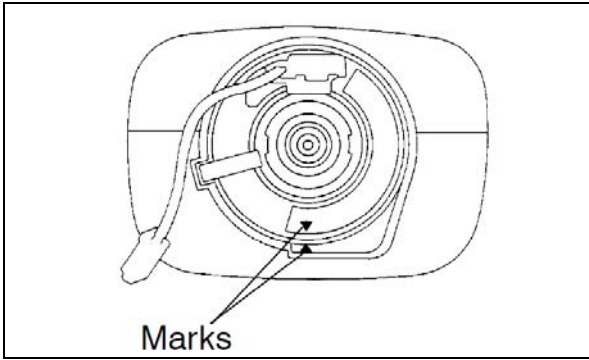
11. CENTER THE SPIRAL CABLE

- Confirm the front wheels are in a straight-ahead position.
- Turn the spiral cable counterclockwise by hand until it becomes hard to turn.
- Then rotate the spiral cable clockwise about 2.5 turns to align the marks.

The spiral cable will rotate approximately 2.5 turns to the left or right from its center position.

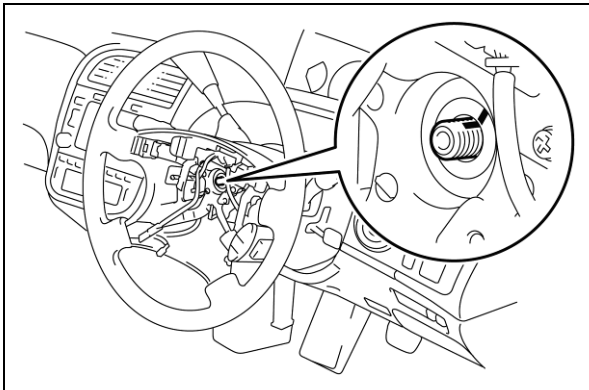
12. REINSTALL THE STEERING WHEEL

- Utilizing the matchmarks, reinstall the steering wheel to the main shaft assembly.
- Reinstall the steering wheel nut and torque to spec.

Torque: 50 N·m (510 kgf·cm, 37 ft·lbf)

- Reconnect the connector.

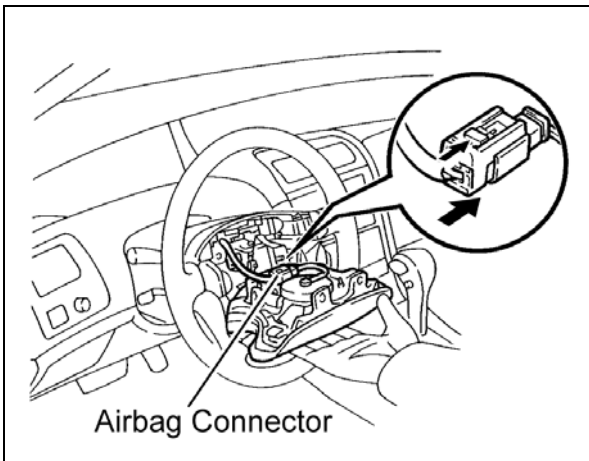
13. REINSTALL THE STEERING WHEEL PAD (AIRBAG)

- Reconnect the horn and airbag connector.
- Reinstall the wheel pad (airbag) to the steering wheel.

- Reinstall the 2 Torx® screws and torque to spec.

Torque: 8.8 N·m (90 kgf·cm, 78 in·lbf)
