Entune Audio Head Unit Software Update (Panasonic)

Service Category Audio/Visual/Telematics

Section Navigation/Multi Info Display

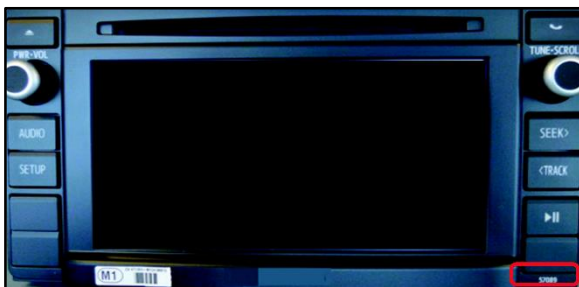
1. Confirm the audio system type by checking the Panel ID printed on the bottom-right or bottom-center of the machine.

Figure 1. Avalon, Avalon HV, Highlander, Highlander HV, Prius V, Sienna, Sequoia, Tacoma, and Tundra.

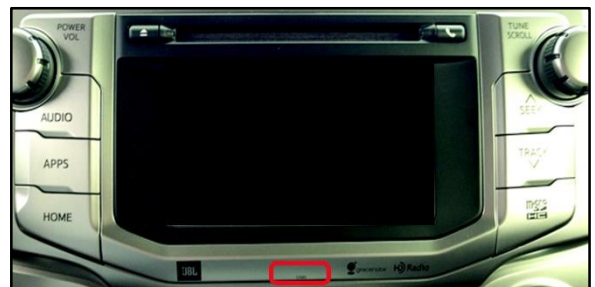
Figure 2. 4Runner

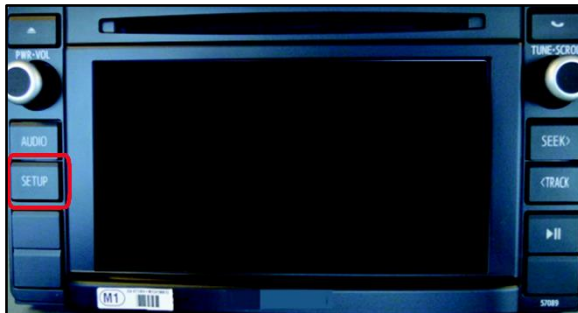
3. Go to the Setup screen.
 - A. For Entune™ Audio:
 - Press the SETUP button on the panel.

Figure 3. 4Runner, Highlander, Highlander HV, Sequoia, Tacoma, and Tundra

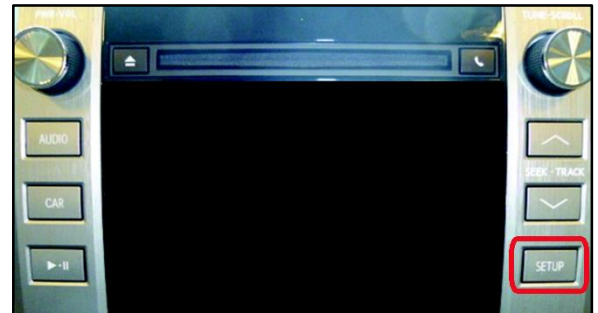
Figure 4. 4Runner

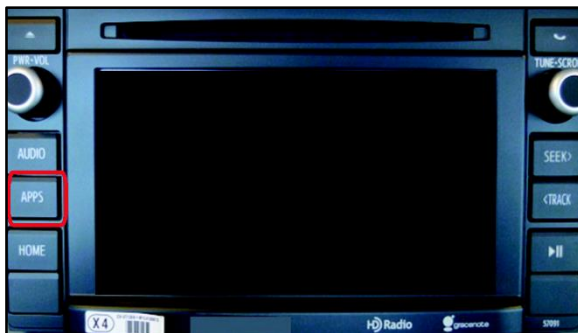
- B. For Entune™ Audio Plus / Entune™ Premium Audio:
 - (1) Press the APPS button on the panel.

Figure 5. 4Runner, Highlander, Highlander HV, Sequoia, Tacoma, and Tundra

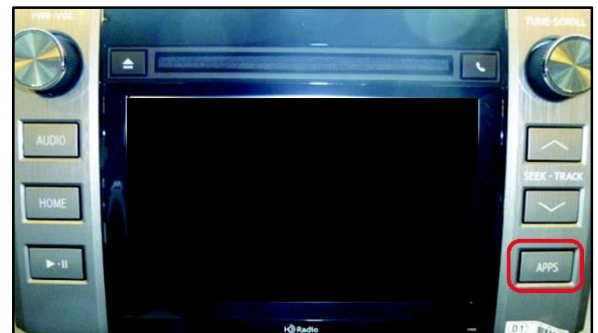
Figure 6. Tundra

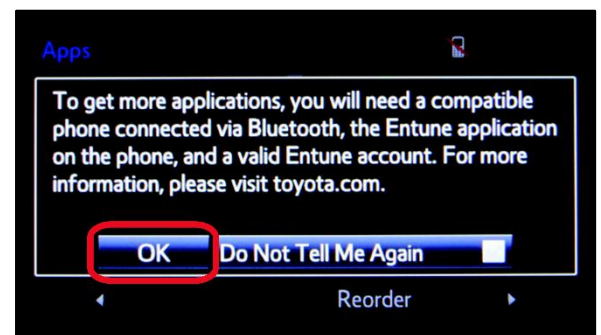
Figure 7.

If Entune™ pop-up displays, select OK.

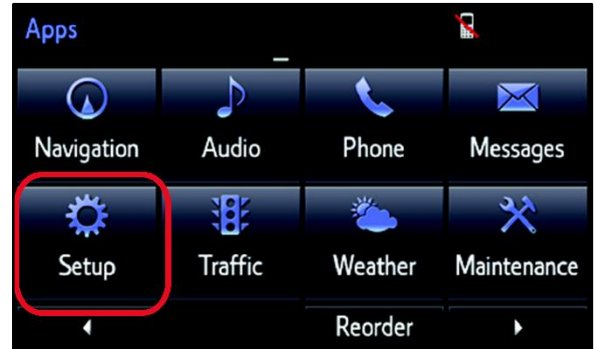
Figure 8.

- (2) Select Setup on the Apps screen.

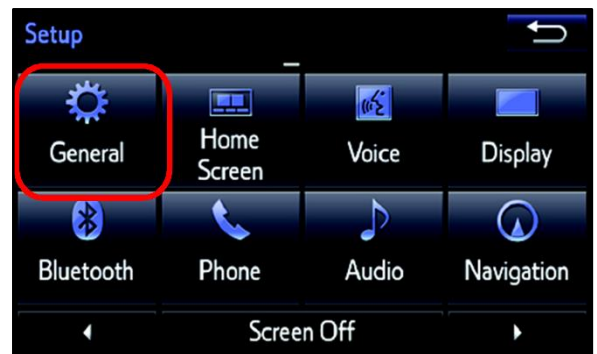
Figure 9.

4. Select General on the Setup screen.

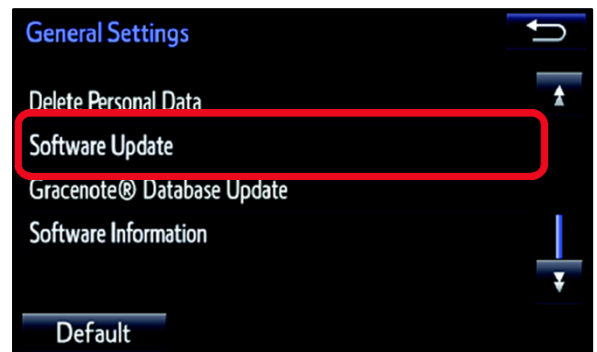
Figure 10.

5. Select Software Update from the list on the General Settings screen.

Scroll down the list until Software Update is displayed.

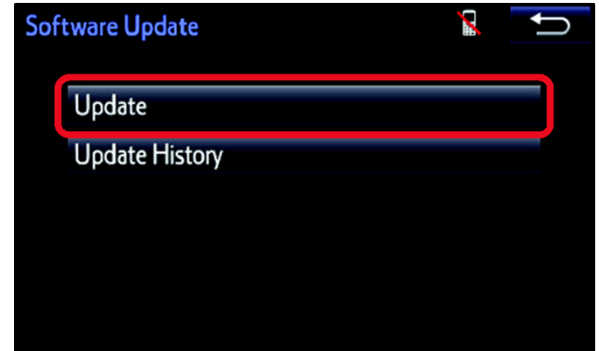
Figure 11.

6. Select Update on the Software Update screen.

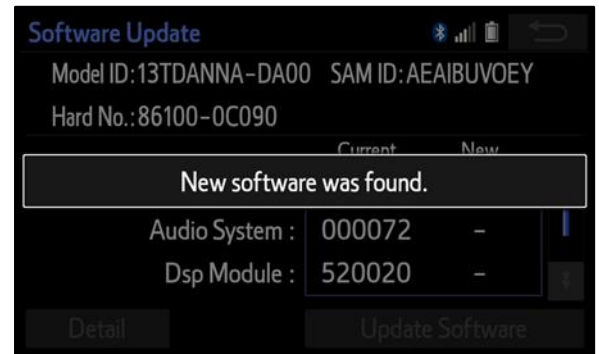
Figure 12.

7. Insert the USB flash drive containing the NEW software into the vehicle USB port.

If the software has been detected properly, a "New software was found" pop-up will display.

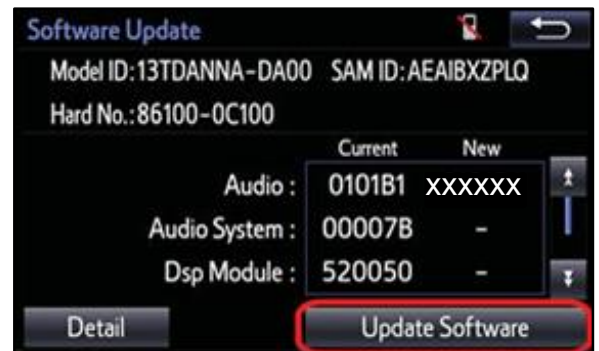
Figure 13.

8. Verify that the NEW software is up-to-date on the Software Update screen, using Table 2 as a guide.

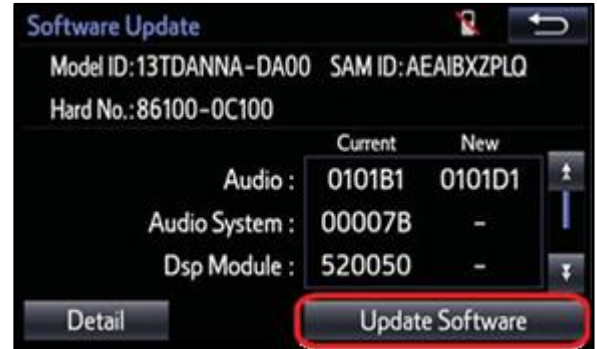
Figure 14.

9. Select Update Software on the Software Update screen.

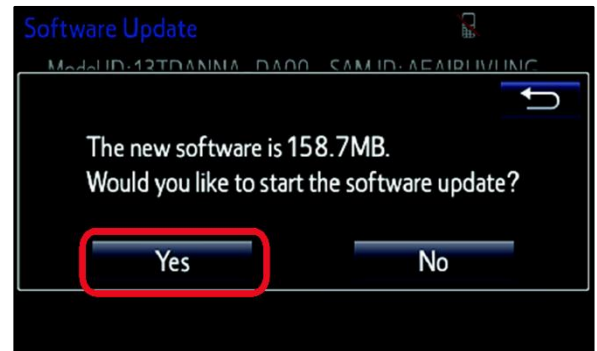
Figure 15.

10. Select Yes on the "Would you like to start the software update?" pop-up.

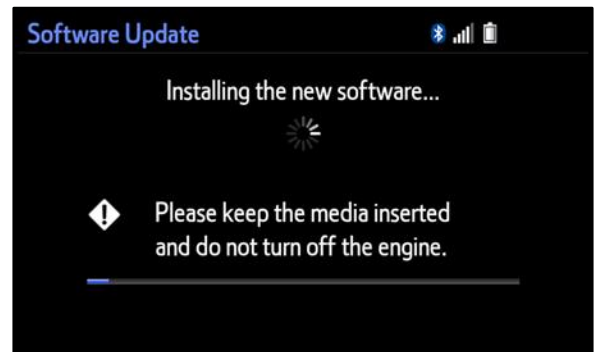
Figure 16.

11. The unit begins installation. The update will take about 10 minutes.

- Do NOT turn off the engine or ACC BEFORE the software is ready for updating.
- Do NOT pull the USB flash drive SST out of the vehicle USB port.

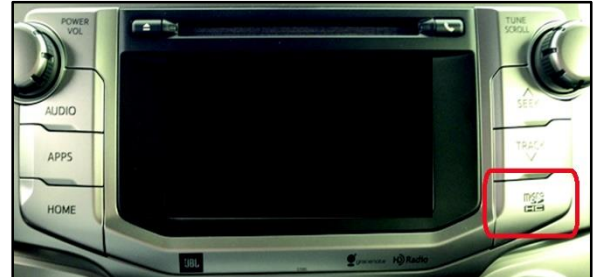
Figure 17.

- Once the update is complete, reinsert the Map Micro SD card into the head unit, cycle the ignition OFF, and continue to step 12.
12. When “The software is ready for updating.” displays, cycle the ignition OFF.

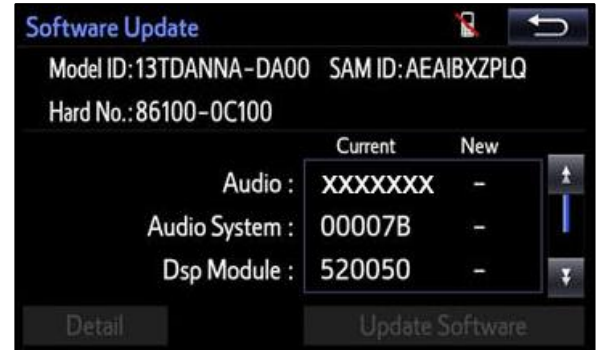
Figure 19.

1. Perform steps 3 – 7 of the Software Update Procedure to re-enter the Software Update screen.
2. Verify that the software information is up-to-date on the Software Update screen.
