Techstream ECU Flash Reprogramming Procedure

Service Category Engine/Hybrid System

Section Engine Control

Market USA

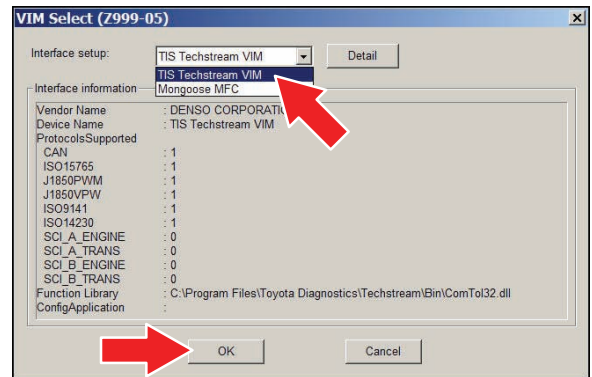
- If using TIS Techstream, select *TIS Techstream VIM* (this is the default).

Figure 3. Select TIS Techstream VIM (default) to Use TIS Techstream

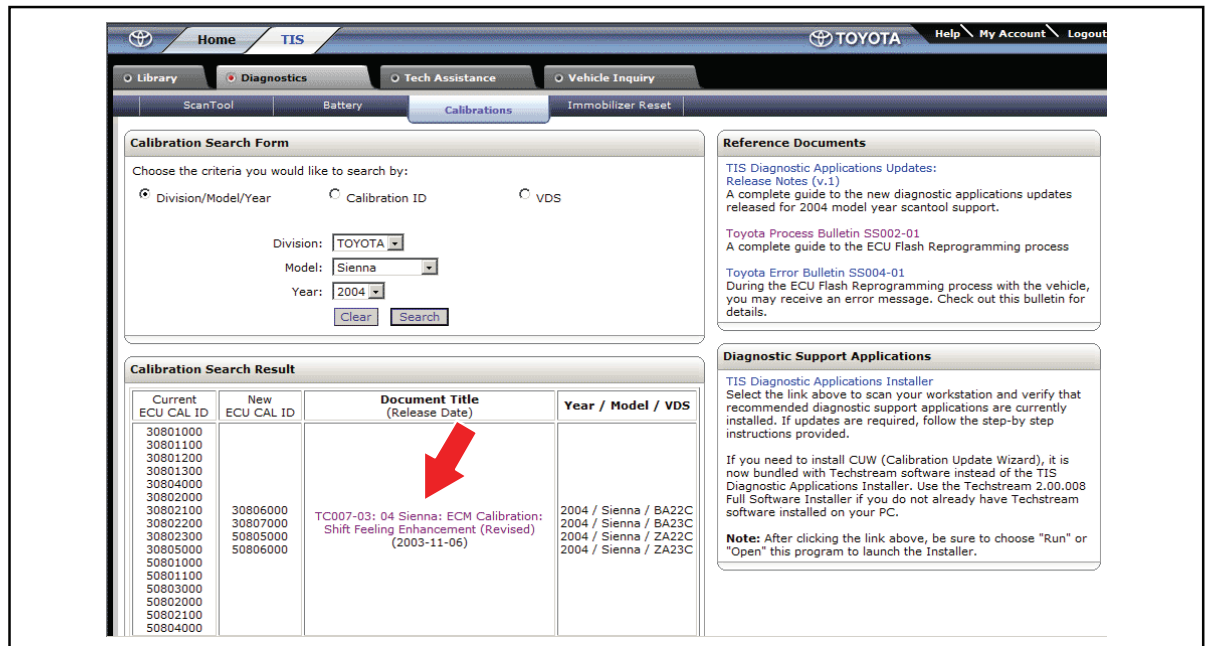
Figure 8.

H. To review the Service Bulletin and access the calibration file, click the Service Bulletin link in the *Document Title* column of the *Calibration Search Result* portlet.

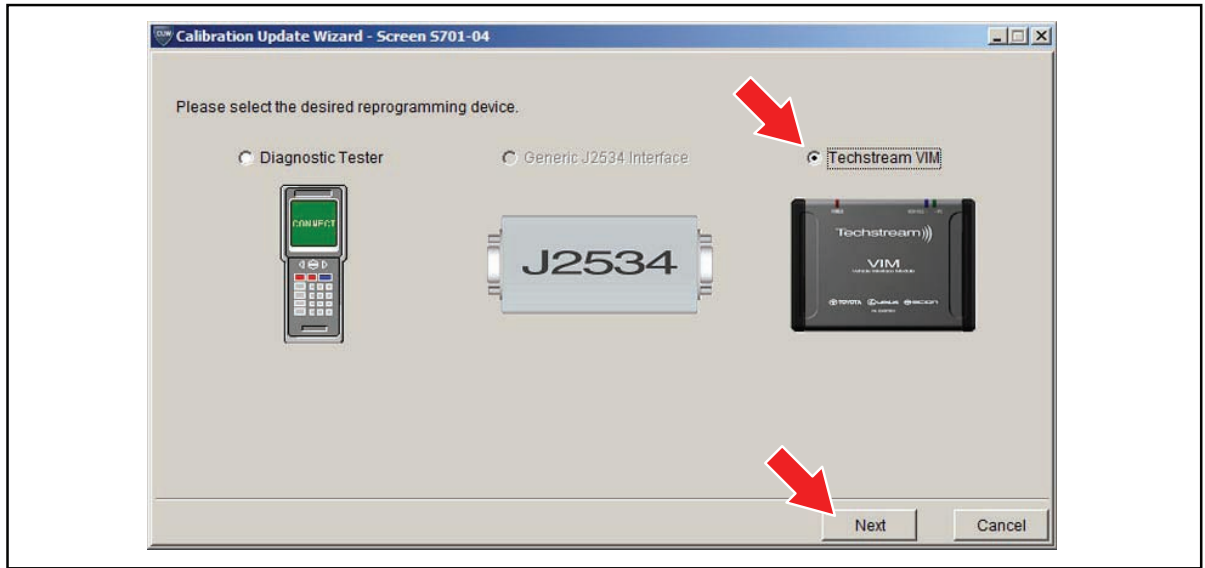
Figure 13.

- D. When using TIS Techstream, select *Techstream VIM* as the desired programming device. Then click *Next*.

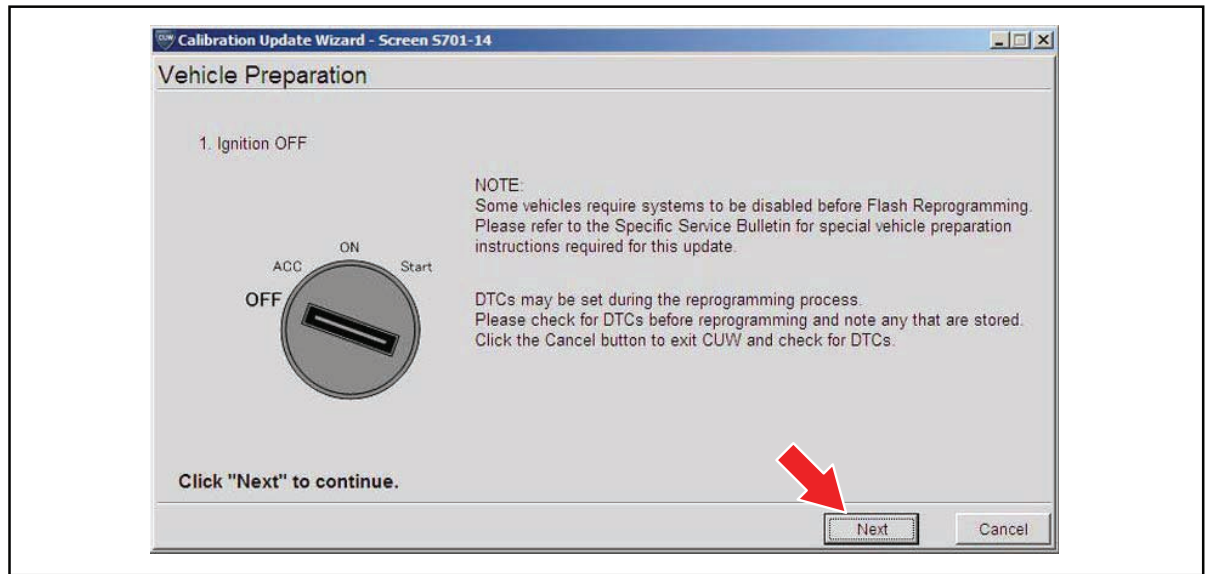
Figure 18.

G. Turn ignition OFF. Then click *Next*.

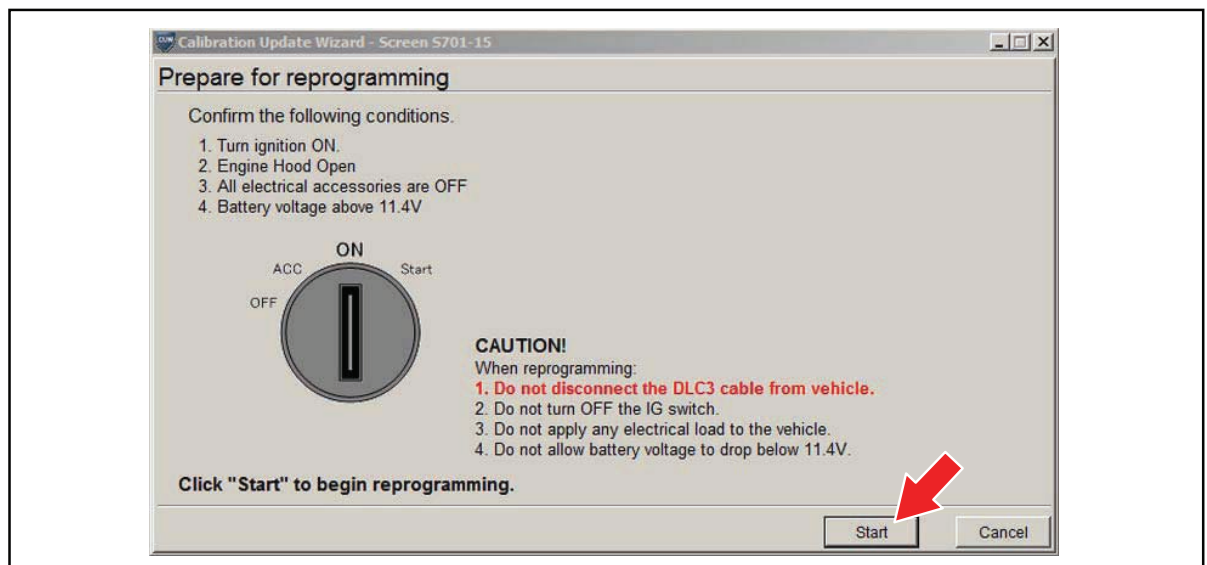
Figure 22.

- K. Turn ignition to the ON position. Then click *Start*.

If key cycle is NOT done properly, reprogramming will stop at 10% and Cal 2 will fail to load.

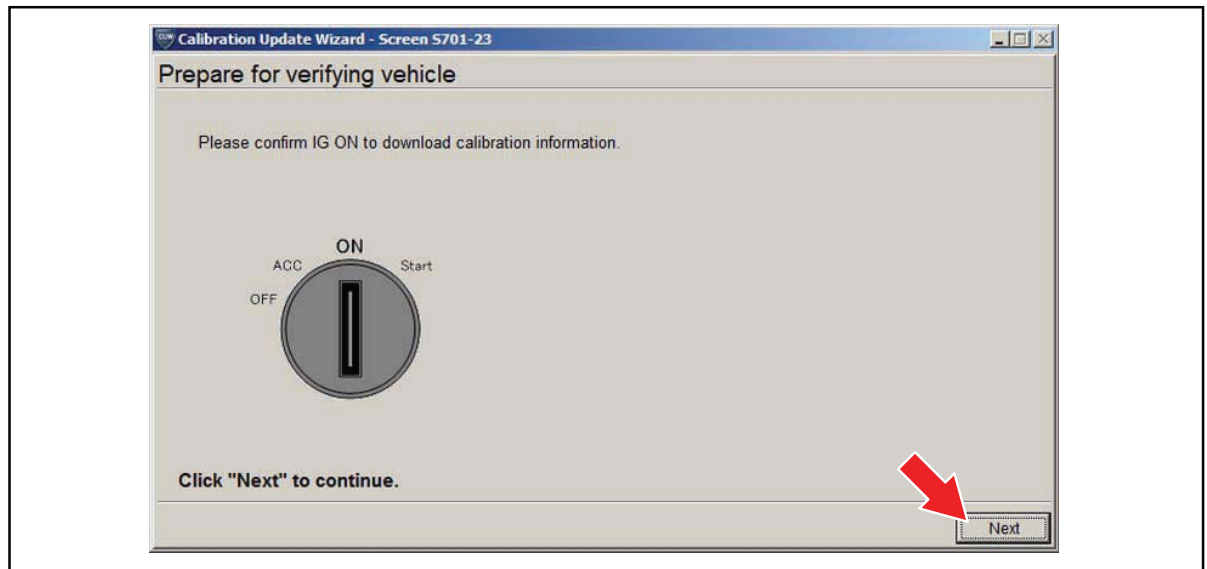
Figure 25.

N. Turn ignition to the ON position. Then click *Next*.
