Entune Audio Head Unit Software Update (Panasonic)

Service Category Audio/Visual/Telematics

Section Navigation/Multi Info Display

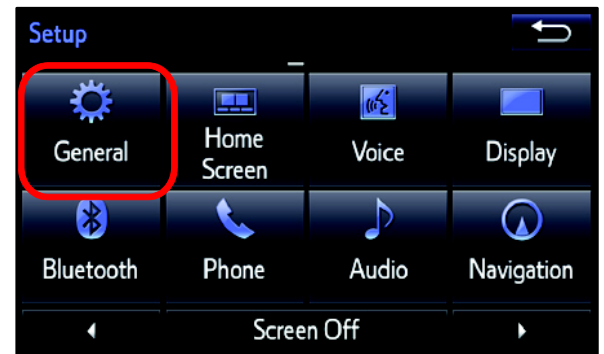
Figure 9.

5. Select *General* on the Setup screen.

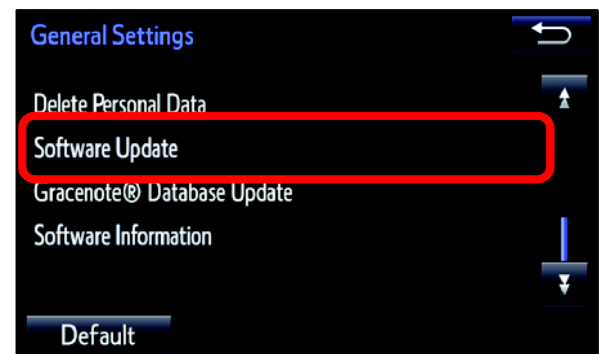
Figure 10.

6. Select *Software Update* from the list on the General Settings screen.

Scroll down the list until *Software Update* is displayed.

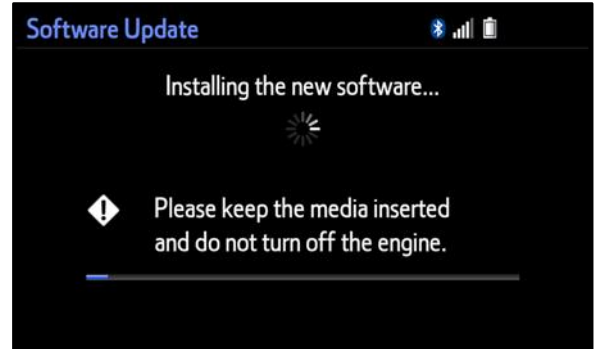
Figure 16.

- When “The software is ready for updating.” displays, cycle the ignition OFF.
