# Entune Audio Head Unit Software Update (Panasonic)

YEAR(S)	MODEL(S)	ADDITIONAL INFORMATION
2014 - 2015	4Runner, Highlander, Highlander HV, Sequoia, Tacoma, Tundra	
2015	Avalon, Avalon HV, Prius V, Sienna, Venza

## **Entune Audio Head Unit Software Update (Panasonic)**

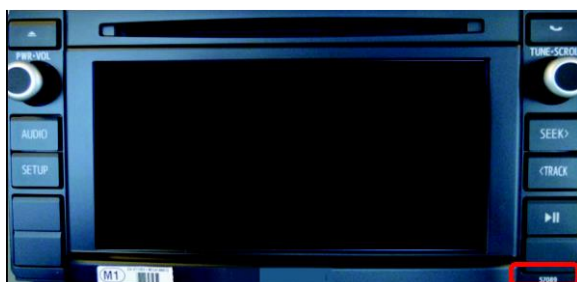
1. Confirm the audio system type by checking the Panel ID printed on the bottom-right or bottom-center of the machine.

**Figure 1. Avalon, Avalon HV, Highlander, Highlander HV, Prius V, Sienna, Sequoia, Tacoma & Tundra.**

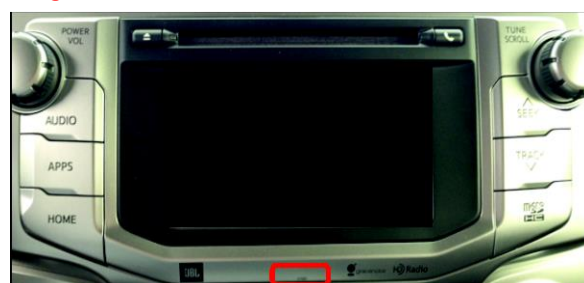
**Figure 2. 4Runner**

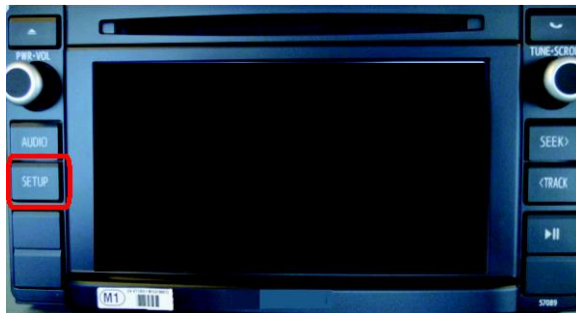
Press the **SETUP** button on the panel.

**Figure 3. 4Runner, Highlander, Highlander HV, Sequoia, Tacoma & Tundra.**

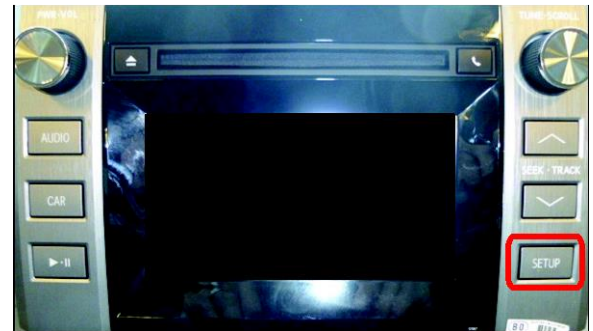
**Figure 4. 4Runner**

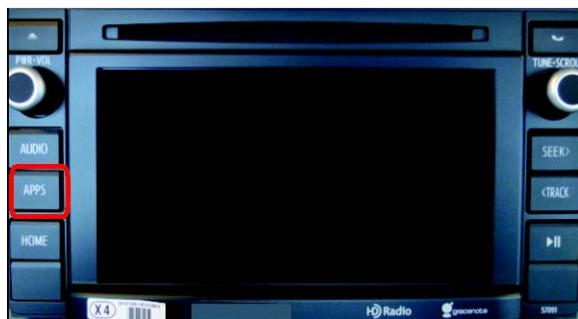
- (1) Press the **APPS** button on the panel.

**Figure 5. 4Runner, Highlander, Highlander HV, Sequoia, Tacoma & Tundra**

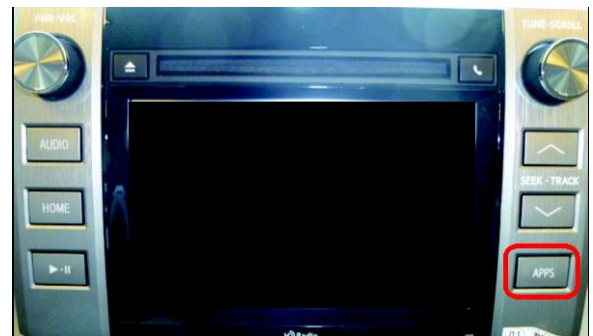
**Figure 6. Tundra**

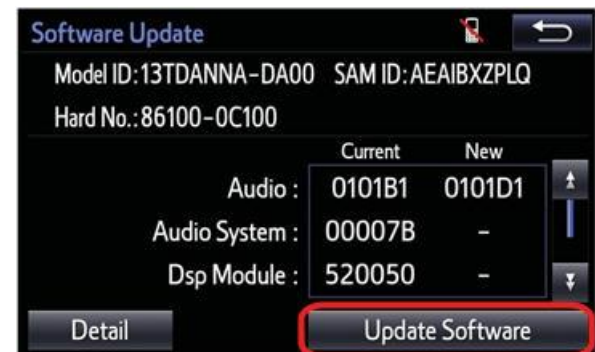
**Figure 13.**

7. Verify that the new software is up-to-date on the *Software Update* screen.

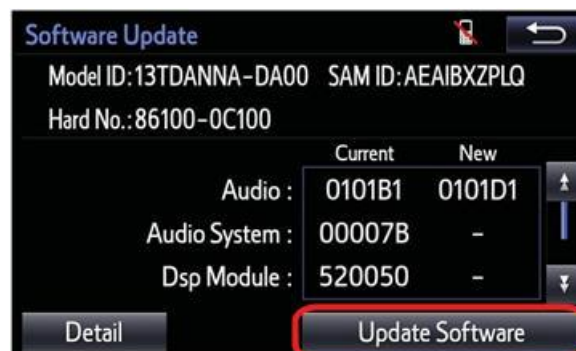
**Figure 14.**

8. Select *Update Software* on the *Software Update* screen.

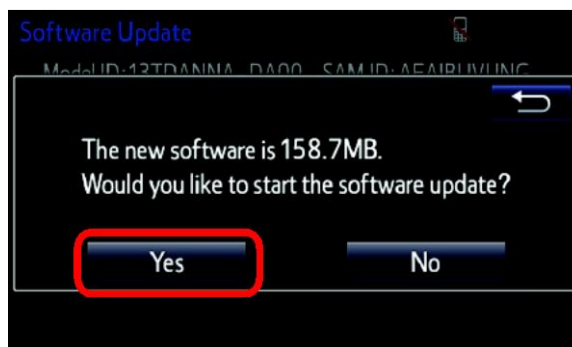
Figure 15.

9. Select Yes on the “Would you like to start the software update?” pop-up.

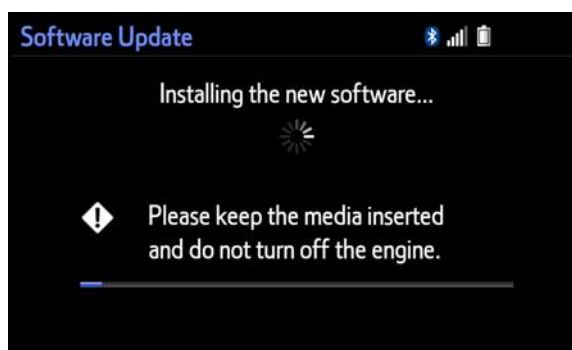
Figure 16.

10. The unit begins installation. The update will take about 10 minutes.

- Do NOT turn off the engine or ACC before the software is ready for updating.
- Do NOT pull the USB Drive SST out of the vehicle USB port.

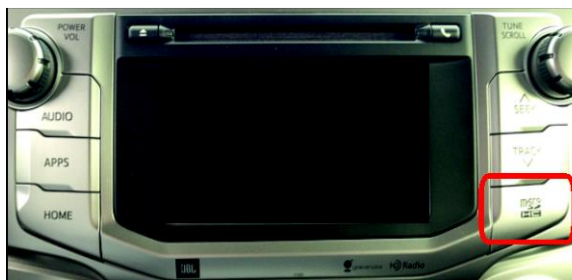
Figure 17.

If update fails and the error message “New software is not compatible with the system.” displays, cycle the ignition OFF, remove the Map Micro SD Card from the head unit, and repeat steps 2 – 11.

Once update is complete, reinsert the Map Micro SD card into the head unit, cycle the ignition OFF, and proceed to step 13.

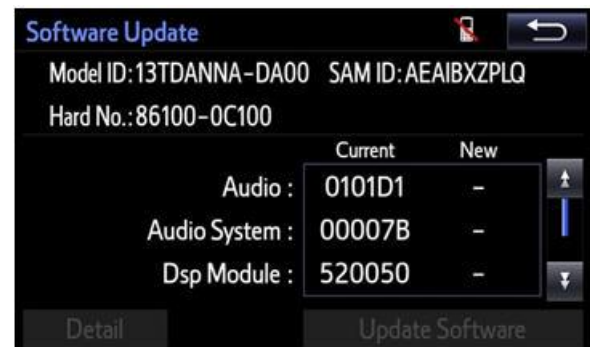
Figure 19

1. Perform steps 3 – 7 of the Software Update procedure to re-enter the *Software Update* screen.
2. Verify that the software information is updated on the *Software Update* screen.
