**Technical Service  
Information Bulletin**

**AUDIO QUICK REFERENCE GUIDE**

'01 – '07 All Lexus

**AUDIO**  
**AU001-06**

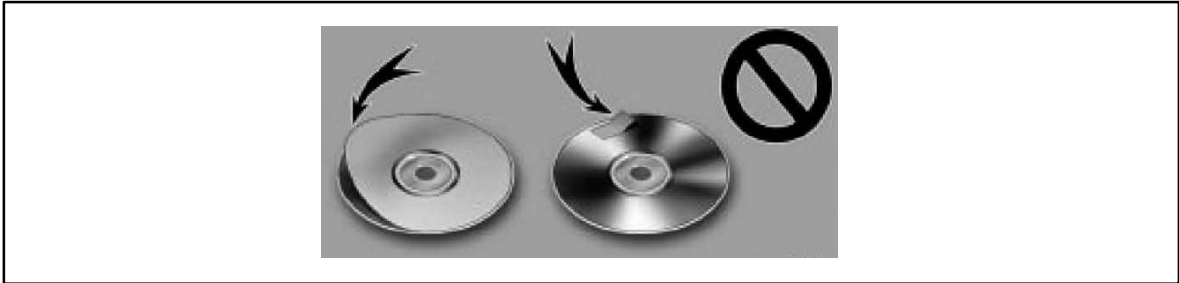
2. Inspect customer’s CDs. Common problem areas are:

- CDR (with label)

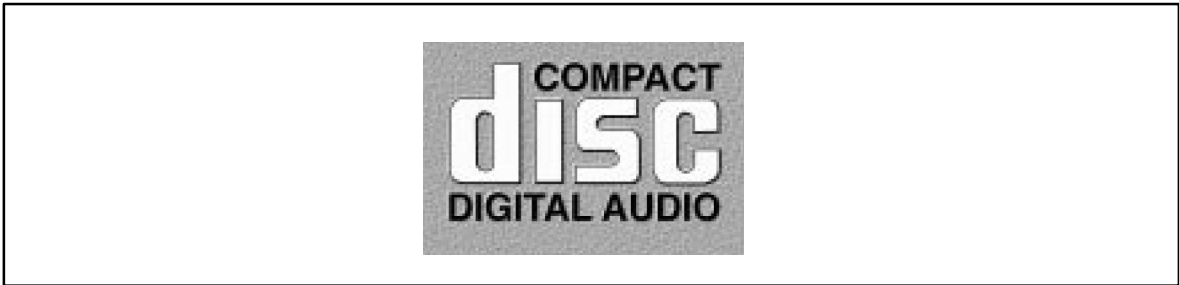
- Scratches/cracks
- Fingerprints
- Dust and/or dirt
- 8 cm diameter CDs
- CD Digital Audio logo (Confirm the CD has this logo. Lexus CD player may NOT be able to play CDs that do NOT have this logo.)
