TECHNICAL INSTRUCTIONS
FOR
SAFETY RECALL E0L
DRIVER SIDE SEAT TRACKS REPLACEMENT
CERTAIN 2006-2010 YARIS SEDAN

II. BACKGROUND

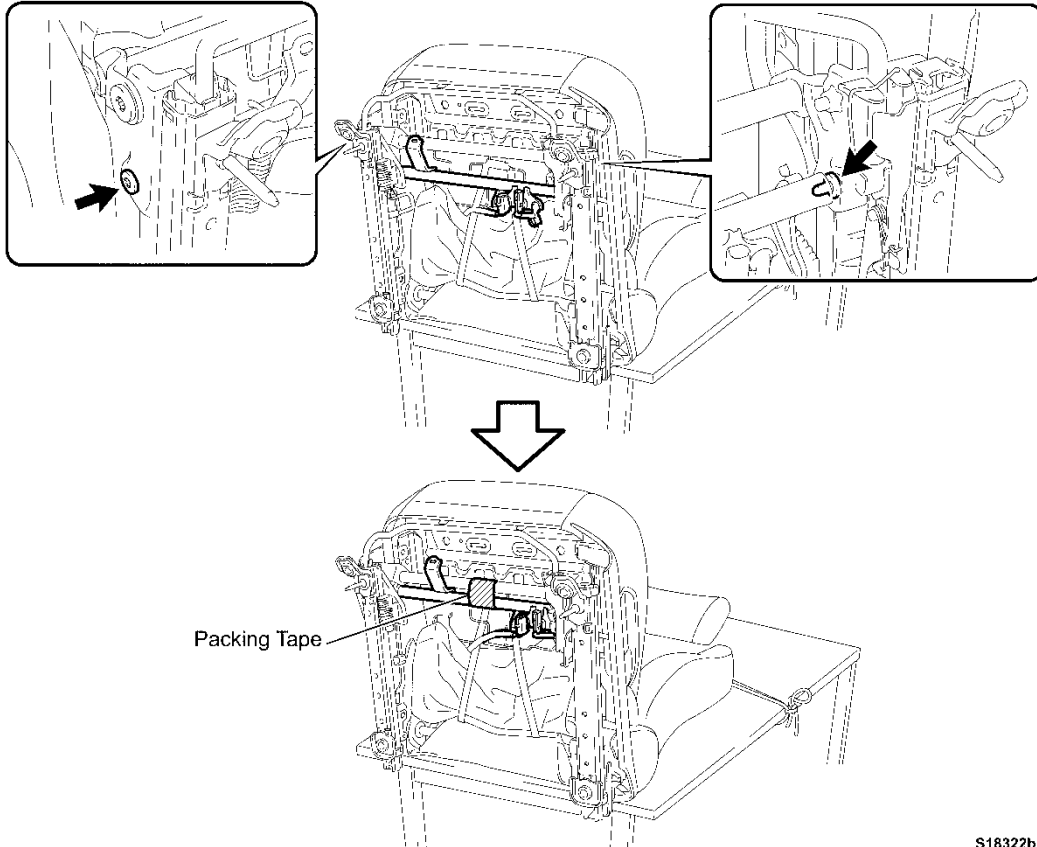
S18322bP

- c) Remove the 2 bolts, using a T40 Torx socket, to detach the adjusting rod.
- d) Using tape or zip ties, secure the adjusting rod to the seat frame as shown below.

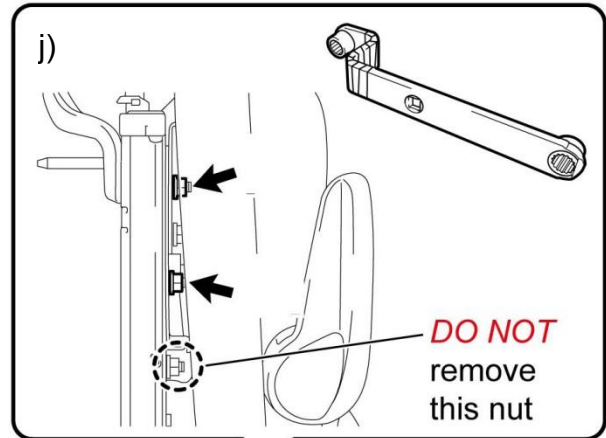
S18323dS

- g) Remove the 2 nuts securing the seat position sensor and front part of the seat track assembly.
- h) Place the seat position sensor in a safe location where it cannot be damaged.
- i) Remove the 2 remaining nuts securing the inner seat track.
- j) Using the seat track wrench, remove the 4 nuts from the outer track.
- k) Carefully remove both seat tracks from the seat assembly.

- Remove the seat position sensor nuts and seat sensor first to ensure it is not dropped or damaged.
- **DO NOT** remove the nut identified below.

- l) Discard the old nuts to ensure that they are not reused.

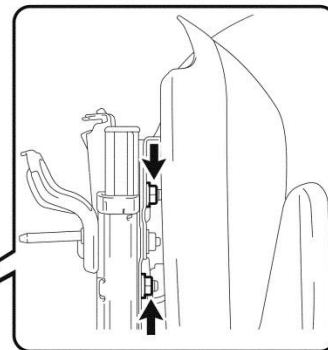
S18966bS

- Tighten the outer track nuts to spec.
- Ensure that the track adjustment gauge pins are still flush with the seat track and that the track orientation did not move while torquing the nuts.

Standard Torque: 25 Nm (255 kgf cm, 18 ft lbf)
