T-SB-0055-13

Sunvisor Mount Reinforcement Bracket Kit Installation

YEAR(S)	MODEL(S)	ADDITIONAL INFORMATION
2007 – 2011	Camry, Camry HV

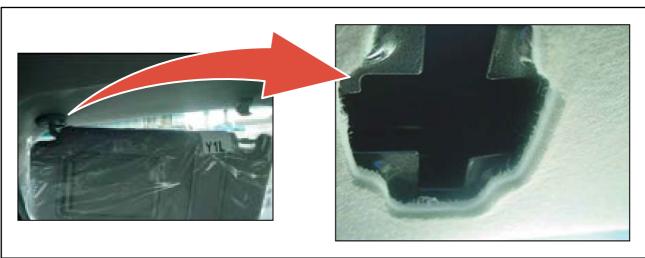
Figure 1.

The purpose of this bulletin is to provide a procedure to repair the sunvisor mount after improper installation/removal or if the sunvisors are operated forcefully resulting in the sheet metal at the mounting area being damaged. If this has occurred, the sunvisor base located on the headliner may become loose. To address this, a newly designed mounting bracket has been developed to address this condition. Use the following repair procedures to install the new mounting brackets.

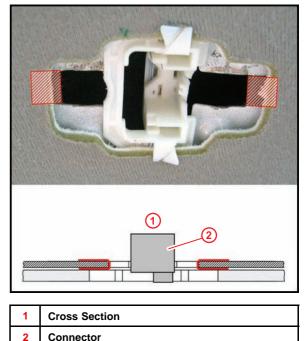
Figure 6.

5. Apply felt to the roof panel opening for visor as shown.

From the Noise Kit, cut 2 felt strips of the following dimensions:

Length: 25 mm (1 in.)

Width: 9 mm (3/8 in.)

Thickness: 0.5 mm (0.02 in.) thinnest felt sheet material in the kit

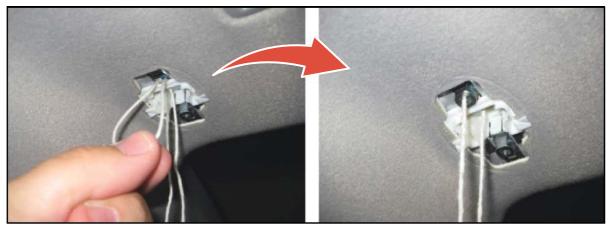
C. Reposition the string or wire as indicated in Figure 12.

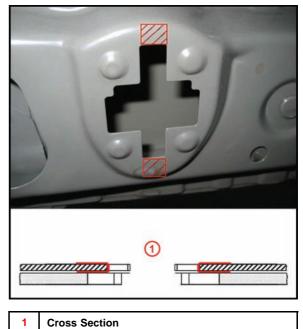
Figure 20.

5. Apply felt to the roof panel opening for visor as shown.

From the Noise Kit, cut 2 felt strips of the following dimensions:

Length: 25 mm (1 in.)

Width: 9 mm (3/8 in.)

Thickness: 0.5 mm (0.02 in.) thinnest felt sheet material in the kit
