Water Pump Inspection and Diagnostic Tips

Market USA

This service bulletin contains water pump leak inspection and diagnostic tips.

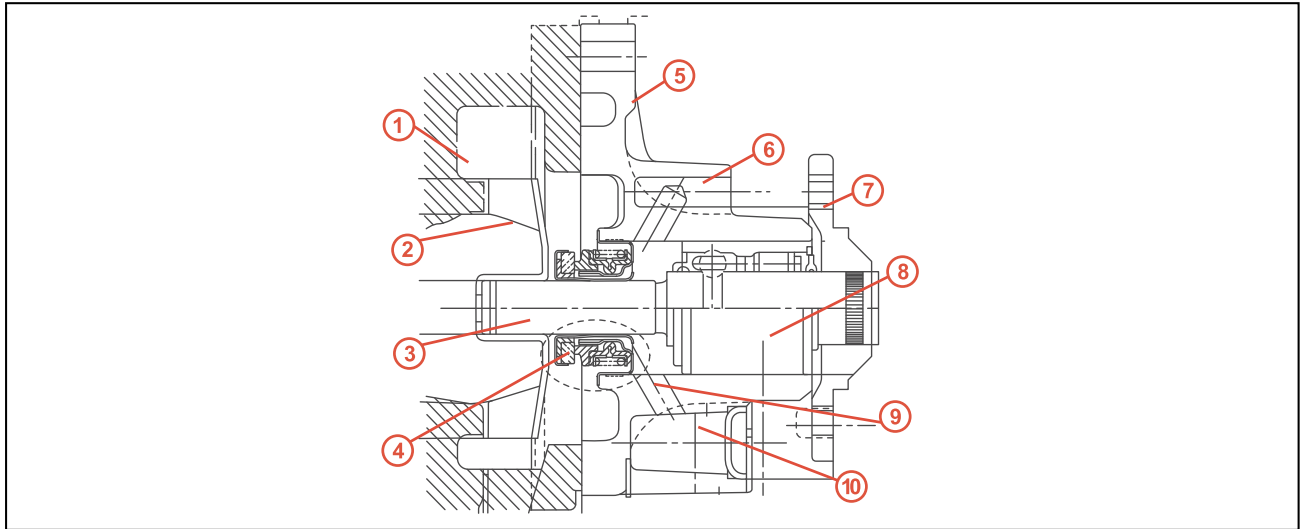
Figure 1. Water Pump Construction

1	Engine Block
2	Impeller
3	Shaft
4	Mechanical Seal
5	Pump Body

6	Breather Hole
7	Pulley Seat
8	Bearing
9	Weep Hole
10	Fluid Catch Pocket

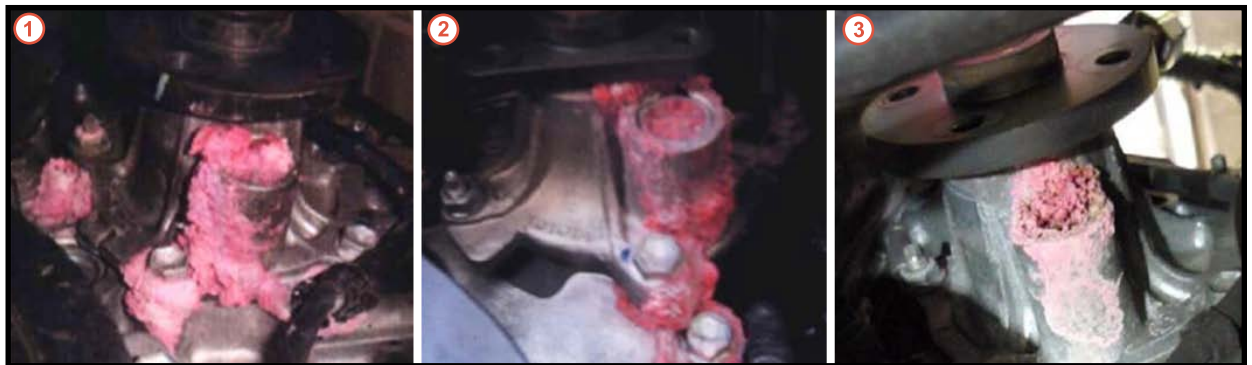
Figure 6. Possible Temporary Leaks – Inspect Water Pump

1	Thick coolant deposits present on water pump only
2	Moderate coolant deposits present on water pump only
3	Light coolant deposits present on water pump only

If the above conditions do not apply or amount of deposits are in question, the leak may have been temporary and additional inspection is necessary.

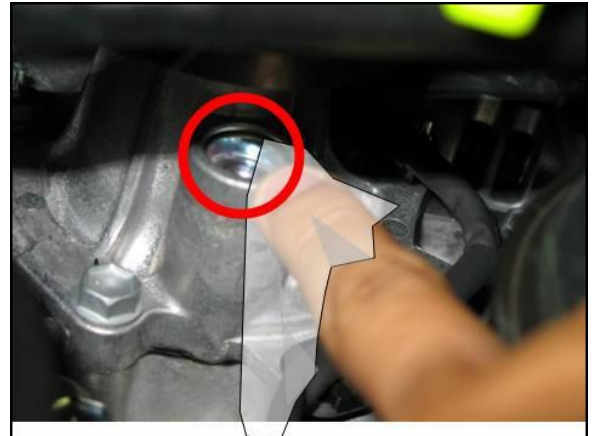
Figure 7.

2. A paper towel should be used to determine if a leak is current, or was temporary due to debris that has now cleared.

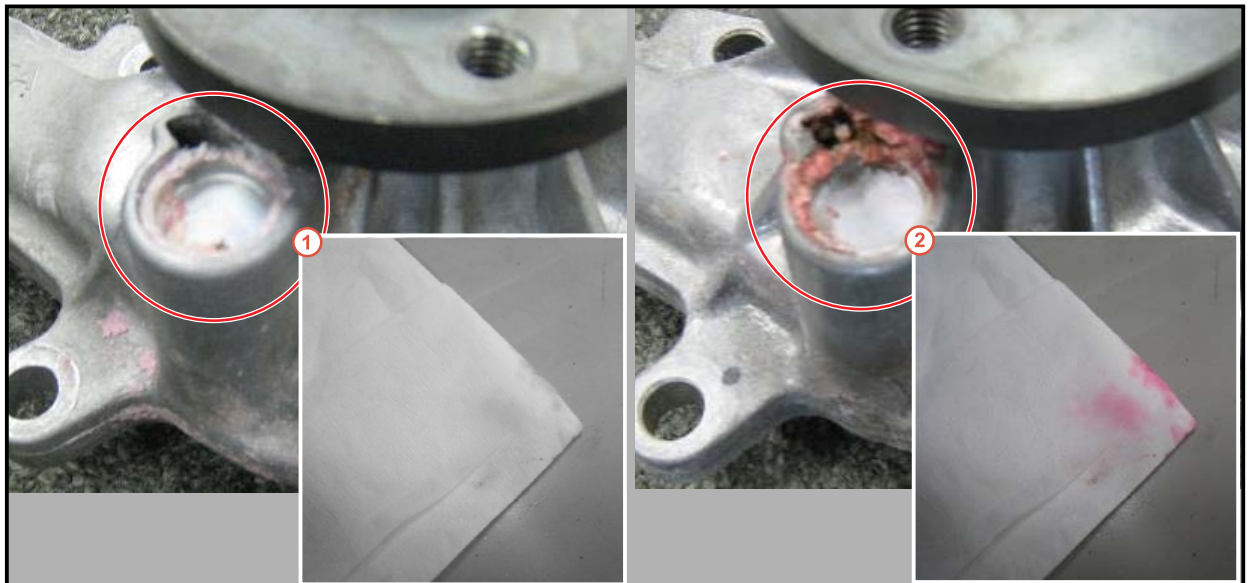
Figure 8.

1 Dry Paper Towel DO NOT Replace Water Pump

2 Wet Paper Towel Replace Water Pump

3. Apply a dry paper towel to the coolant deposits around the weep hole. If the paper towel remains dry the leak was temporary and the water pump does not need to be replaced. If the paper towel becomes wet the leak is current and the water pump should be replaced.
