Headliner Sagging/Loose Behind Moon Roof Opening

YEAR(S)	MODEL(S)	ADDITIONAL INFORMATION
2013 – 2014	Avalon, Avalon HV

Some 2013 – 2014 model year Avalon and Avalon HV vehicles may exhibit a condition where the headliner is sagging or loose along the rear edge of the moon roof opening and there is a noticeable gap between the headliner and sun shade. This is due to the force of the headliner being greater than the strength of the Dual Lock™ fasteners/adhesive which causes them to separate, allowing the headliner to sag in this area. Use the following Repair Procedure to address this condition.

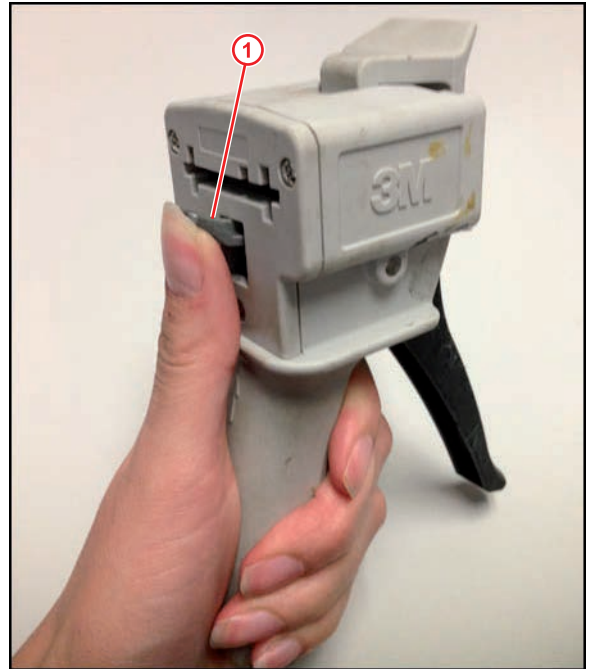
Figure 7.

A. Push up on silver release lever.

1	Silver Release Lever
----------	-----------------------------

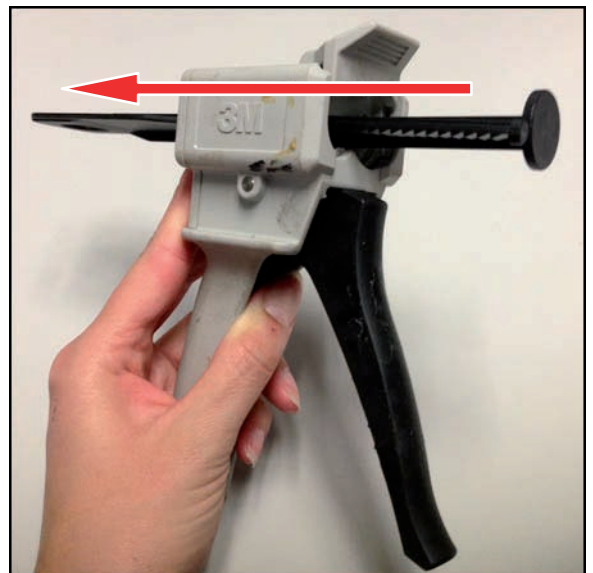
Figure 8.

B. Insert plunger from the left portion of the adhesive gun (opposite side from lever), flat end first, stepped portion down.
